YOUR INSPECTION REPORT

187 Saint Johns Road
Toronto, ON M6P 1V3

INSPECTION DATE:
Monday, September 24, 2018

RE: Report No. 2338
187 Saint Johns Road
Toronto, ON
M6P 1V3

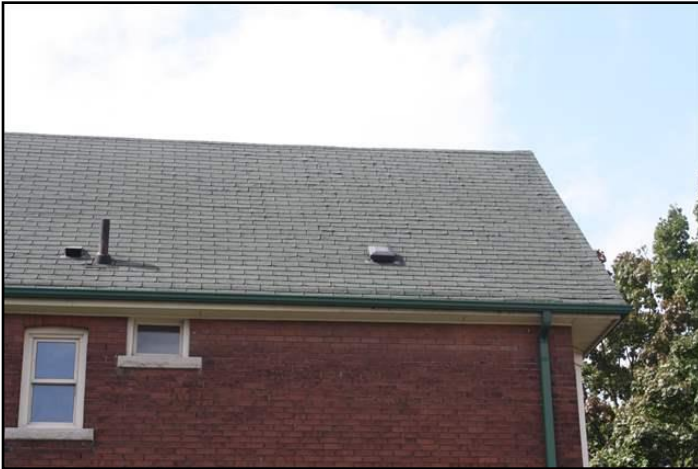
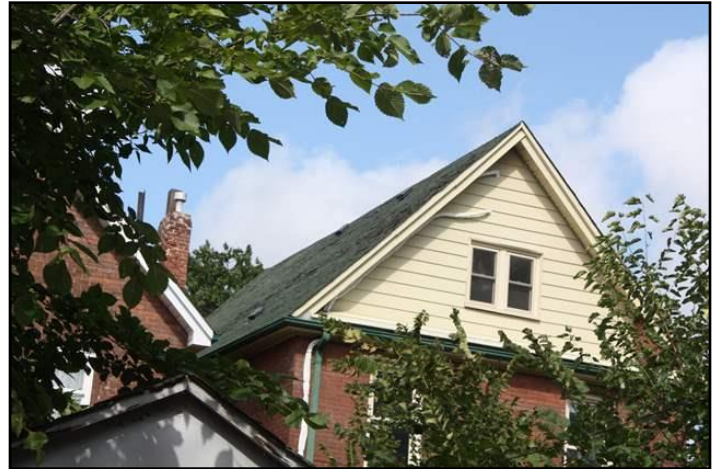
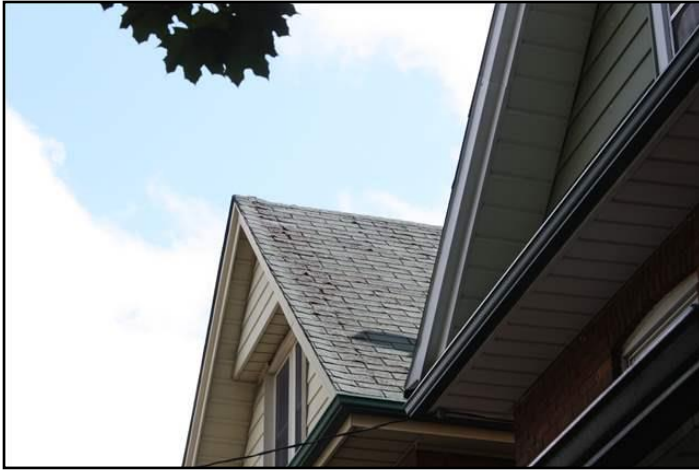
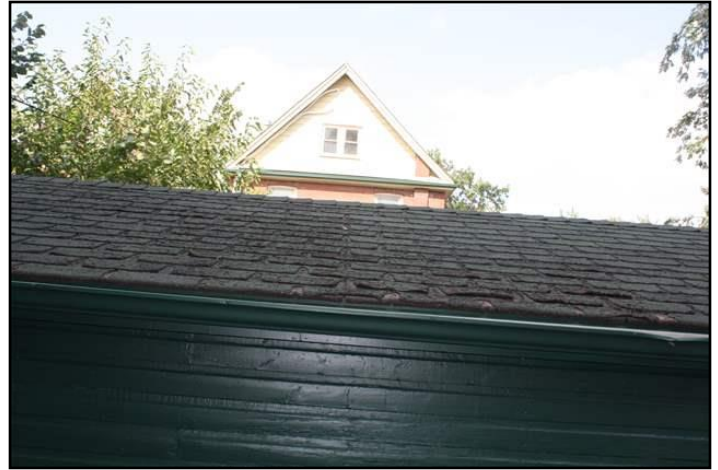
Condition: • [Old, worn out](#)

The current roof covering is old / worn, particularly on the west side roof.

Implication(s): Chance of water damage to contents, finishes and/or structure

1. Old, worn out

2. Old, worn out

3. Old, worn out

4. Old, worn out

Task: Replace

Cost: \$6,000 - \$9,000

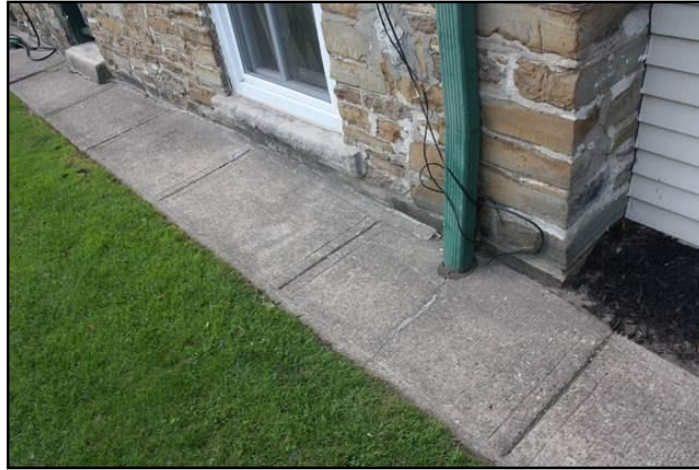
Condition: • [Discharge below grade](#)

Also, if the downspouts are connected to the city sewers, removal is required. More information here -

5. Discharge below grade

Task: Improve

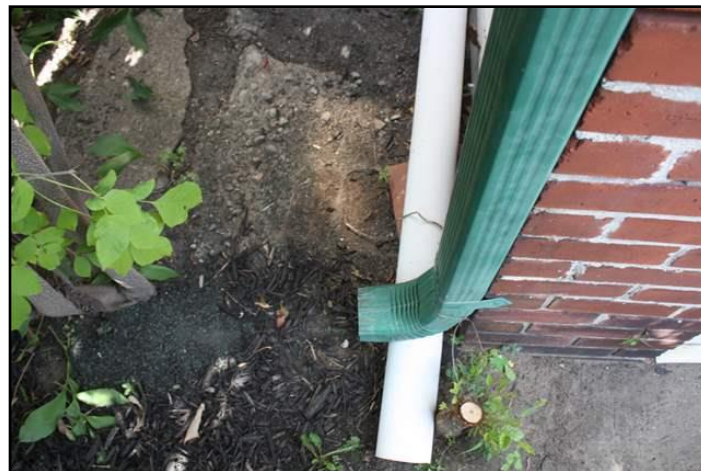
Condition: • [Discharge too close to building](#)

6. Discharge too close to building

Task: Improve

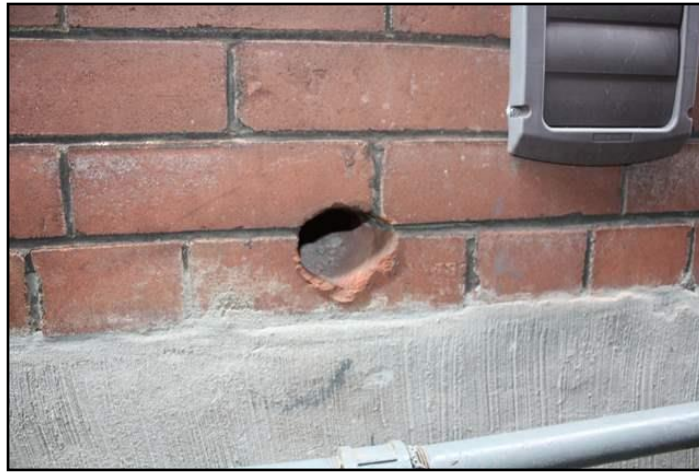
7.

Condition: • Gap at Wall

Task: Seal

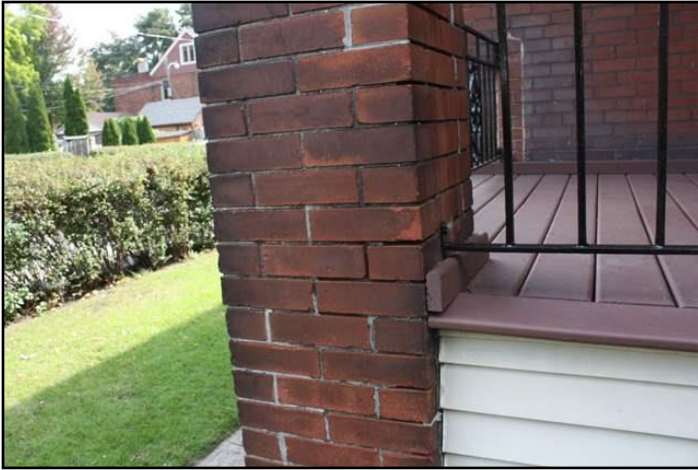
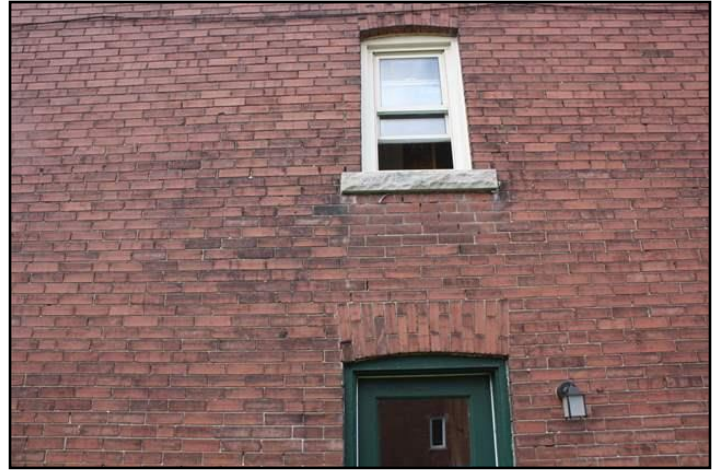
Condition: • [Mortar deterioration](#)

8. Mortar deterioration

9. Mortar deterioration

Task: Repair

Repointing

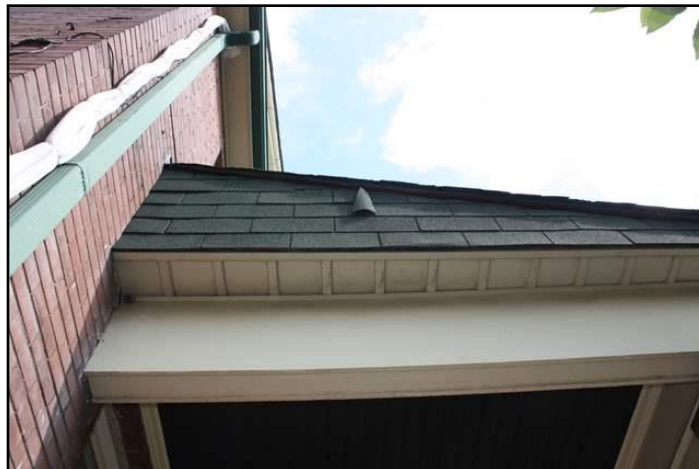
Condition: • [Loose, missing or torn tabs](#)

Implication(s): Chance of water damage to contents, finishes and/or structure

10. Loose, missing or torn tabs

Task: Repair

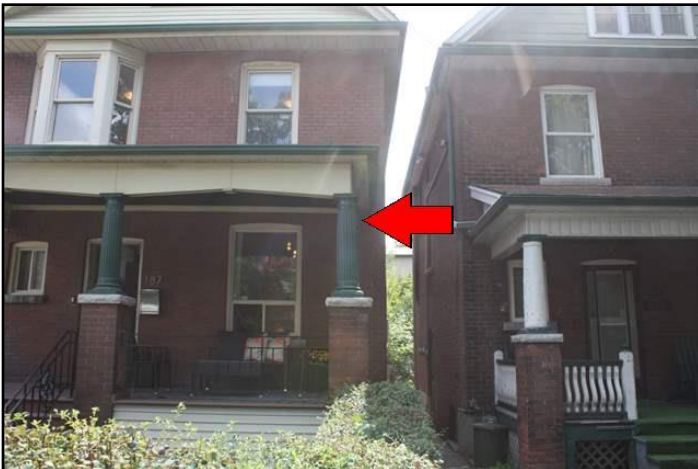
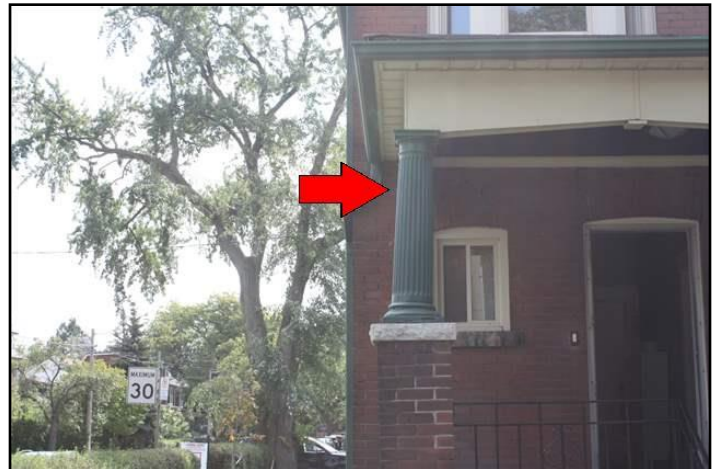
Condition: • [Leaning](#)

Minor lean noted. Likely occurred over long period of time.

11. Leaning

12. Leaning

Task: Repair / Replace

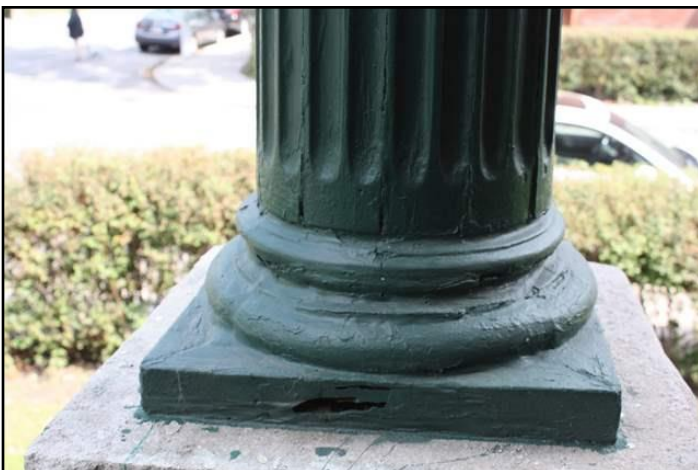
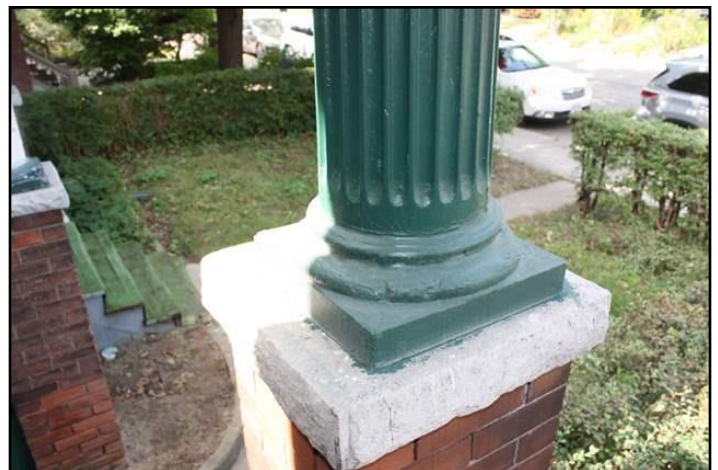
Condition: • [Rot](#)

Wood columns rot painted over. spongy in areas.

13. Rot

14. Rot

Task: Repair / Replace

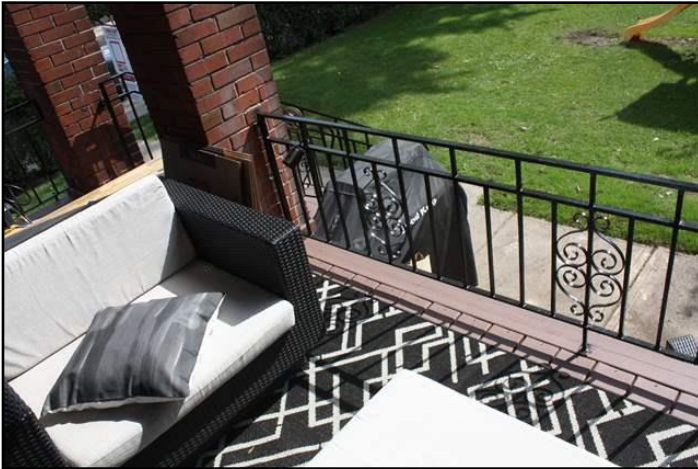
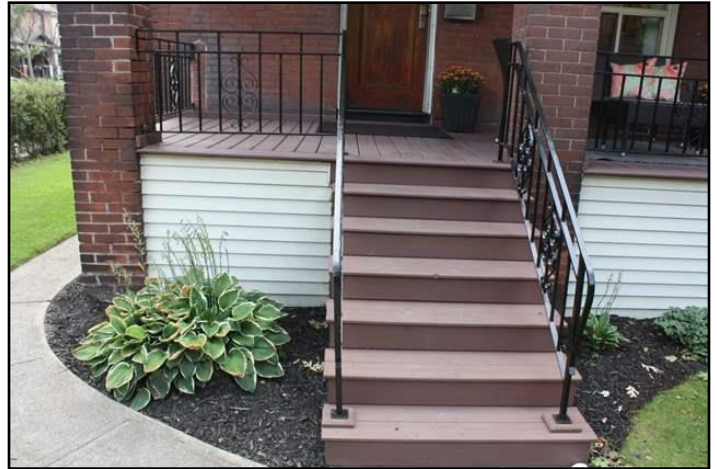
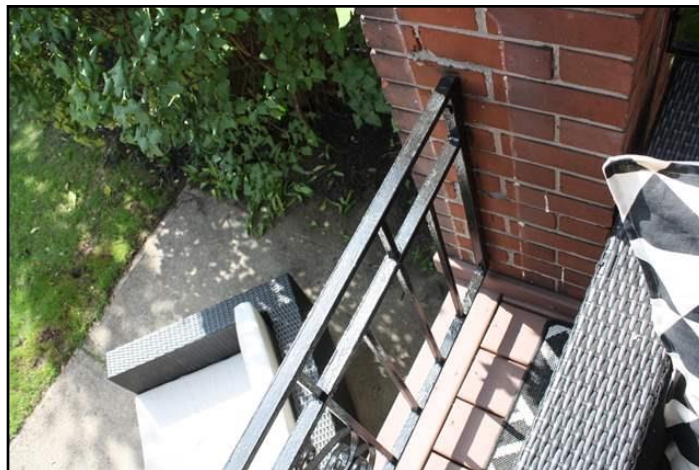
Condition: • [Loose](#)

Loose or weak at various areas of hand and guard rails.

Implication(s): Fall hazard

15. Loose

16. Loose

17. Loose

Task: Improve/Repair/Replace

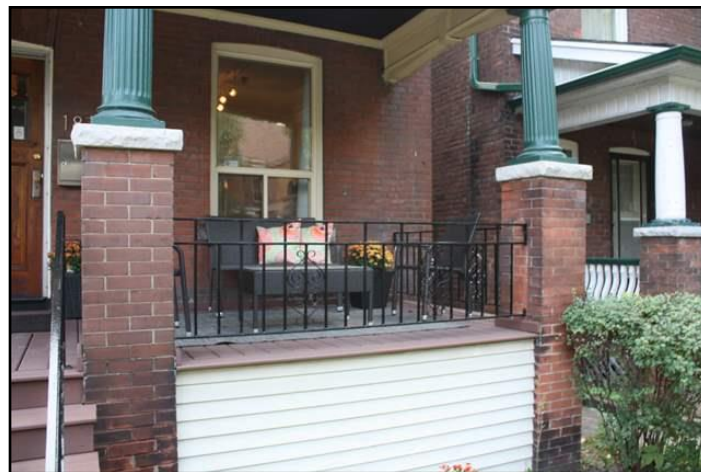
Condition: • [Too low](#)

Implication(s): Fall hazard

18. Too low

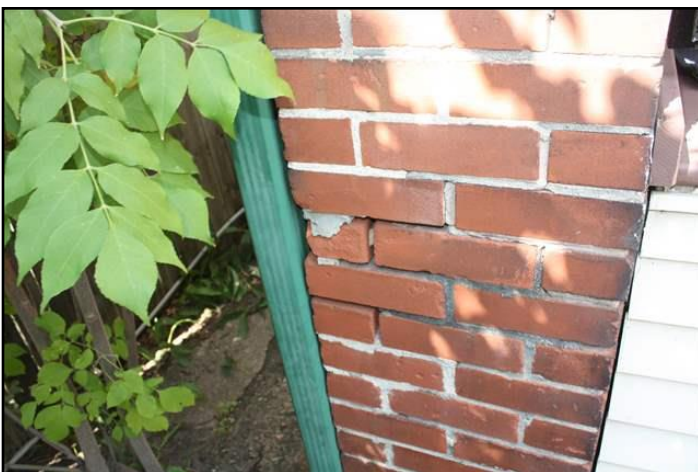
Condition: • [Masonry deteriorated](#)

19. Masonry deteriorated

Task: Repair

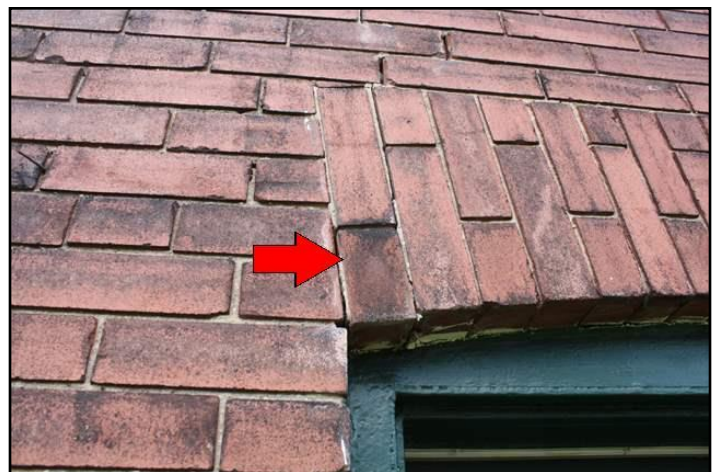
20. Loose brick

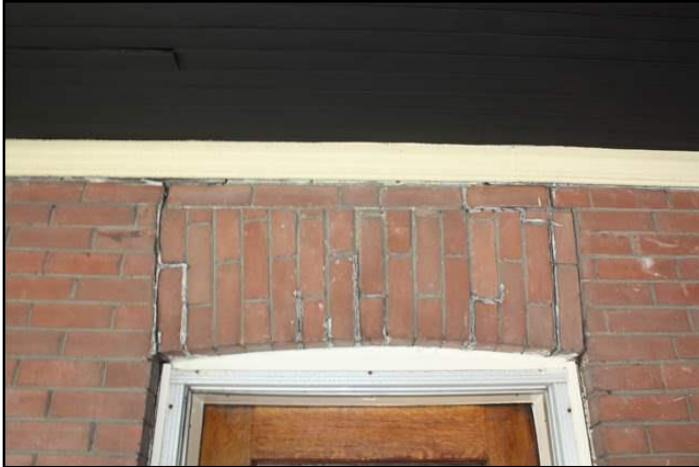
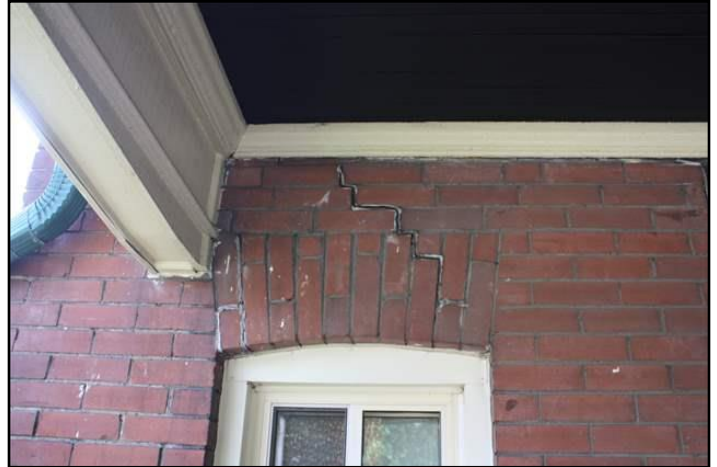
Condition: • [Cracked](#)

Very common to find cracks and settlements at arches above windows. Patch to prevent further damage and/or movement

21. example

22. example

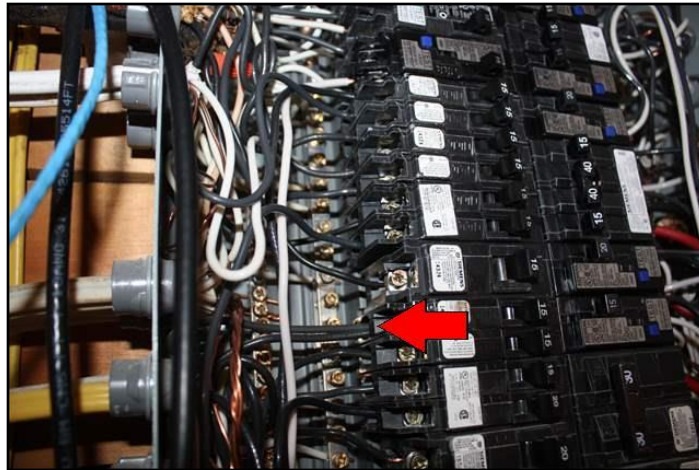
Condition: • [Double taps](#)

Implication(s): Fire hazard

23. Double taps

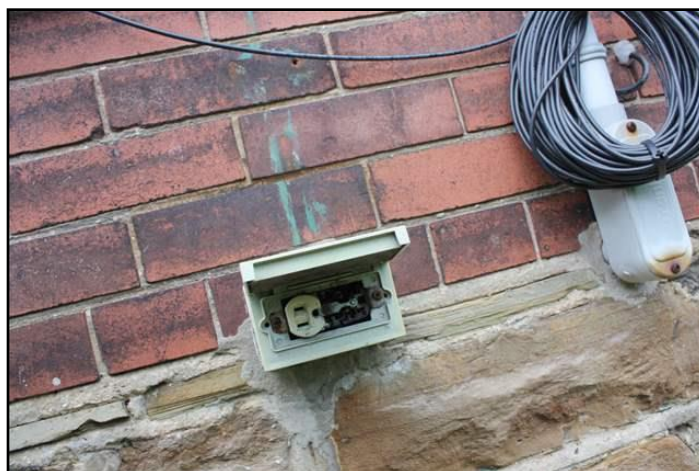
Condition: • [Damage](#)

Implication(s): Fire hazard | Electric shock

24. Damage

Task: Replace

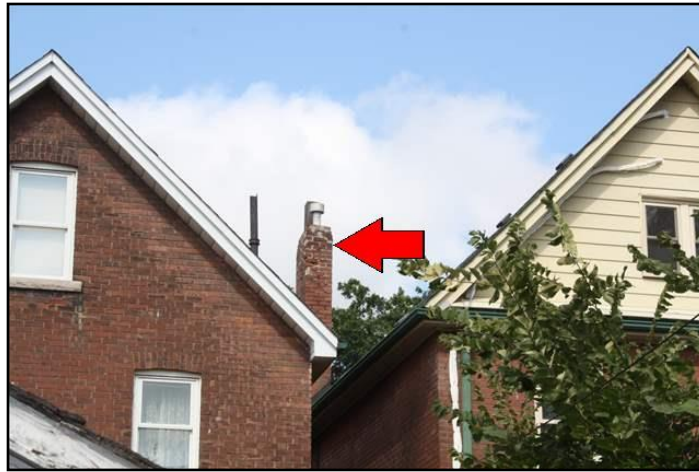
Condition: • [Loose, missing or deteriorated masonry](#)

Implication(s): Material deterioration

25. Loose, missing or deteriorated masonry

Task: Repair / Replace

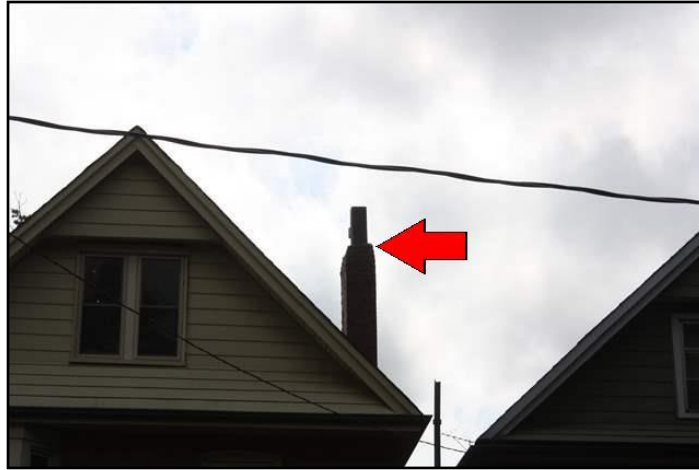
Condition: • [Missing](#)

Implication(s): Shortened life expectancy of material | Chance of water damage to contents, finishes and/or structure

26. Missing

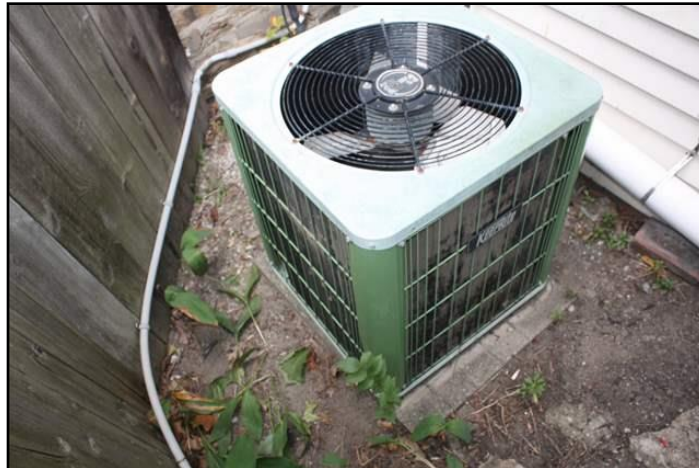
Condition: • [Damage](#)

Some fins are damaged and/or corroded. Service.

27. Damage

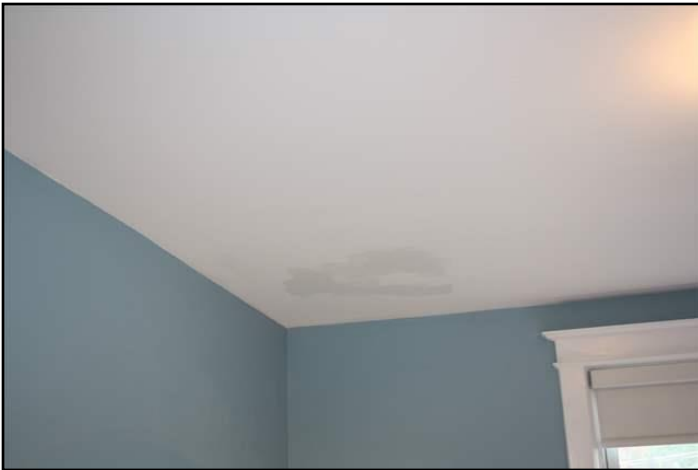
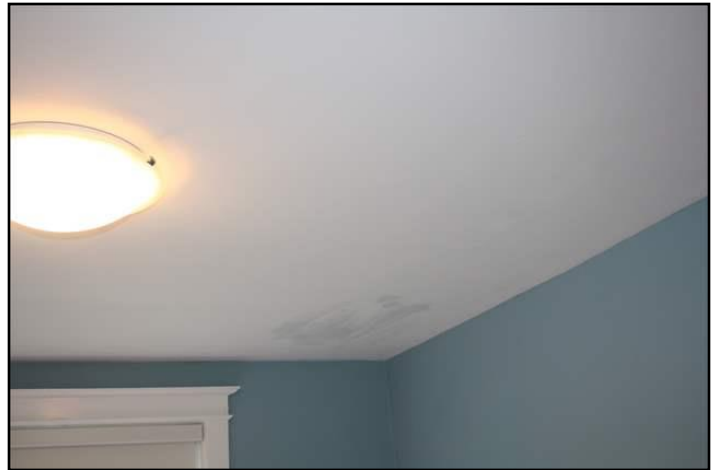
Condition: • Typical flaws

31. Typical flaws

32. Typical flaws

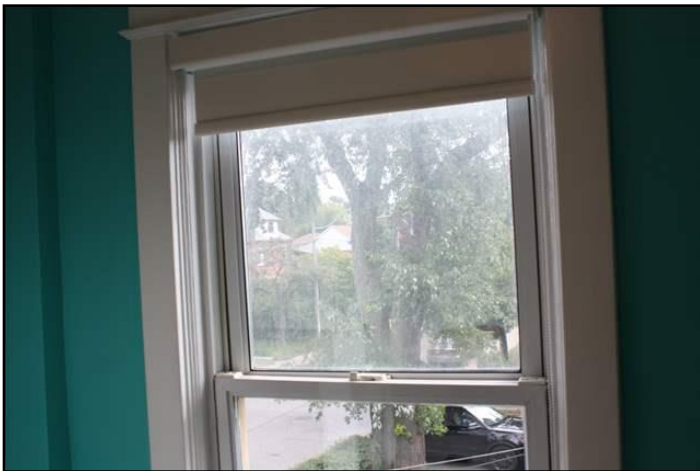
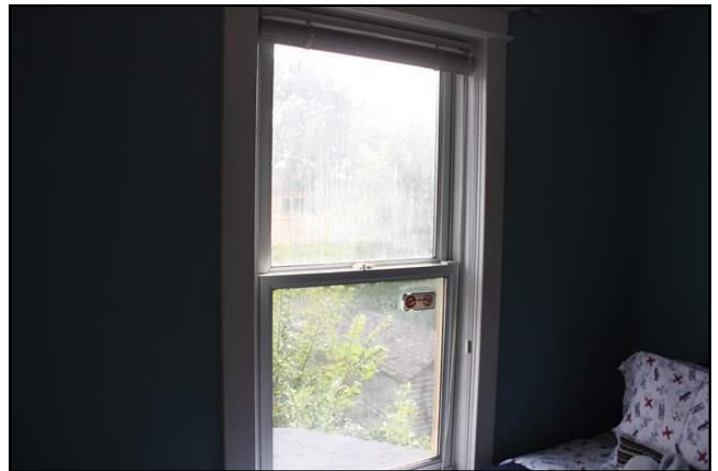
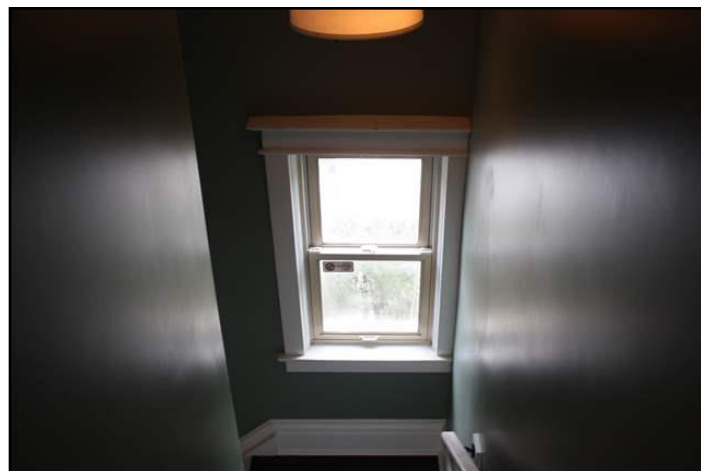
Condition: • [Lost seal on double or triple glazing](#)

33. Lost seal on double or triple glazing

34. Lost seal on double or triple glazing

35. Lost seal on double or triple glazing

Task: Replace

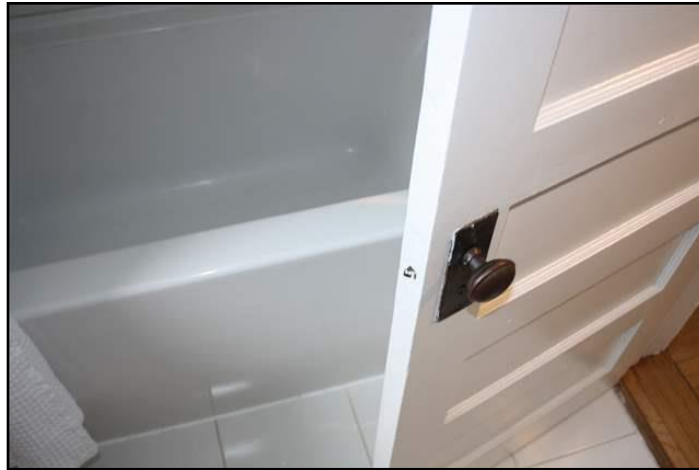
Condition: • [Ineffective](#)

36. Ineffective

Task: Replace

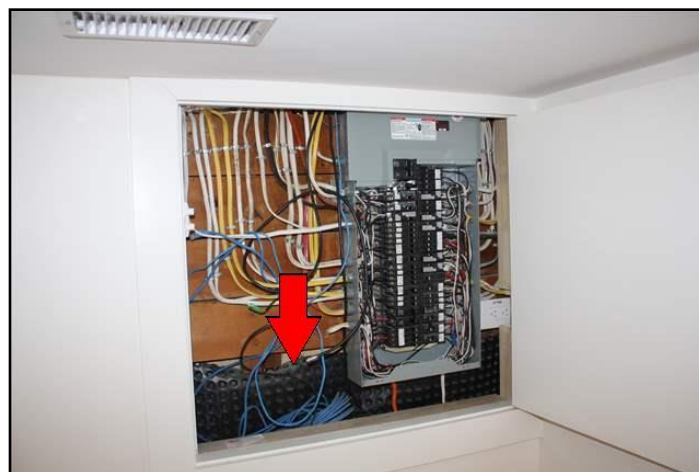
Condition: • [Drainage membrane](#)

For Your Information - drainage membrane was observed at basement foundation wall. This is a common method used to help manage moisture on stone foundations.

37. Drainage membrane
