YOUR INSPECTION REPORT

FOR THE PROPERTY AT:
643 Windermere Avenue
Toronto, ON M6S 3L9

INSPECTION DATE:
Thursday, September 6, 2018

RE: Report No. 2325
643 Windermere Avenue
Toronto, ON
M6S 3L9

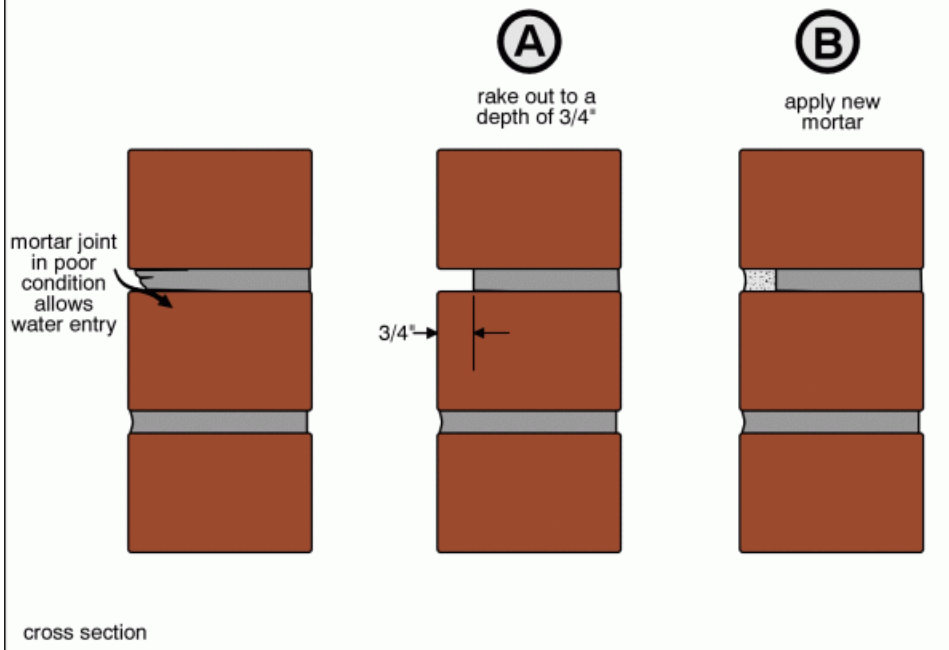
Repointing

Condition: • [Mortar deterioration](#)

Provide mortar (Repointing, Tuck pointing) at various wall and columns. This is common maintenance for homes of this age.

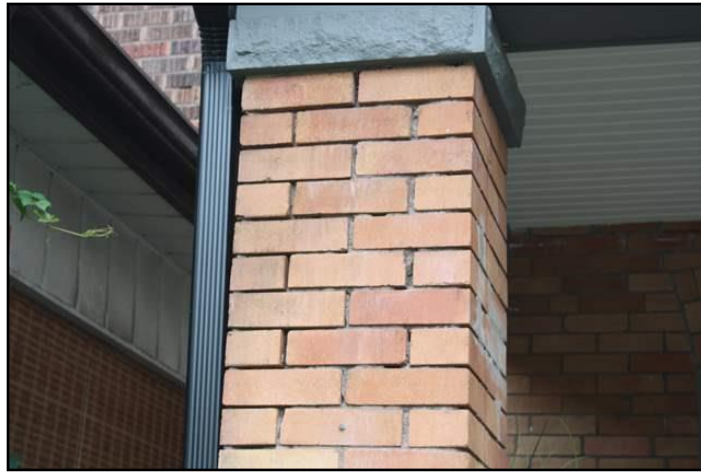
1. Mortar deterioration

Implication(s): Chance of water entering building | Weakened structure | Chance of structural movement

Location: Exterior walls / columns

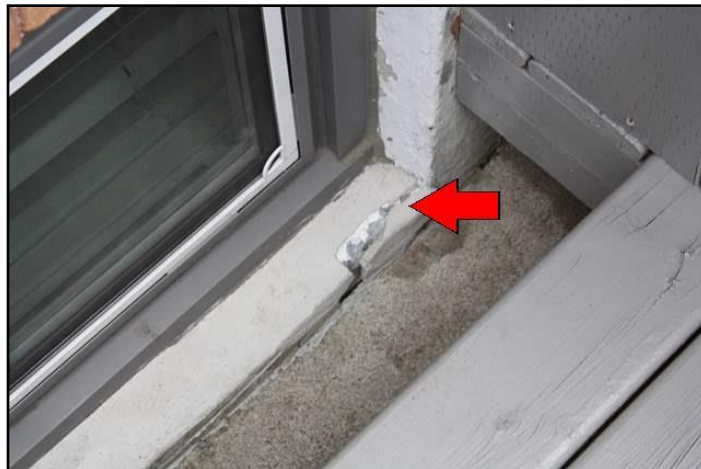
2. Damage

Condition: • [Damage](#)

Implication(s): Chance of water damage to contents, finishes and/or structure

Location: Rear Exterior

Task: Patch

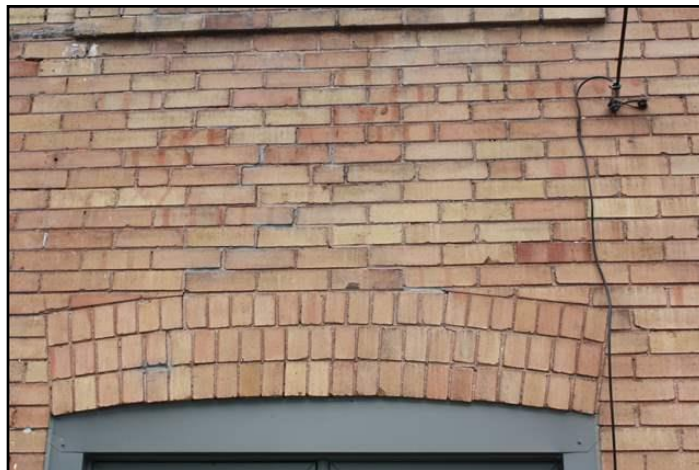
3. Dropped, rotating or leaning

Condition: • [Dropped, rotating or leaning](#)

This is very common on arches of homes of this age. Repair cracks to prevent further movement.

Implication(s): Weakened structure | Chance of structural movement

Location: Rear Exterior Wall

Task: Repair

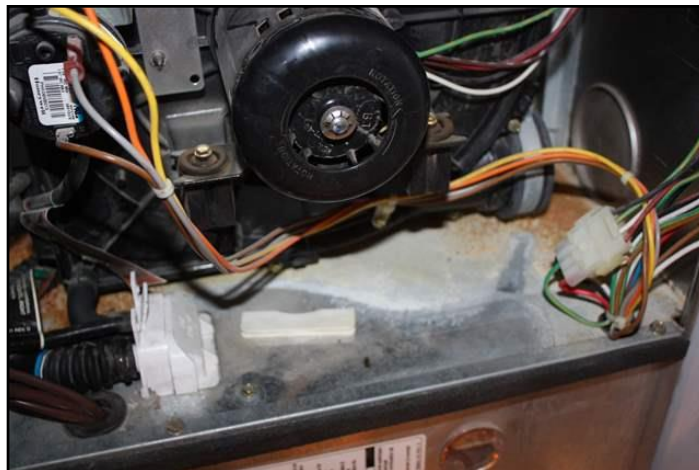
5. Rust

Condition: • [Rust](#)

Rust noted inside furnace cabinet. Prior condensate leak. Unknown if still active or intermittent. Dry at time of inspection

Implication(s): Material deterioration | Reduced system life expectancy

Location: Basement Furnace

Task: Service

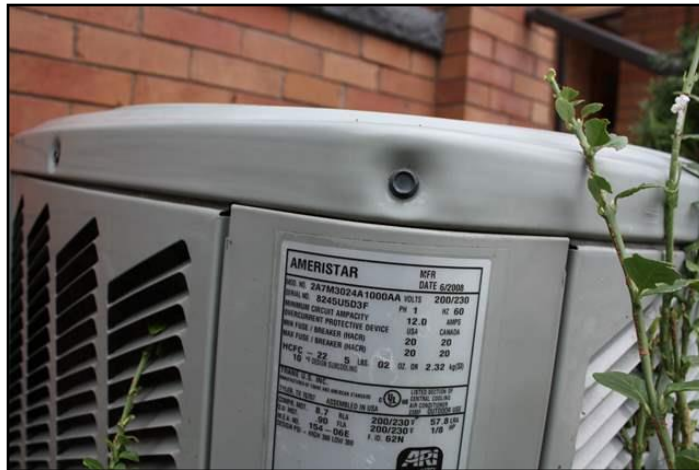
6. 10 years

Condition: • Aging

Typical lifespan is 10-15 years. The current unit is 10 years old (manufactured 2008). The unit was functional at time of inspection. Continue to use.

Task: Replace

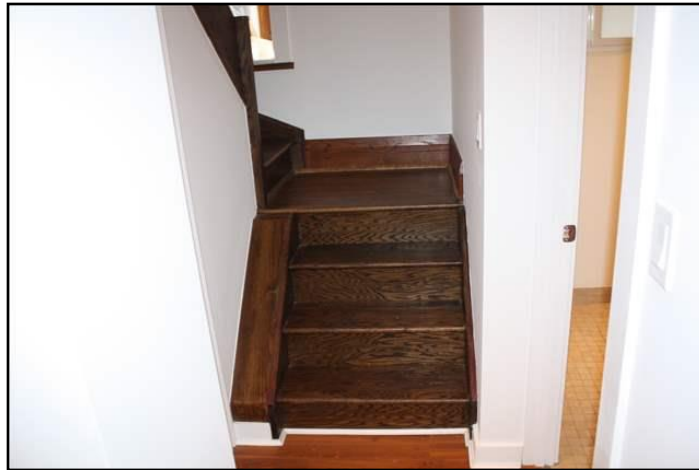
10. Missing

Condition: • [Missing](#)

Implication(s): Fall hazard

Location: Basement Staircase

Task: Provide handrails
