YOUR INSPECTION REPORT

53 Woodside Avenue
Toronto, ON M6P 1L9

INSPECTION DATE:
Thursday, November 8, 2018

RE: Report No. 2370
53 Woodside Avenue
Toronto, ON
M6P 1L9

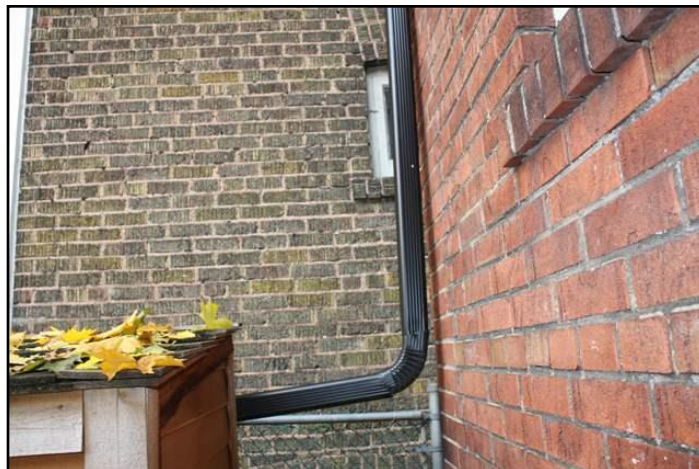
Condition: • [Not well secured](#)

Implication(s): Leakage

Location: Rear Exterior Wall

1. Not well secured

Task: Improve / Provide additional fastener

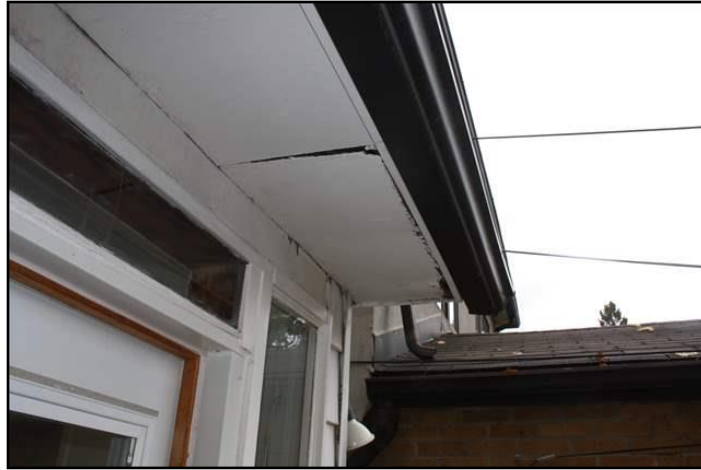
Condition: • [Loose or missing pieces](#)

Implication(s): Chance of pests entering building | Chance of water damage to contents, finishes and/or structure

Location: Rear Exterior

2. Loose or missing pieces

Task: Improve

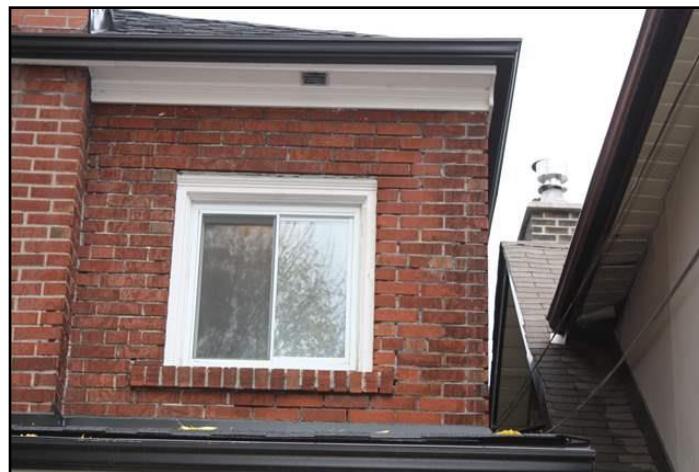
3. Example

Condition: • [Mortar deterioration](#)

Implication(s): Chance of structural movement | Weakened structure | Chance of water entering building

Location: Various Exterior Wall

Provide mortar (Repointing, Tuck pointing) at various wall and window sills. This is common maintenance for homes of this age.

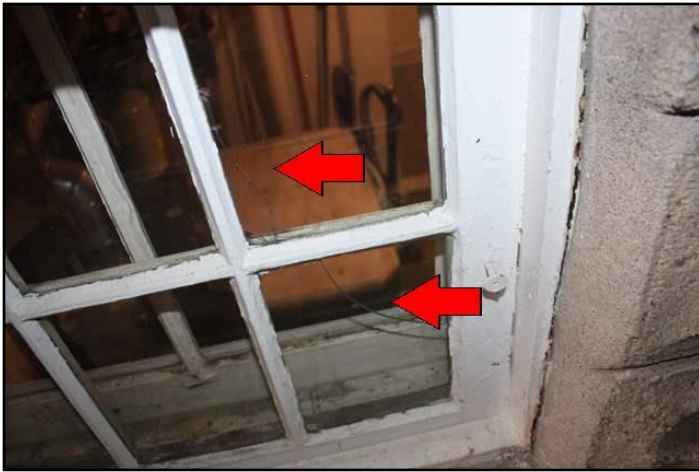
Condition: • [Cracked](#)

Location: Various Exterior

4. Cracked

Task: Replace

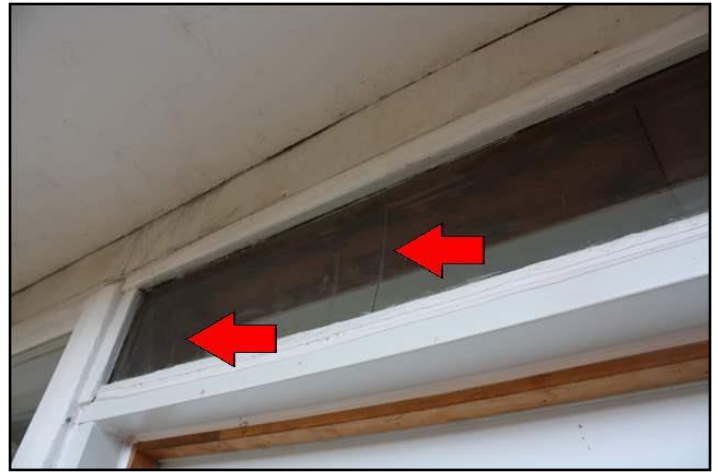
5. Cracked

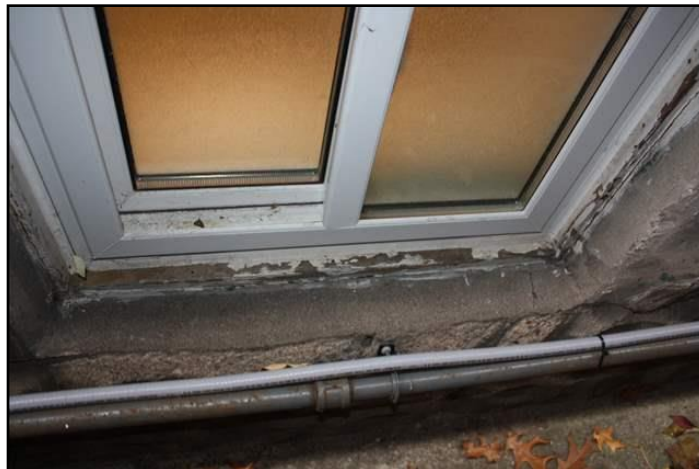
Condition: • [Paint or stain needed](#)

Implication(s): Material deterioration | Chance of water damage to contents, finishes and/or structure

Location: Various Exterior

6. Paint or stain needed

Task: Improve

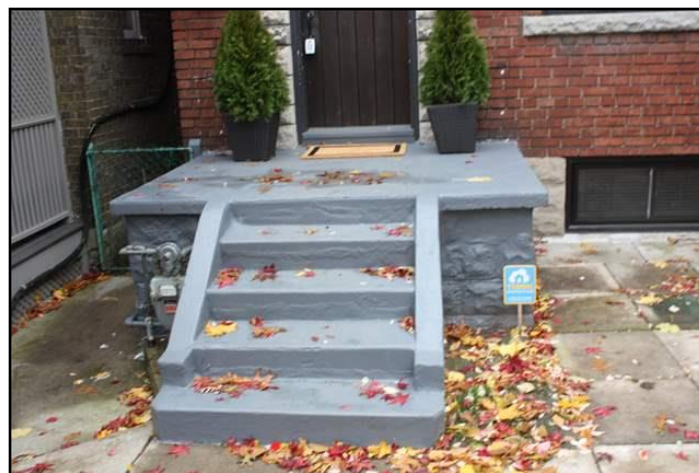
Condition: • [Missing](#)

Implication(s): Fall hazard

Location: Front Exterior Porch

7. Missing

Task: Provide Hand and Guard Rails

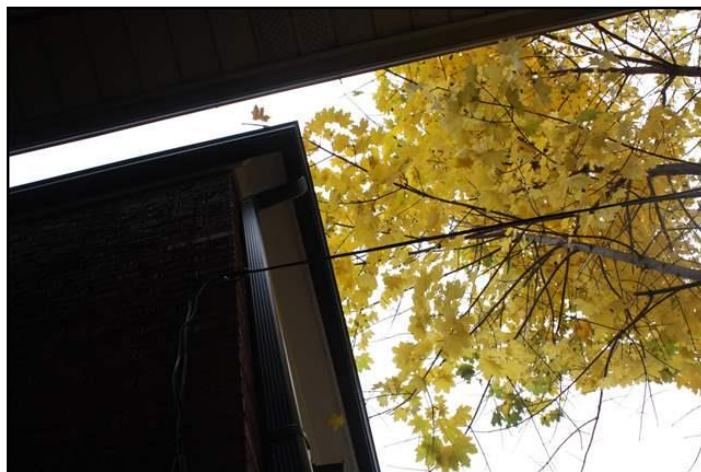
Condition: • [Trees or shrubs too close to building](#)

Implication(s): Material deterioration | Chance of pests entering building | Chance of water damage to contents, finishes and/or structure

8. Trees or shrubs too close to building

Keep tree branches trimmed back 3 feet from roof line.

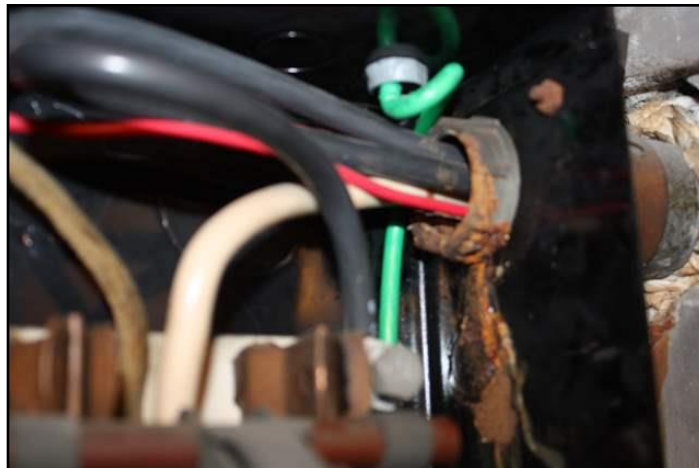
Condition: • [Rust](#)

Prior moisture. Dry at time of inspection.

Implication(s): Increased fire hazard | Electric shock

Location: Basement

9. Rust

Task: Further evaluation and seal where needed

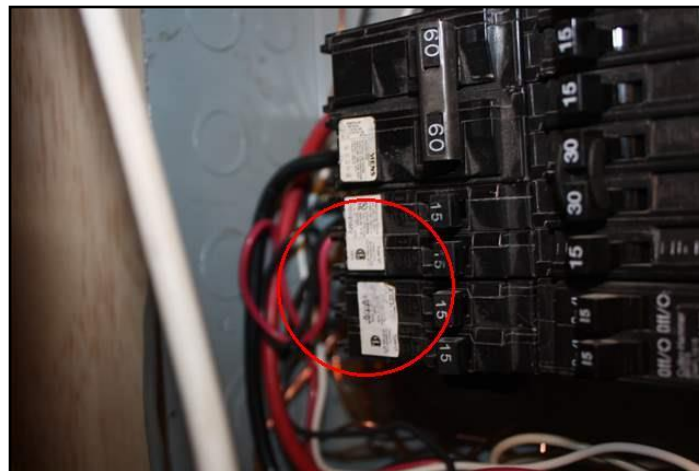
Condition: • [No links for multi-wire circuits](#)

Implication(s): Electric shock

Location: Basement Panel

10. No links for multi-wire circuits

Task: Correct

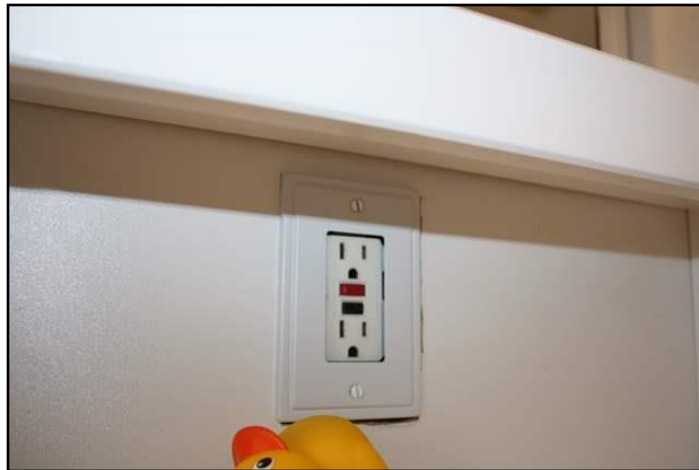
11. Loose

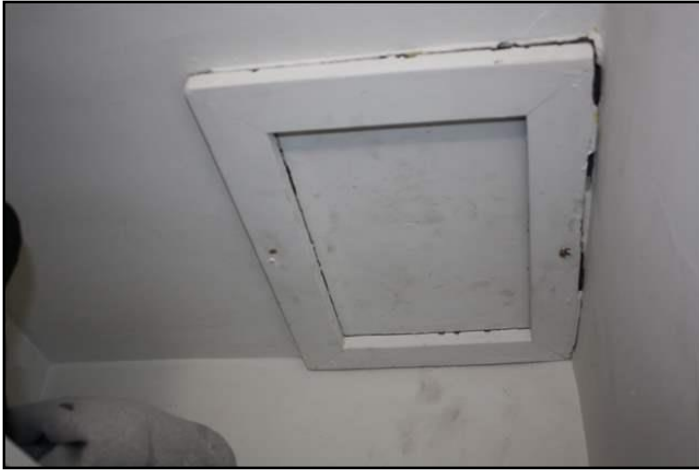
Condition: • [Inaccessible](#)

The attic hatch opening is too small and fastened shut, therefore we could not observe the attic. Attics are important areas. Provide larger access and inspect attic for issues with structure, insulation, water damage, vermiculite asbestos, and mold.

12. Inaccessible

Task: Provide access and inspect

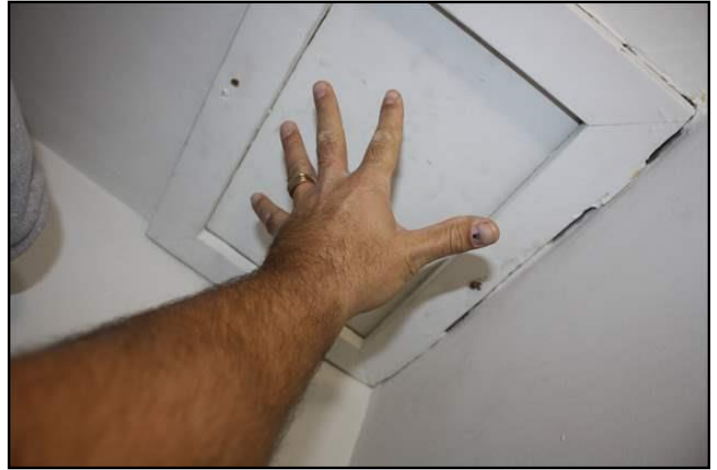
13. Inaccessible

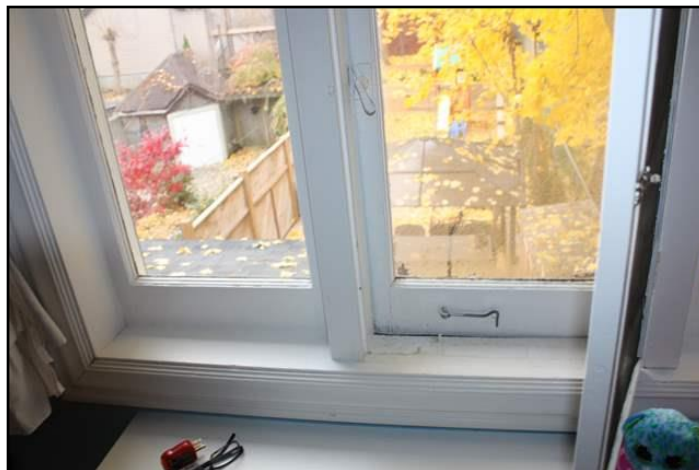
15.

Condition: • Inoperative

Task: Correct

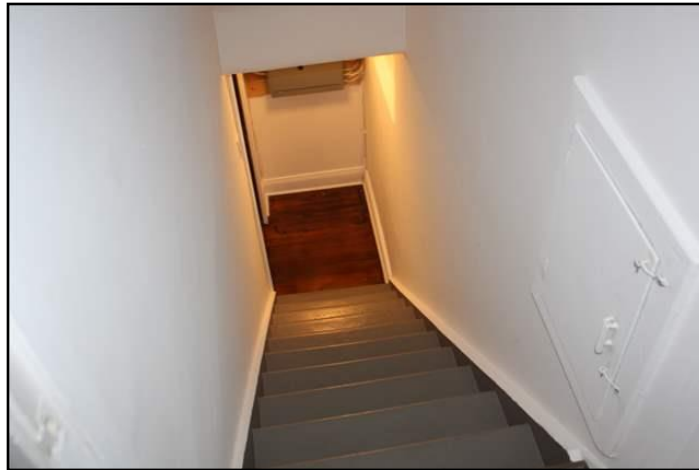
Condition: • [Missing](#)

Implication(s): Fall hazard

16. Missing
