# YOUR INSPECTION REPORT

29 Sibley Avenue  
Toronto, ON M4C 5E8

Wednesday, April 17, 2019

RE: Report No. 2435  
29 Sibley Avenue  
Toronto, ON  
M4C 5E8

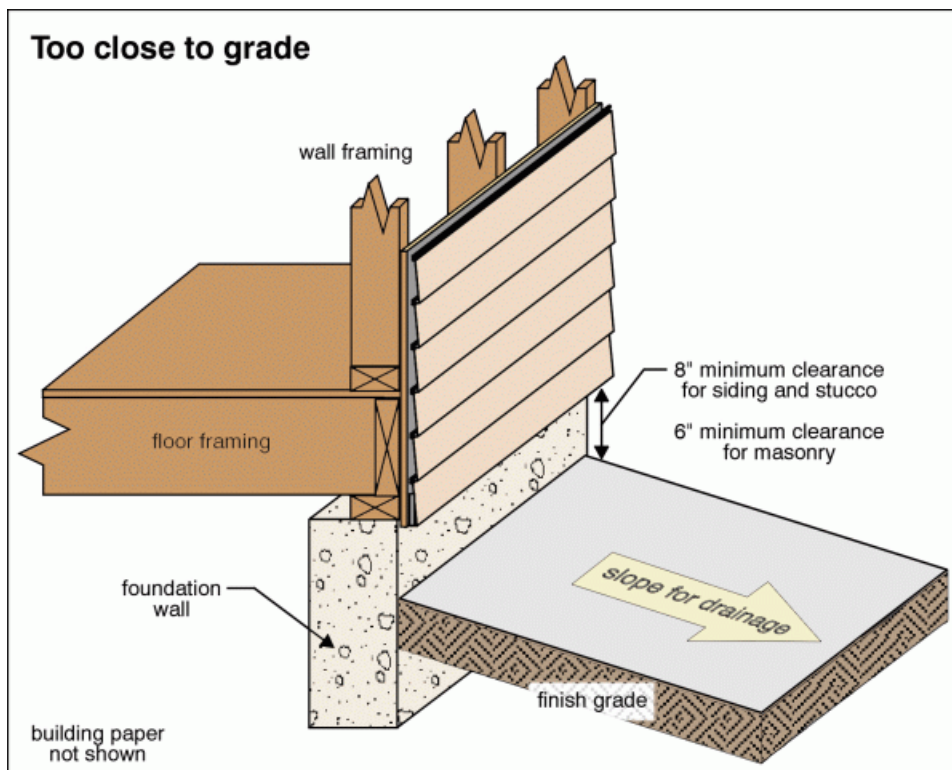
Condition: • [Too close to grade](#)

Implication(s): Chance of water damage to contents, finishes and/or structure | Material deterioration | Rot | Insect damage

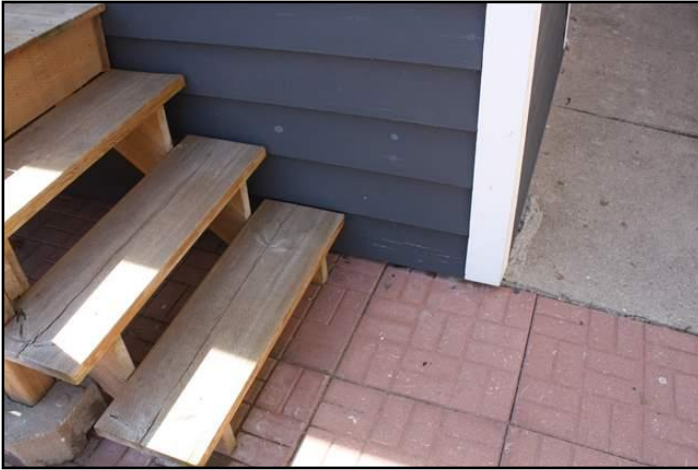
1. Too close to grade

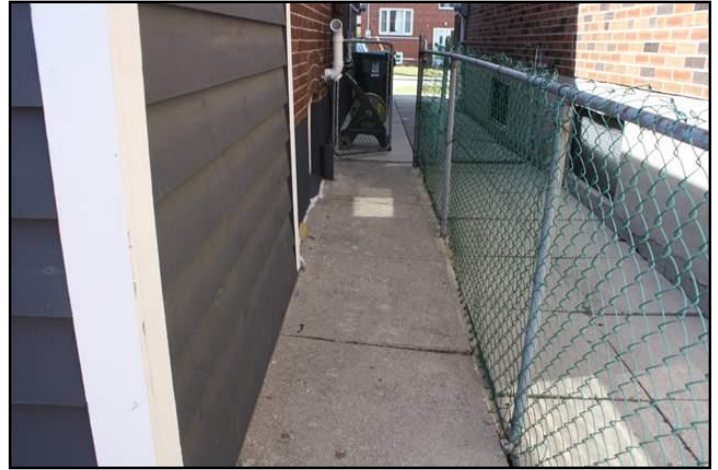
2. Too close to grade

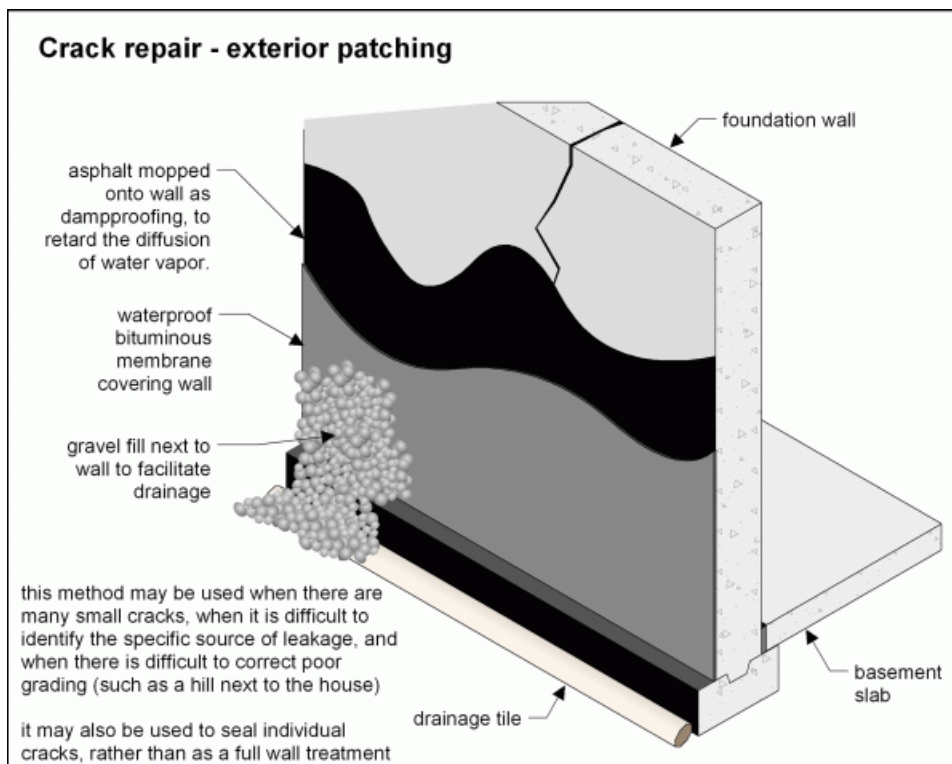
**Condition:** • Typical minor cracks

Almost all houses with poured concrete foundations have minor settlement and/or shrinkage cracks. Monitor all cracks for

movement and nuisance water leakage. Repair cracks only if necessary

**Implication(s):** Chance of water entering building

**Task:** Monitor / Repair

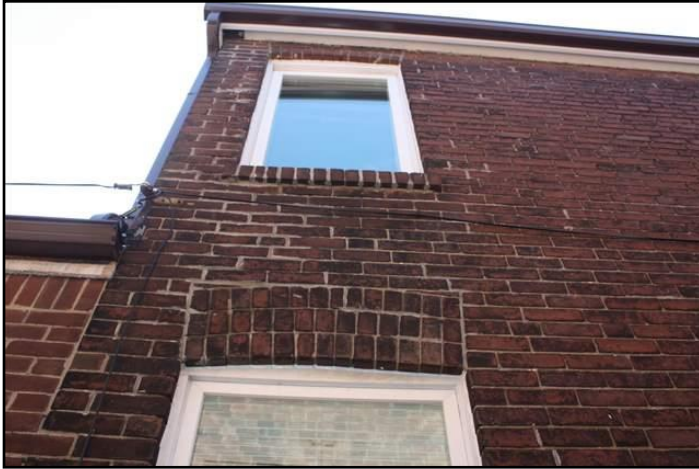
**Condition:** • [Prior repairs](#)

**Implication(s):** Weakened structure

3. Prior repairs

**Task:** For Your Information / Monitor

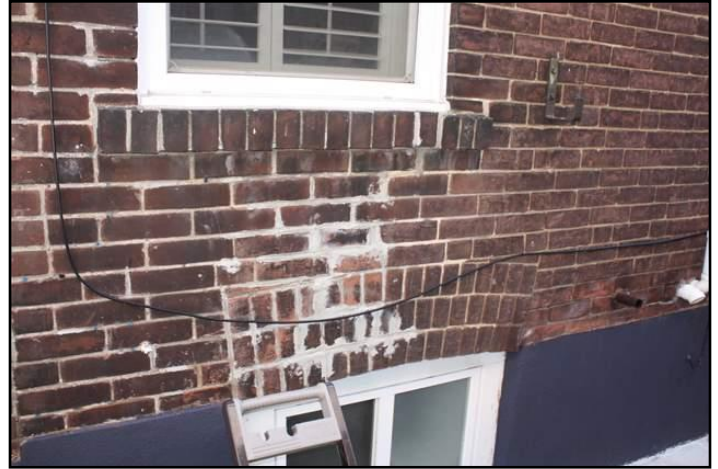
4. Prior repairs

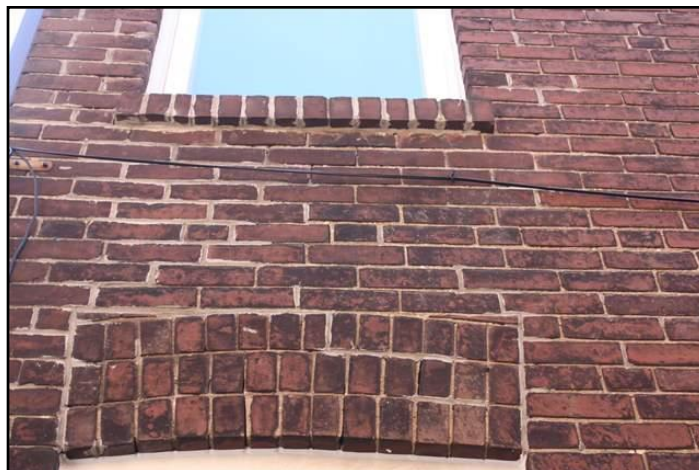
**Condition:** • [Mortar deteriorated](#)

Typical minor maintenance.

**Implication(s):** Weakened structure | Chance of structural movement

5. Mortar deteriorated

**Task:** Repair

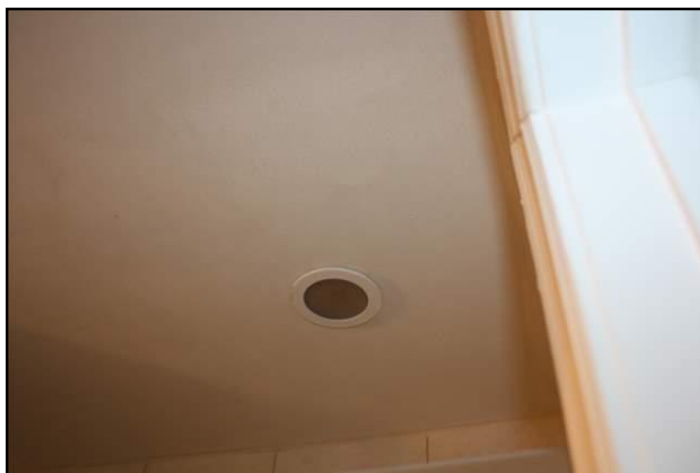
**Condition:** • [Inoperative](#)

Disconnected

**Implication(s):** Inadequate lighting

**Location:** Bathroom shower stall light

8. Inoperative

**Task:** Repair if desired

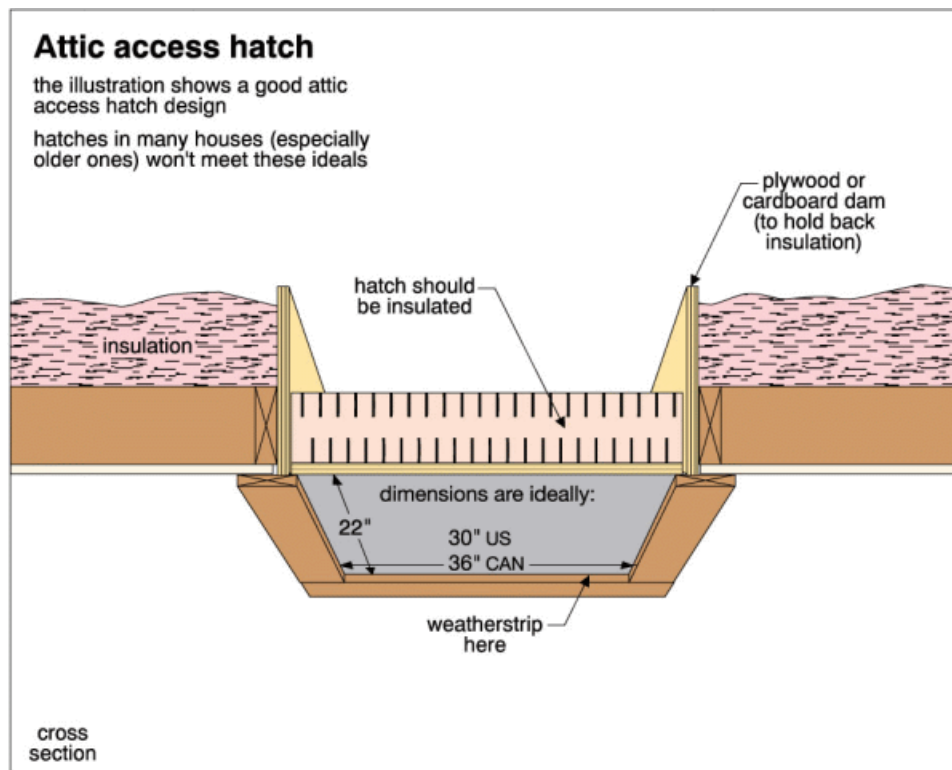
**Condition:** • [Inaccessible](#)

Built-in closet railing and shelving restricted access to the attic. Provide access and inspect. (The attic area will be represent a very small area of the home. The majority is under flat roofs)

**Implication(s):** Difficult access

**Location:** Second Floor Bedroom closet

**Task:** Provide access and inspect

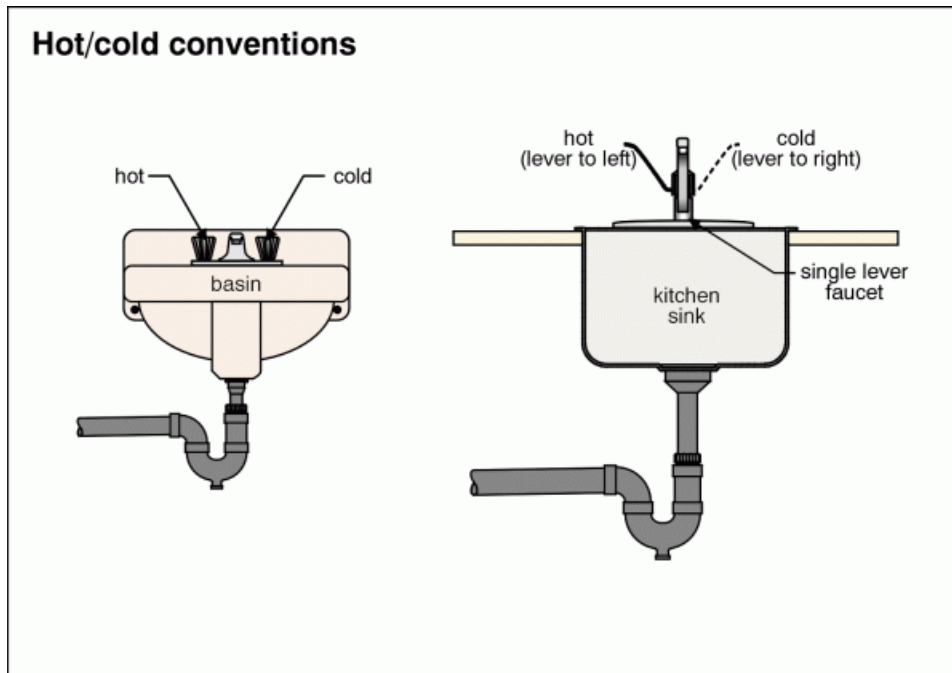
**Condition:** • [Hot and cold reversed](#)

**Implication(s):** Scalding

**Location:** Second Floor Bathroom

**Task:** Correct
