YOUR INSPECTION REPORT

387 Durie Street
Toronto, ON M6S 3G5

INSPECTION DATE:
Friday, May 24, 2019

RE: Report No. 2460, v.2
387 Durie Street
Toronto, ON
M6S 3G5

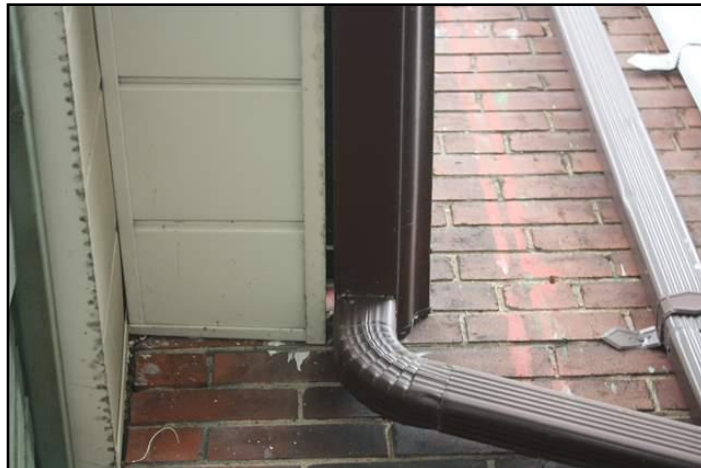
Condition: • Aging - Wear and tear noted. Fasteners loose in some areas

1. Aging - Wear and tear noted. Fasteners...

Task: Improve

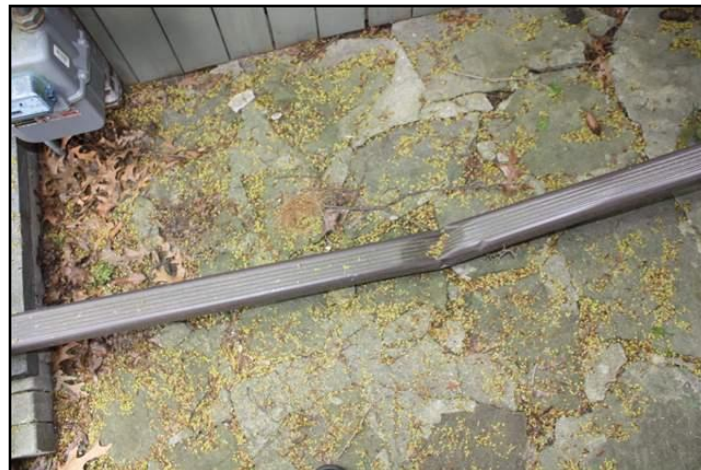
Condition: • [Damage](#)

Implication(s): Chance of water damage to contents, finishes and/or structure

2. Damage

Task: Repair / Replace

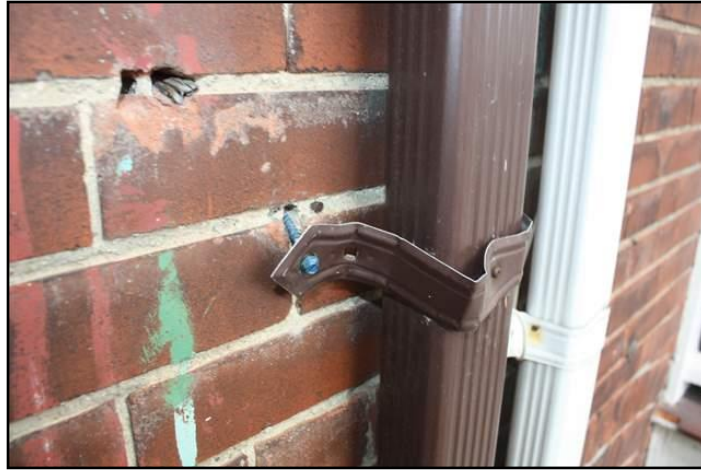
Condition: • [Not well secured](#)

Implication(s): Leakage

3. Not well secured

Task: Improve

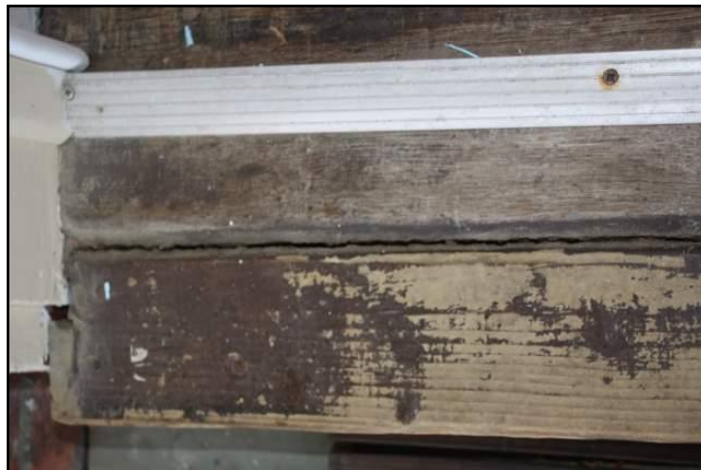
Condition: • [Damaged, cracked or loose](#)

4. Damaged, cracked or loose

Task: Repair / Replace

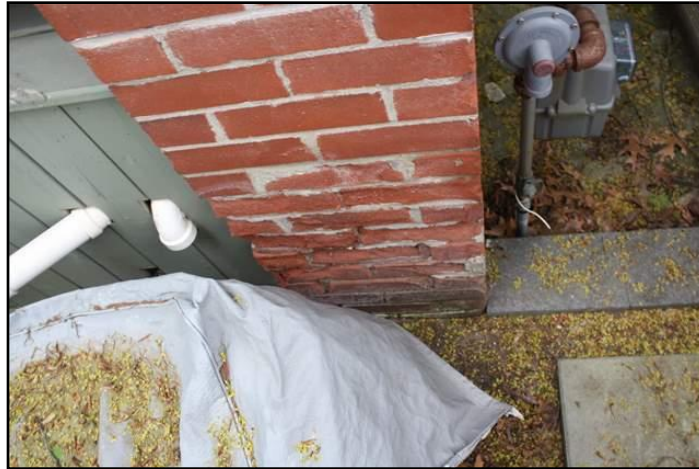
Condition: • [Spalling](#)

5. Spalling

Task: Repair

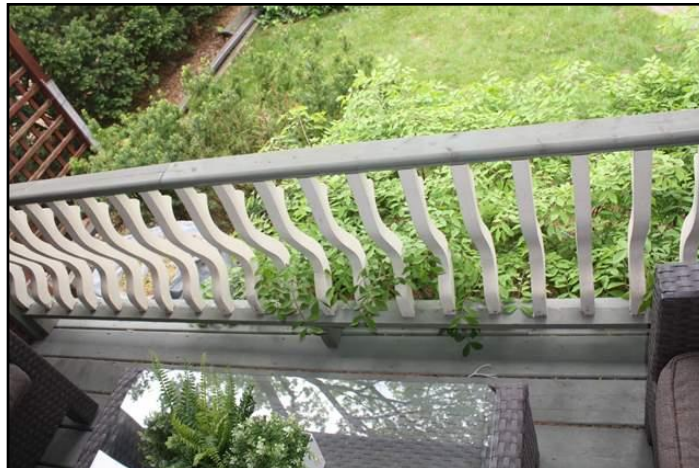
Condition: • [Loose](#)

Implication(s): Fall hazard

6. Loose

Task: Repair / Replace

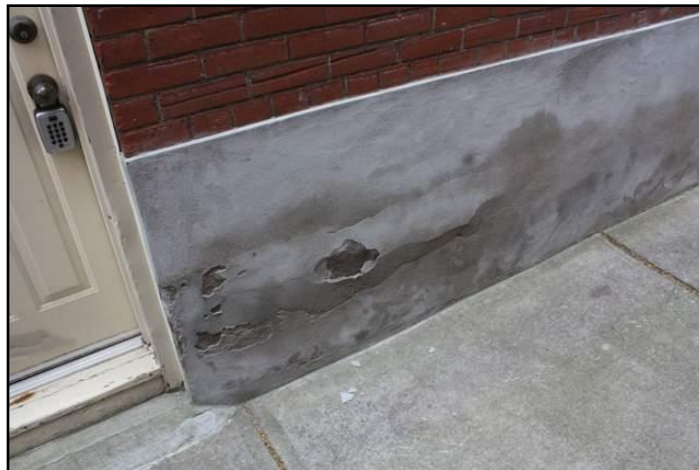
Condition: • [Parging damaged or missing](#)

Implication(s): Chance of damage to structure | Shortened life expectancy of material

7. Parging damaged or missing

Task: Repair

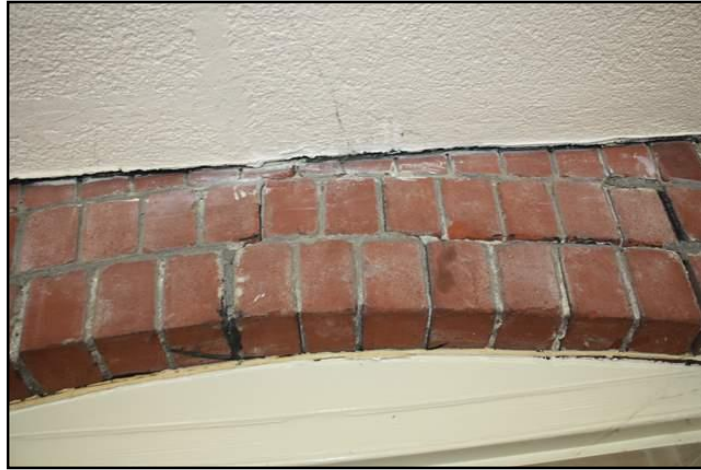
8.

Condition: • [Cracked](#)

Very common to find cracks and settlement at arches above windows or door. The masonry below has been repair and a steel support has been added above the door. Patch any gaps at the arch to prevent further damage and/or movement

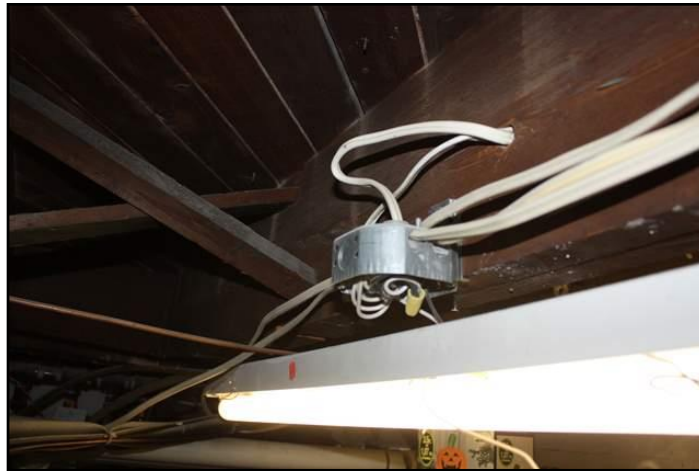
Condition: • [Cover loose or missing](#)

Implication(s): Electric shock | Fire hazard

11. Cover loose or missing

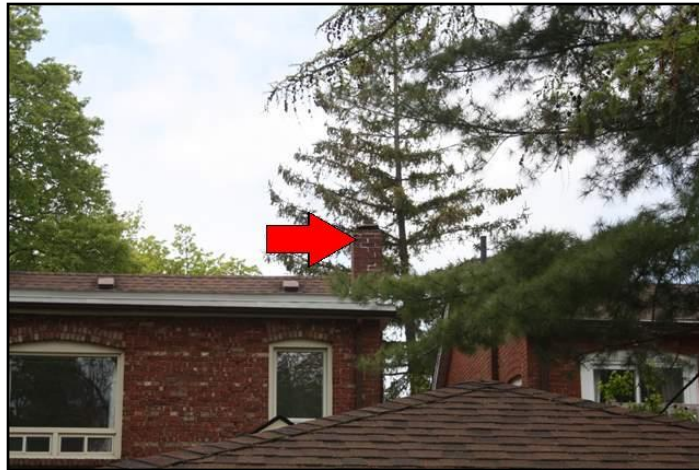
Condition: • [Loose, missing or deteriorated masonry](#)

Appears to be an abandoned chimney. Rather than repair, you may consider removing the chimney altogether.

Implication(s): Material deterioration

12. Loose, missing or deteriorated masonry

Task: Remove

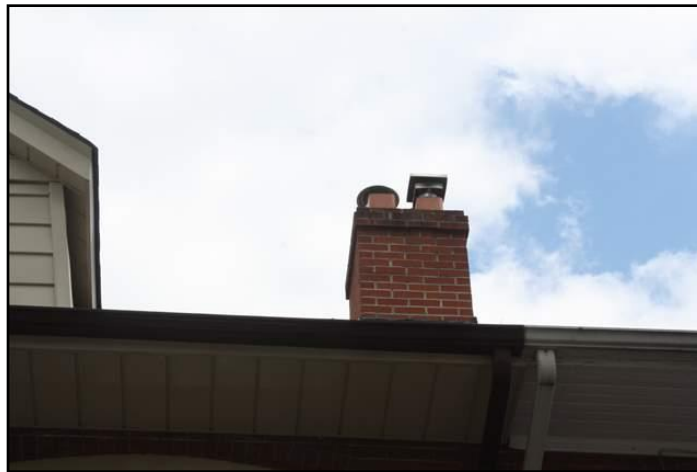
Condition: • [No drip edge on cap](#)

Implication(s): Chance of water damage to contents, finishes and/or structure | Shortened life expectancy of material | Material deterioration

13. No drip edge on cap

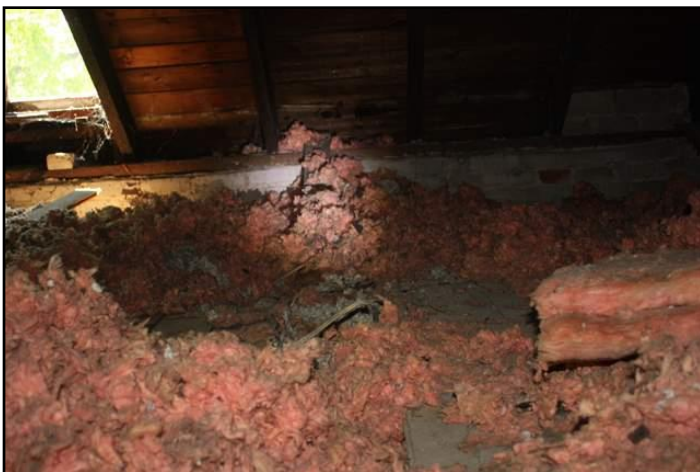
Condition: • [Amount less than current standards](#)

Below current standards of R-50 (as of 2012) . Also gaps or voids in insulation observed

14. Amount less than current standards

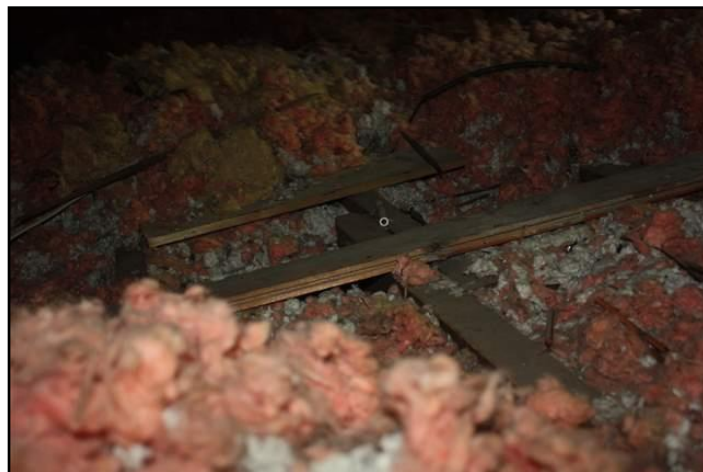
15. Amount less than current standards

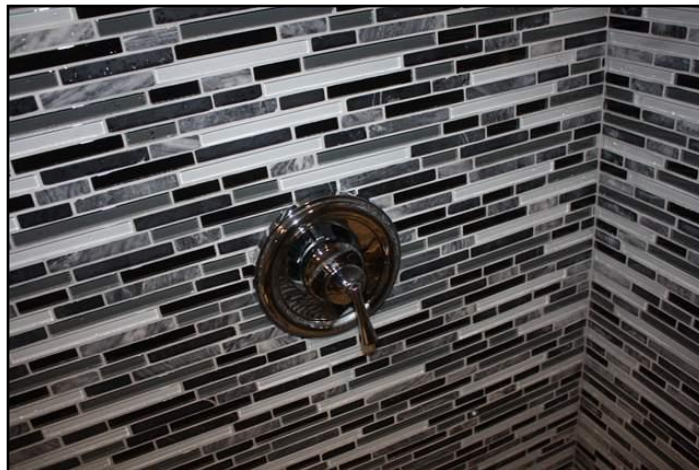
17.

Condition: • Loose fixture

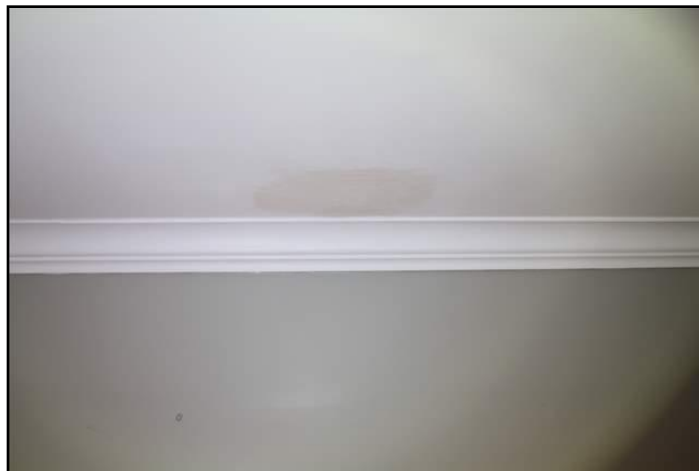
Condition: • Patched

Tested with moisture meter. Dry at time of inspection

18. Patched

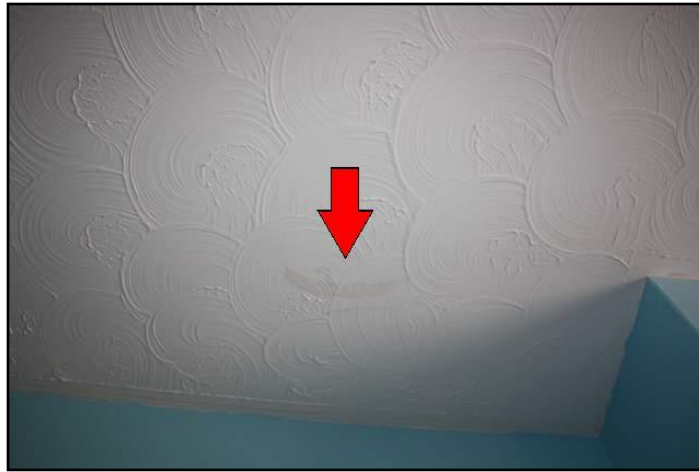
Condition: • Stains

Minor stain. Tested with moisture meter. Dry at time of inspection

19. Stains

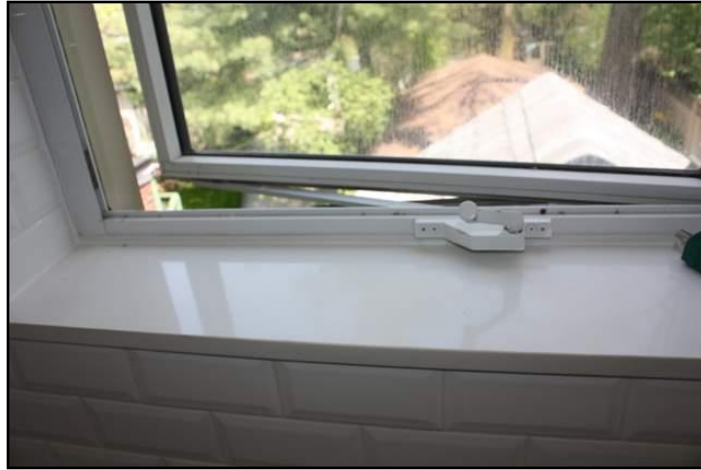
Condition: • [Loose](#)

Implication(s): Equipment failure

20. Loose

Task: Repair

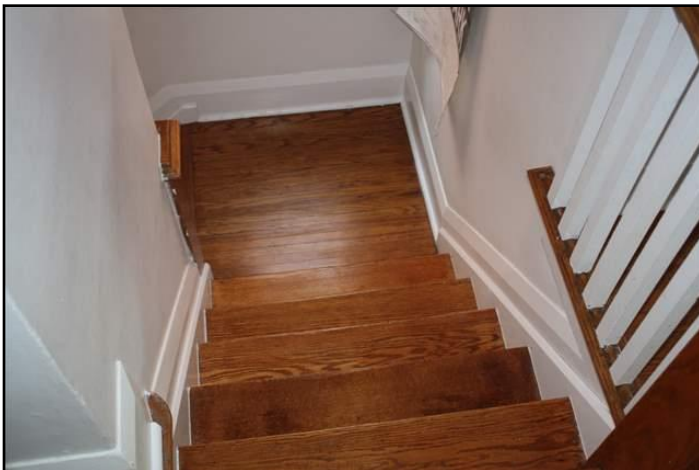
Condition: • [Missing](#)

Implication(s): Fall hazard

21. Missing

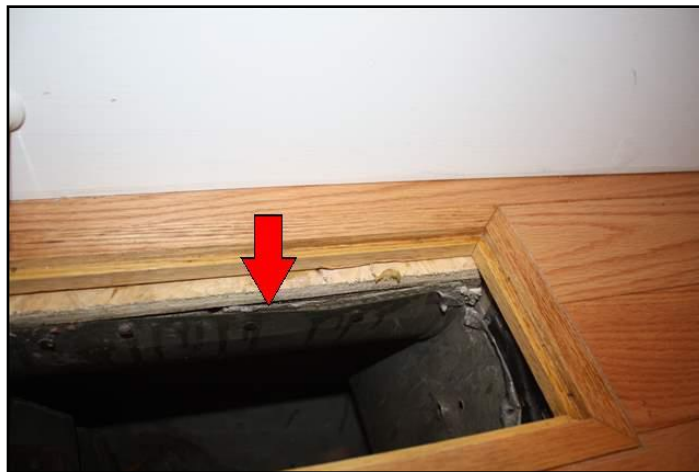
Condition: • Possible asbestos containing materials

During the era when this house was built up until the 1960s, it was very common to wrap registers in asbestos type insulation to protect the floors from overheating. Determining the material type is outside the scope of this inspection. Health Canada recommends that any asbestos material found should stay in place undisturbed. If you plan to remodel or if this is a concern, consult with a specialist for lab testing to confirm if asbestos is present.

Implication(s): Health hazard

23. Possible asbestos containing materials

Task: Evaluate before disturbing or if desired
