YOUR INSPECTION REPORT

494 Durie Street
Toronto, ON M6S 3G7

Thursday, July 4, 2019

RE: Report No. 2492, v.4
494 Durie Street
Toronto, ON
M6S 3G7

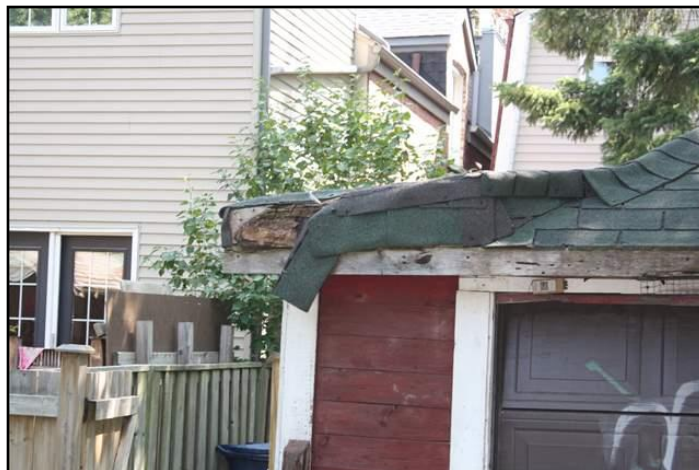
Condition: • [Damage](#)

Implication(s): Chance of water damage to contents, finishes and/or structure

Location: Various Exterior Garage

1. Damage

Task: Repair / Replace

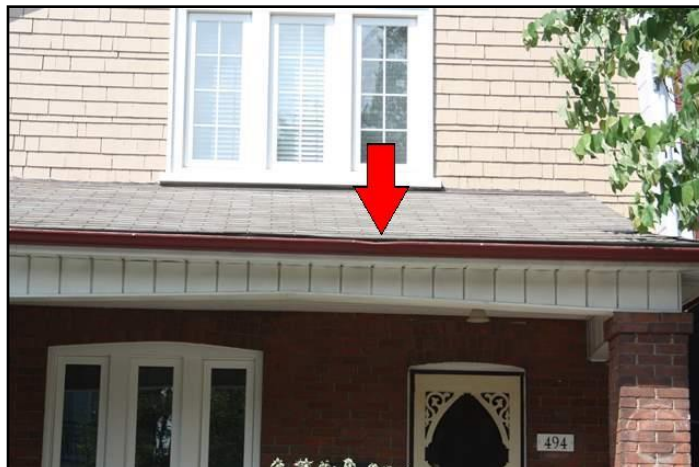
Condition: • Damage

Location: Various Exterior

2. Example

Task: Repair / Replace

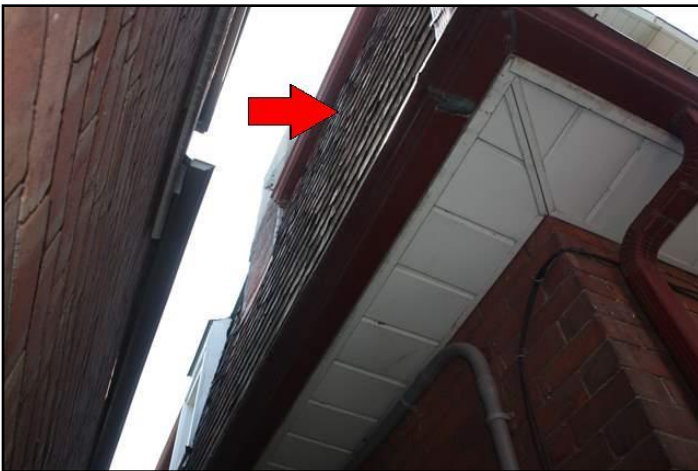
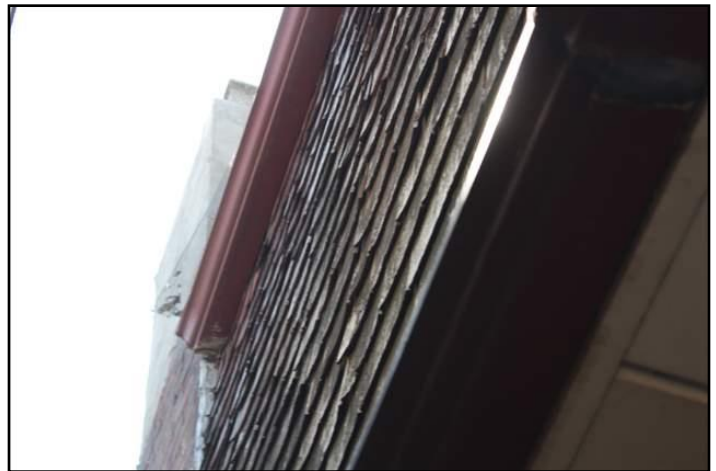
Condition: • [Cracked, split or broken](#)

The wood shingles at the sides of the home on the upper floors have aged. Consider improving similar to front by painting / sealing or replacing with siding similar to the rear vinyl siding. Consult with specialist contractor for recommendations.

Implication(s): Chance of water damage to contents, finishes and/or structure

3. Cracked, split or broken

4. Cracked, split or broken

Task: Repair or replace

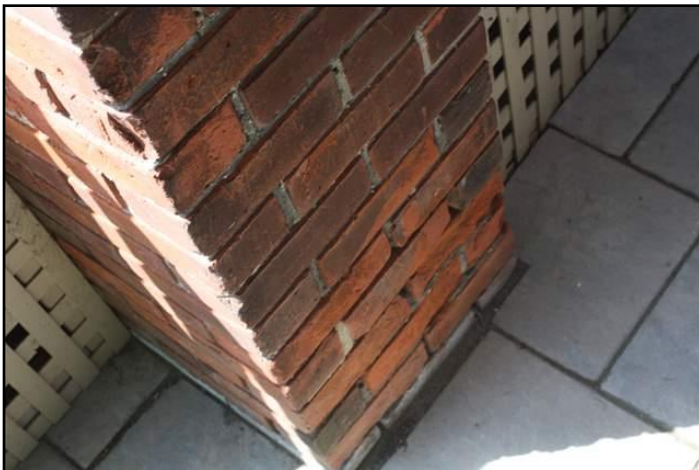
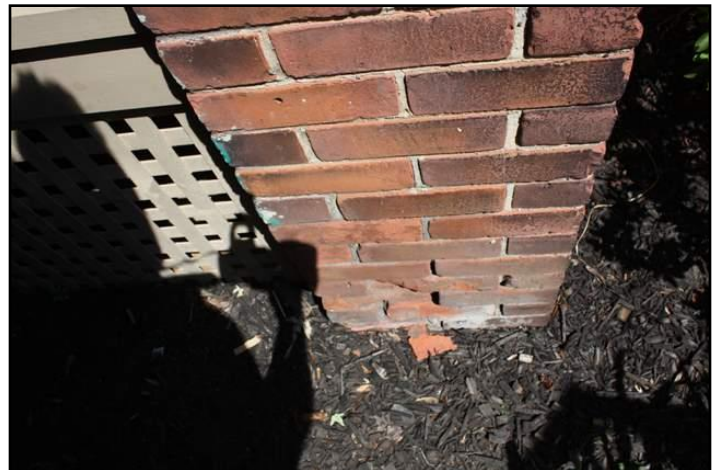
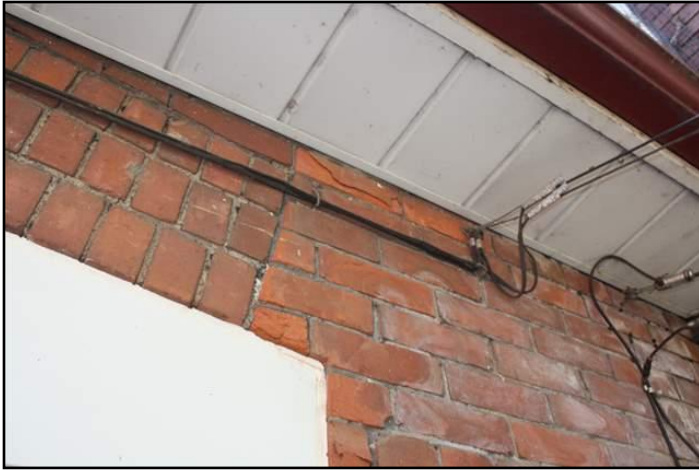
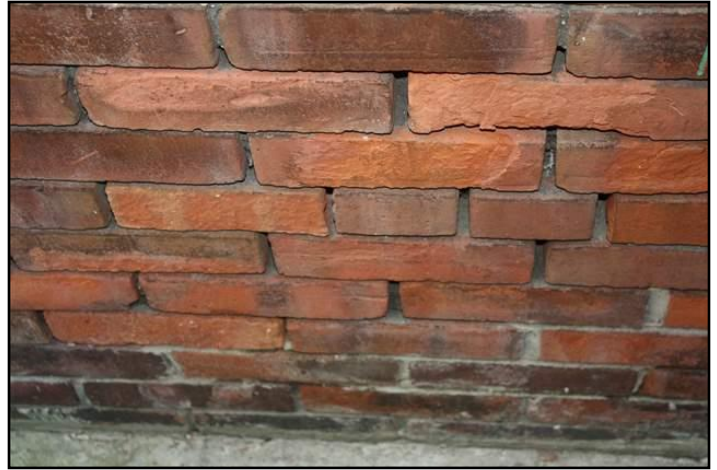
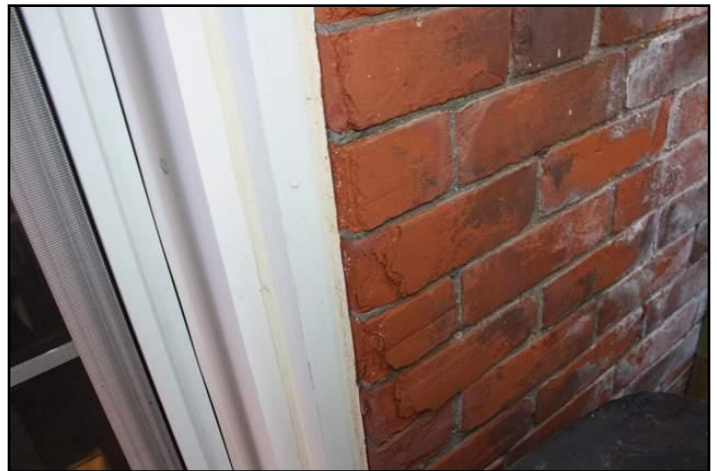
Condition: • [Spalling](#)

Spalling / masonry deterioration / mortar deterioration noted at various areas. Repair / Replace / Tuck point masonry. This is regular maintenance for a home of this age. photos show a sampling

Implication(s): Chance of structural movement | Weakened structure

5. Spalling

6. Spalling

7. Spalling

8. Spalling

10. Spalling

Task: Repair

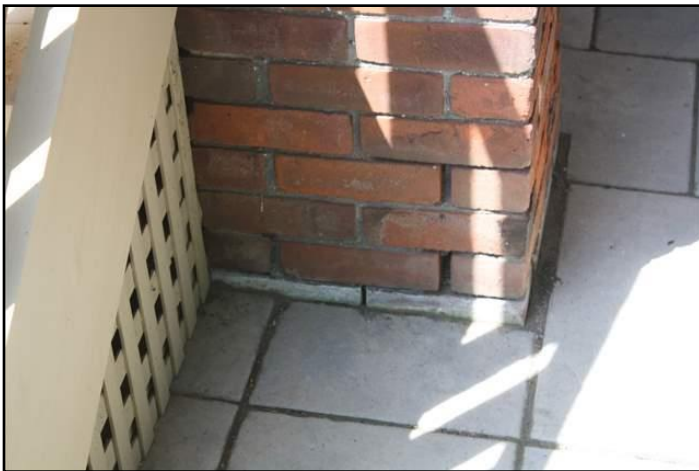
9. Missing mortar

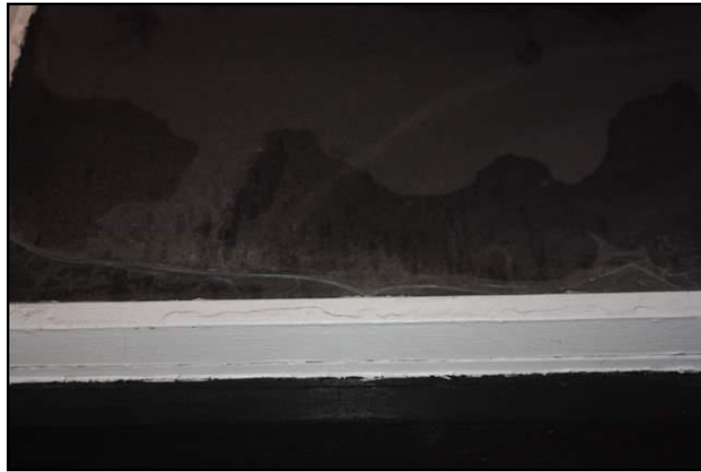
Condition: • [Cracked](#)

11. Cracked

Task: Replace

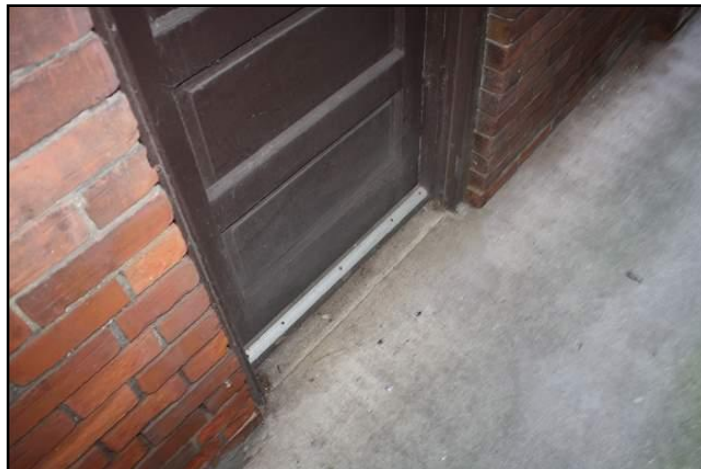
Condition: • [Sill too low](#)

Implication(s): Chance of damage to finishes and structure

12. Sill too low

Task: Monitor / Improve

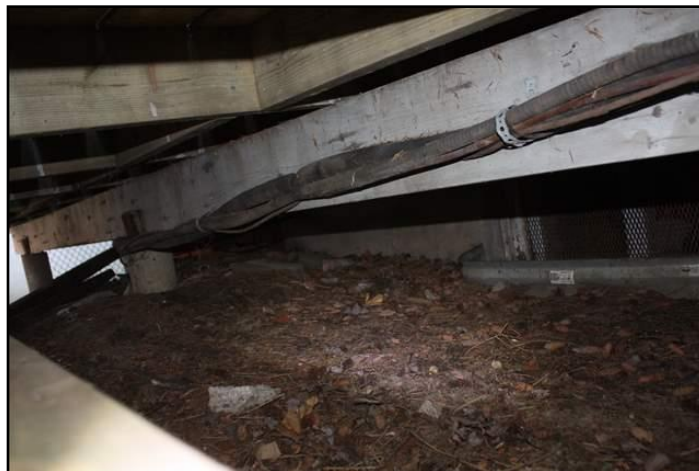
Condition: • Low Areas.

13. Low Areas.

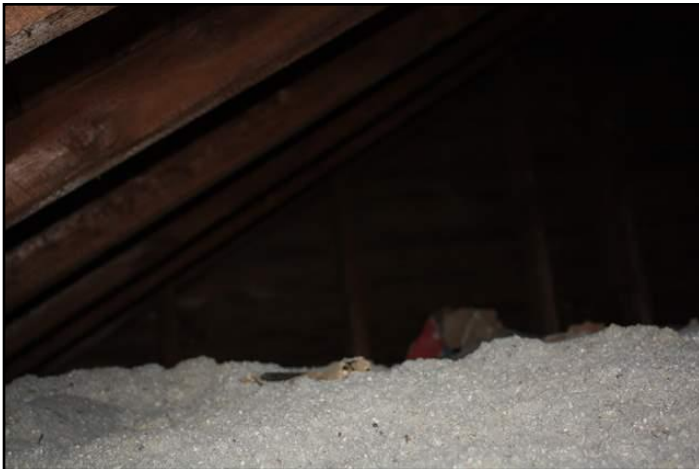
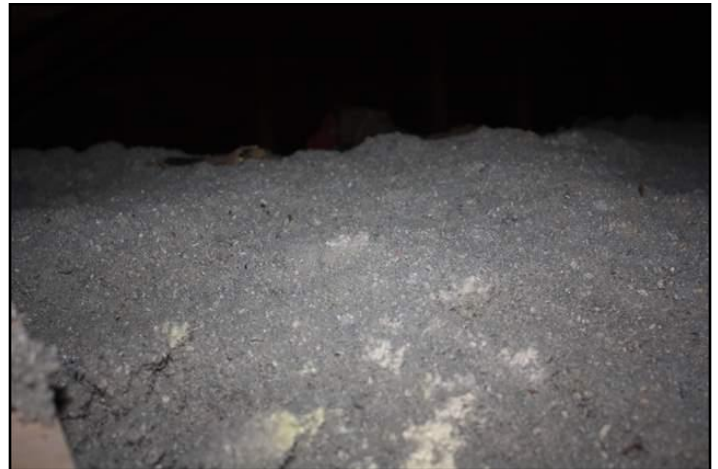
Condition: • [Amount less than current standards](#)

14. Amount less than current standards

15. Amount less than current standards

Task: Upgrade

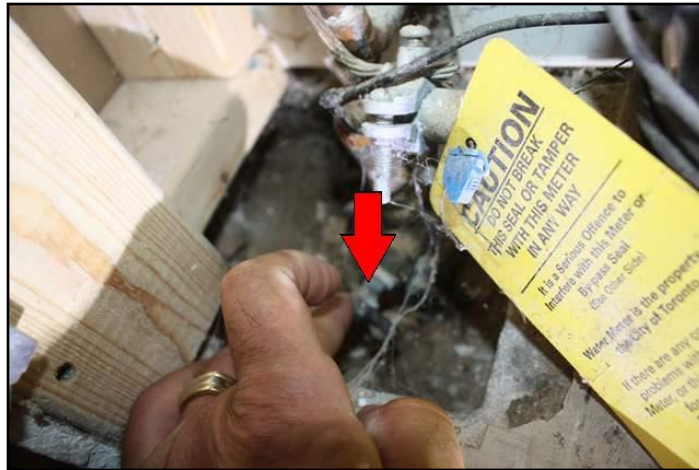
Condition: • [Damaged handle](#)

17. Damaged handle

Task: Replace

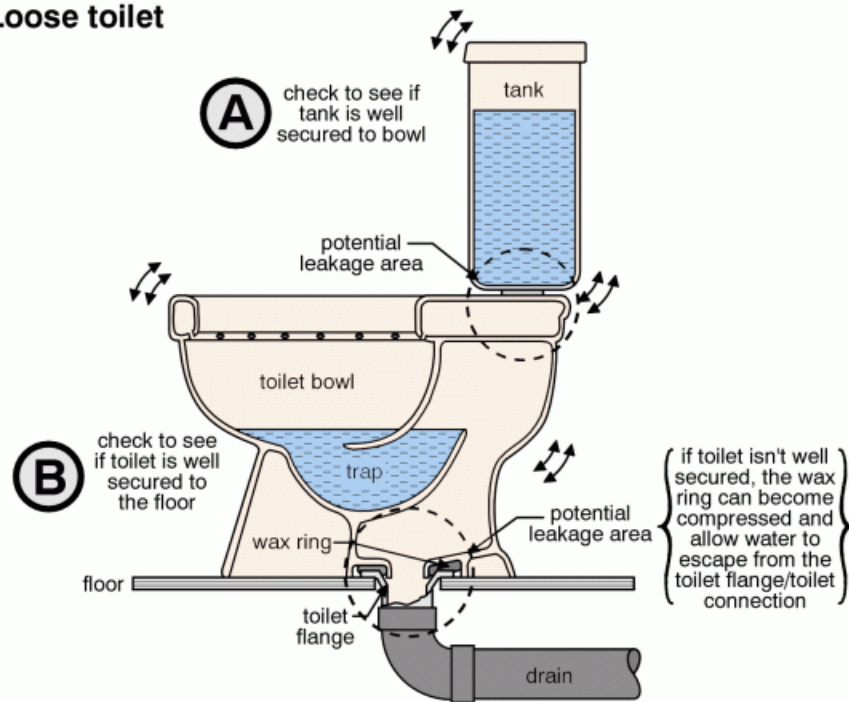
Condition: • [Loose](#)

Implication(s): Sewage entering the building | Chance of water damage to contents, finishes and/or structure

Loose toilet

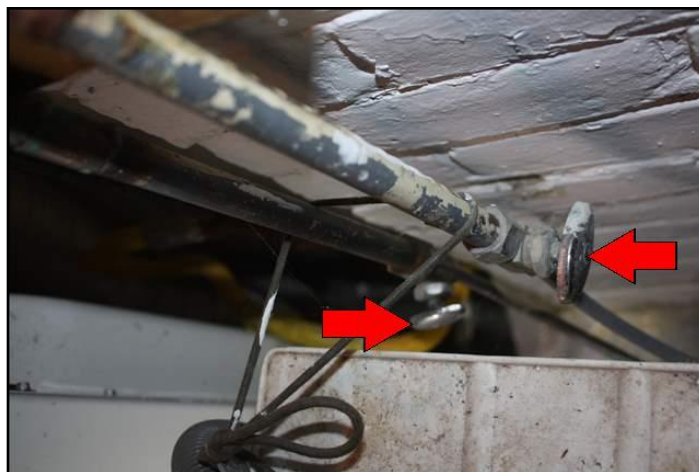
laundry tub supply lines were off

18. isolation valves are off

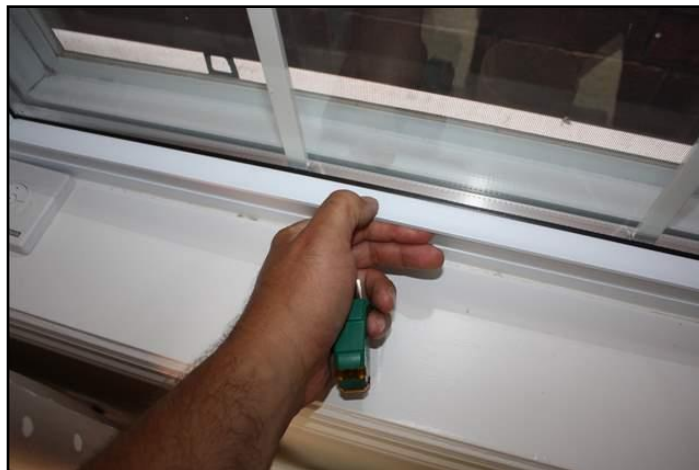
Condition: • [Loose](#)

Implication(s): Material deterioration

19. Loose

Task: Repair

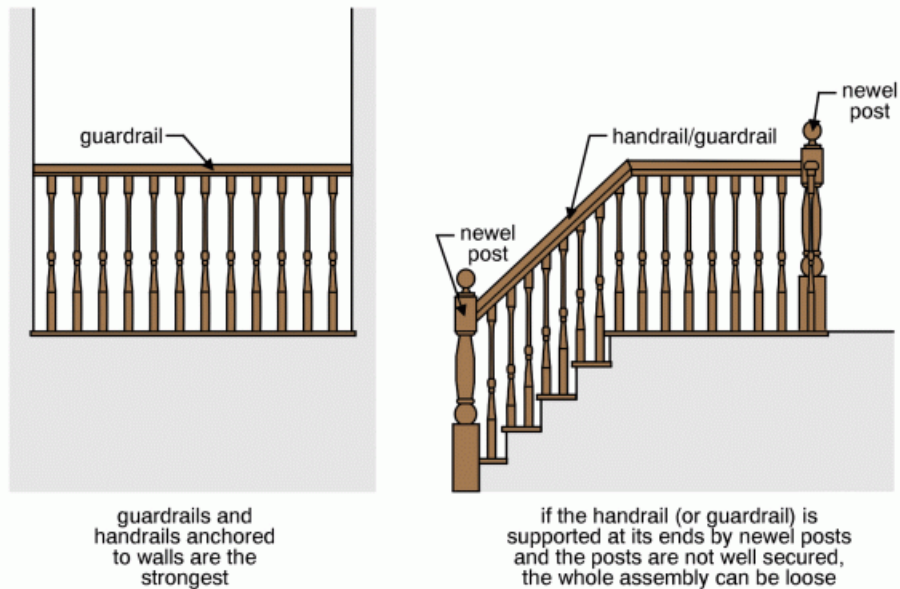
Condition: • [Loose](#)

Implication(s): Fall hazard

Handrail support

Task: Repair

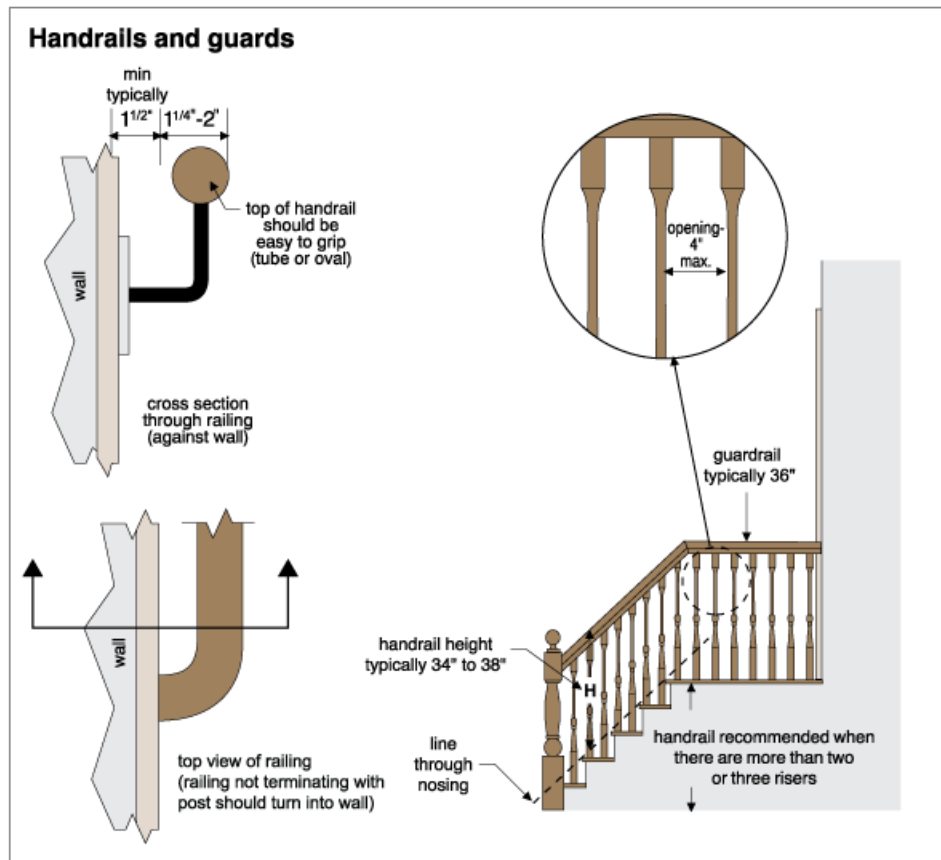
Condition: • [Missing](#)

Implication(s): Fall hazard

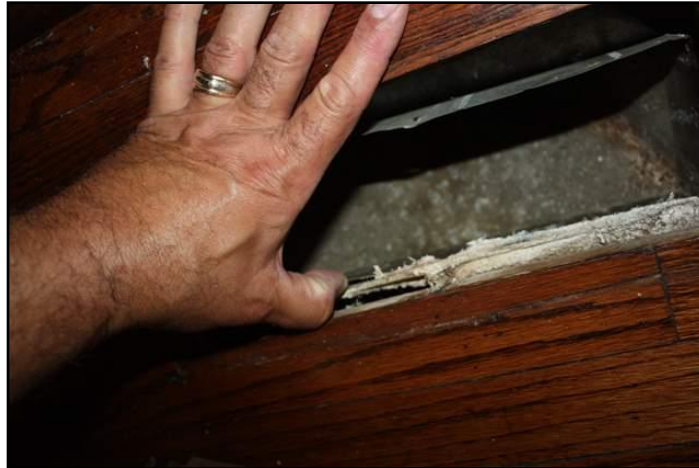
Condition: • Possible asbestos containing materials

During the era when this house was built and up until the 1960s, it was very common to wrap registers in material that may contain asbestos to protect the floors from overheating. Determining the material type is outside the scope of this inspection. Health Canada recommends that any asbestos material found should stay in place undisturbed. If you plan to remodel or if this is a concern, consult with a specialist for lab testing to confirm if asbestos is present.

Implication(s): Health hazard

20. Possible asbestos containing materials
