YOUR INSPECTION REPORT

FOR THE PROPERTY AT:
62 Larchmount Avenue
Toronto, ON M4M 2Y7

RE: Report No. 2556, v.2
62 Larchmount Avenue
Toronto, ON
M4M 2Y7

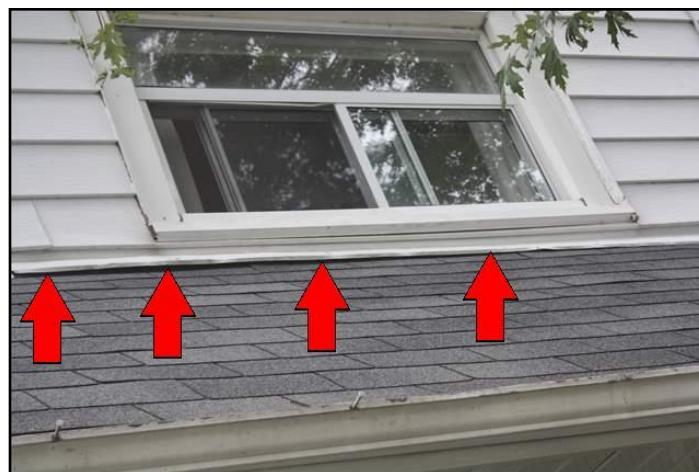
Condition: • [Damage, loose, open seams, patched](#)

Implication(s): Chance of water damage to contents, finishes and/or structure

Location: Front Exterior

1. *Damage, loose, open seams, patched*

Task: Repair

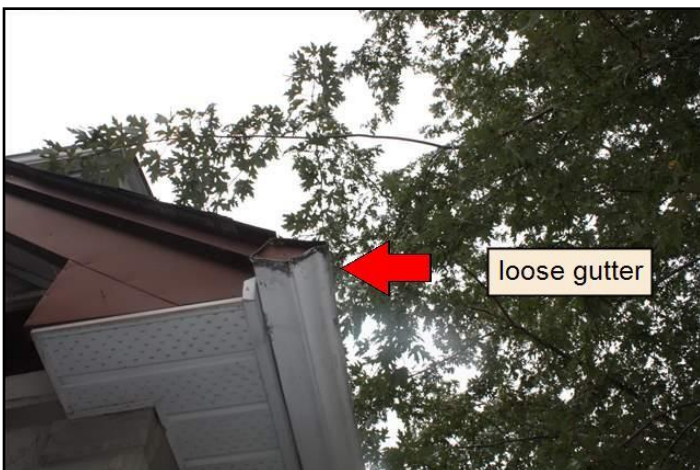
Condition: • Aging - Wear and tear noted. Fasteners loose in some areas

Location: Various Exterior

2. Aging - Wear and tear noted. Fasteners...

Task: Repair / Replace

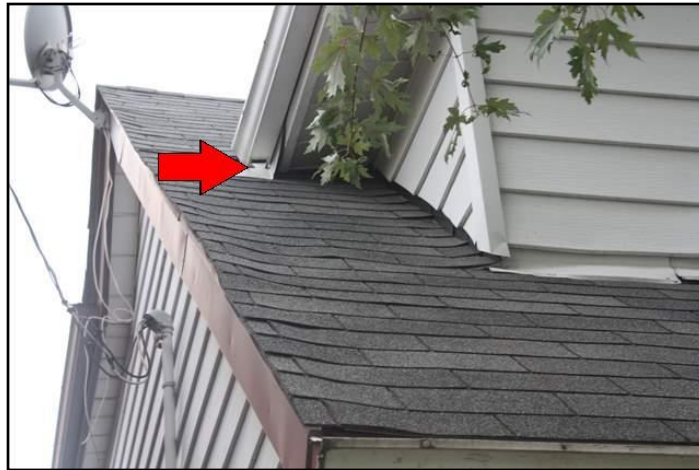
Condition: • [Discharge onto roofs](#)

Implication(s): Material deterioration

Location: Front Exterior

4. Discharge onto roofs

Improvement recommendation - Provide downspout from upper gutter to lower gutter to prevent premature wear to Shingles

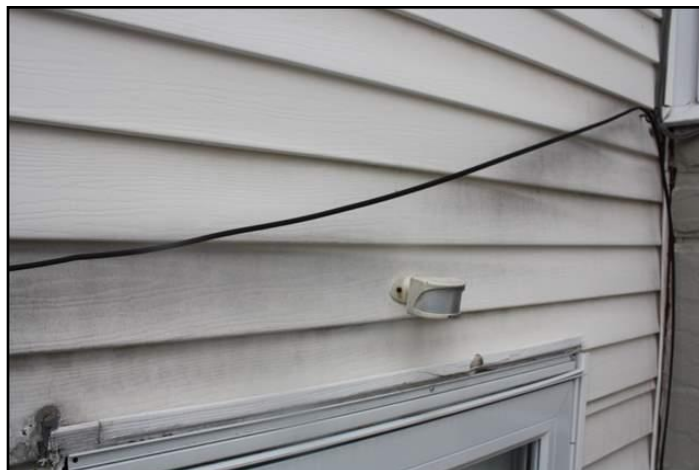
Condition: • [Loose or missing pieces](#)

Implication(s): Chance of water damage to contents, finishes and/or structure

Location: Rear Exterior Above Door

5. Loose or missing pieces

Task: Repair

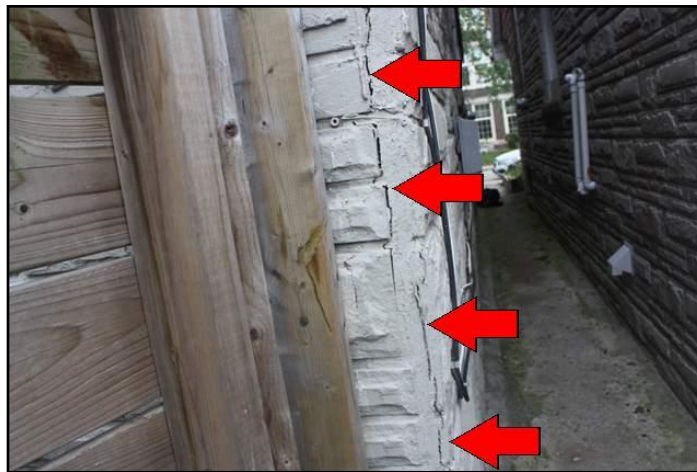
Condition: • Gap at Wall

Location: Corner Exterior

6. Gap at Wall

Patch to prevent water entry and spalling to stone.

Task: Patch / Seal

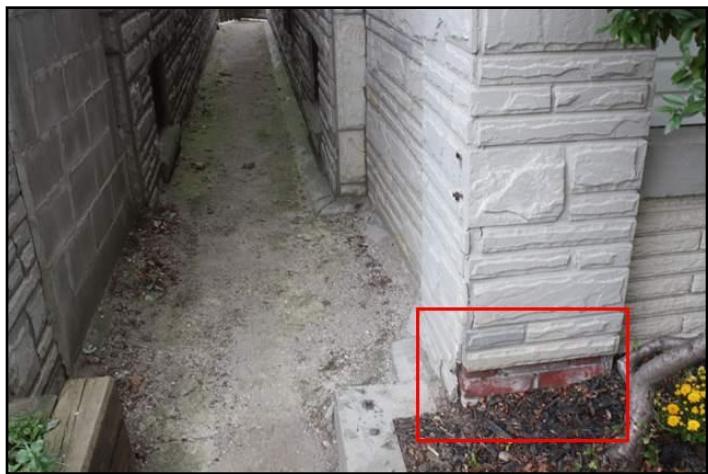
Condition: • [Spalling](#)

Implication(s): Weakened structure | Chance of structural movement

Location: Front Exterior

7. Spalling

Task: Repair

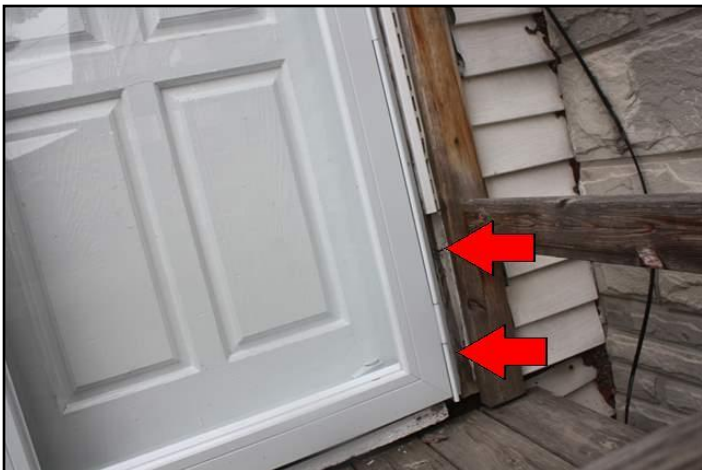
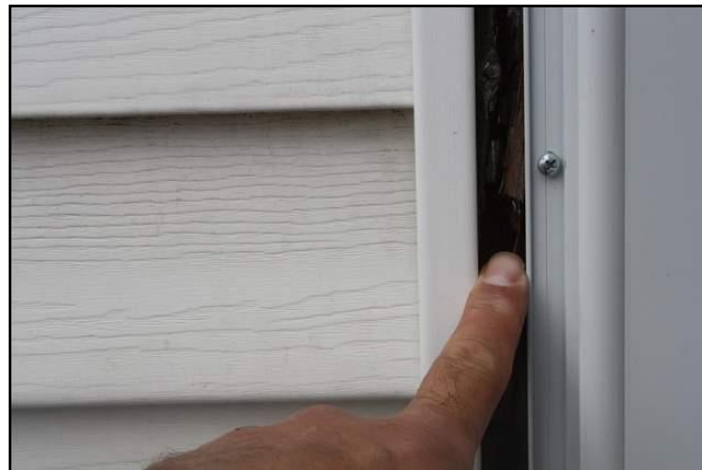
Condition: • [Rot](#)

Implication(s): Chance of damage to finishes and structure

Location: Rear Door

Task: Seal gap around entire door

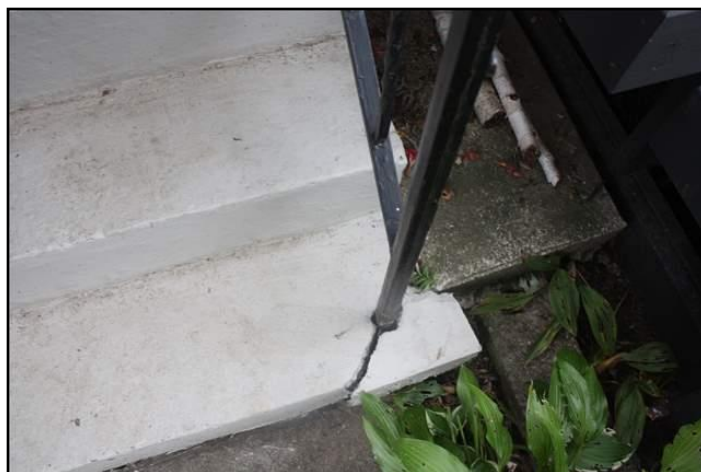
Condition: • [Masonry or concrete cracking](#)

Handrail loose due to damaged step

Implication(s): Weakened structure

Location: Front Exterior Staircase

10. *Masonry or concrete cracking*

Task: Repair / Replace

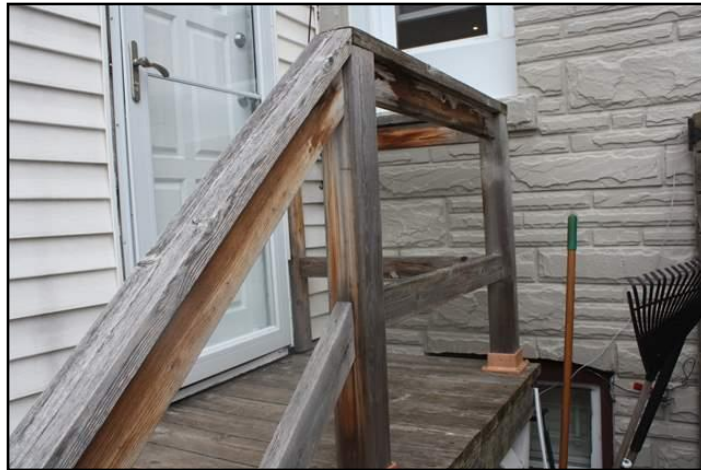
Condition: • [Loose](#)

Implication(s): Fall hazard

Location: Exterior Front Steps and Rear Steps

11. Loose

Task: Improve hand and guardrails

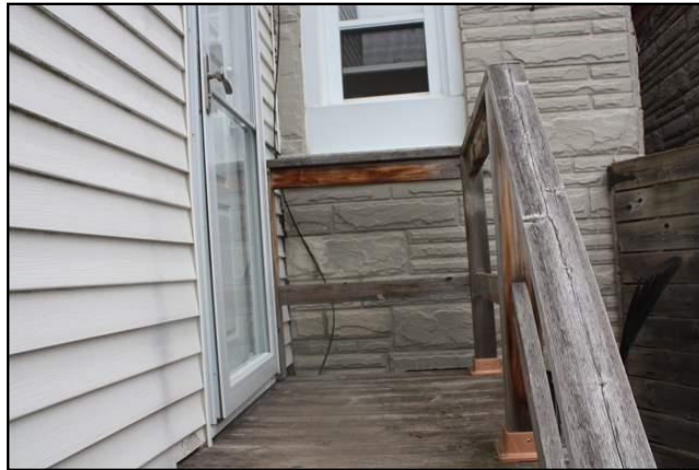
Condition: • [Spindles \(balusters\) climbable](#)

Implication(s): Fall hazard

Location: Rear Exterior

12. Spindles (balusters) climbable

Task: Correct / Provide vertical spindles for child safety

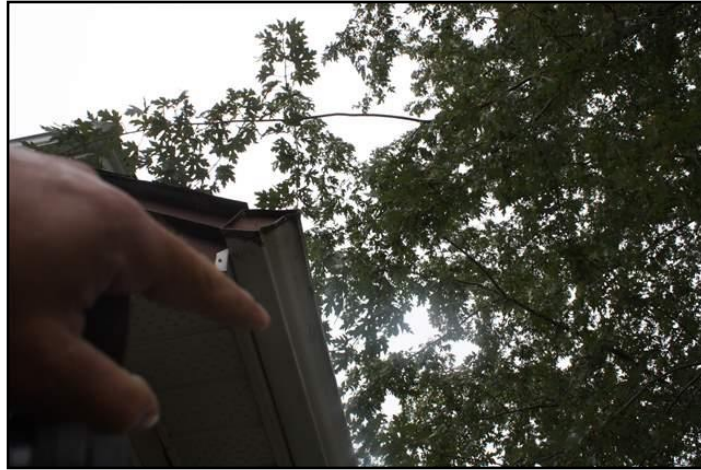
Condition: • [Trees or shrubs too close to building](#)

Implication(s): Chance of water damage to contents, finishes and/or structure | Chance of pests entering building | Material deterioration

Location: Front Exterior

13. *Trees or shrubs too close to building*

Keep tree branches trimmed back 3 feet from roof line

Task: Improve

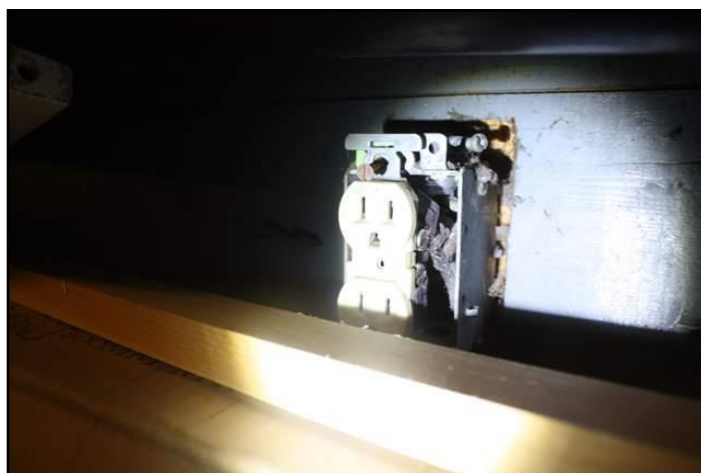
14.

Condition: • We observed one outlet in the rear basement storage room that contained knob and tube wiring. This was likely missed or not seen when the wiring upgrade was completed. For safety we recommend that you cap or provide a gfci outlet before using. Depending on your insurer, they may require that you remove this one line.(approx \$400-\$600) Alternatively, we have an arrangement with David Slack Insurers that may offer you coverage without hassle. For more information contact David Slack Insurance at 1-800-971-1363

Location: Rear Basement

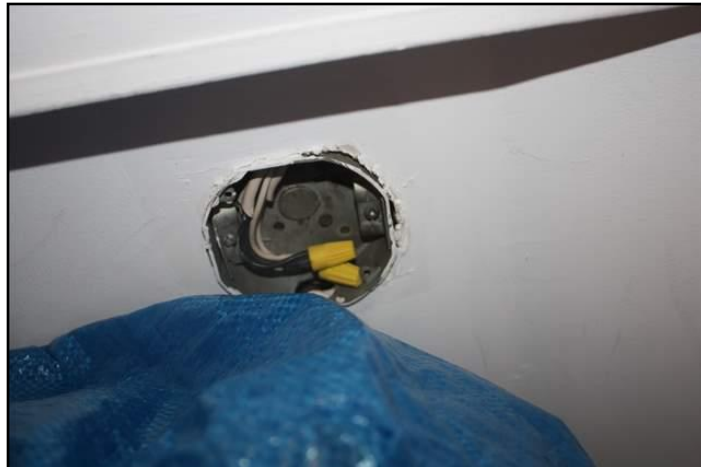
Condition: • [Cover loose or missing](#)

Implication(s): Fire hazard | Electric shock

15. Cover loose

Task: Cover
Time: Immediate
Cost: Minor

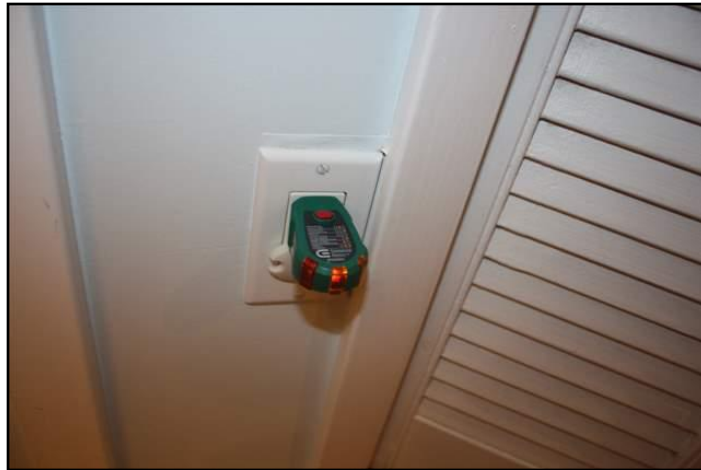
Condition: • [Reversed polarity](#)

16. Reversed polarity

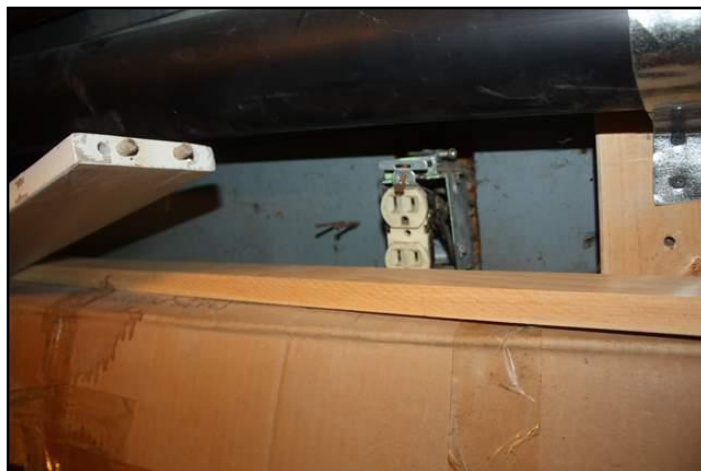
Condition: • [Loose](#)

Implication(s): Fire hazard | Electric shock

17. Loose

Task: Remove

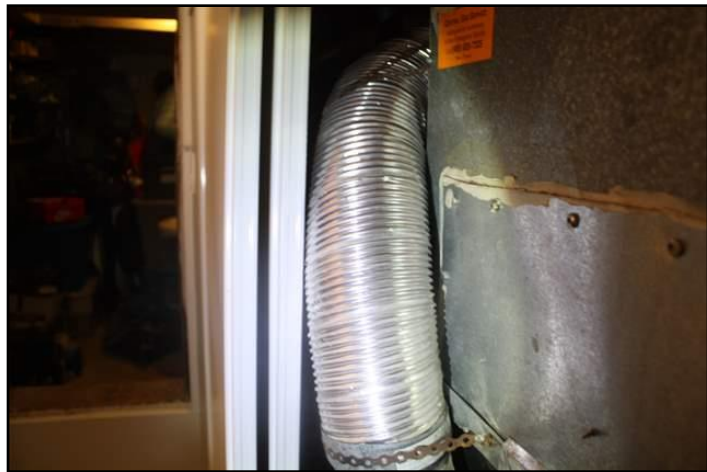
Condition: • [Combustible clearance](#)

Location: Basement Furnace Room

Implication(s): Fire hazard

18. Combustible clearance

Task: Correct - too close to sliding door

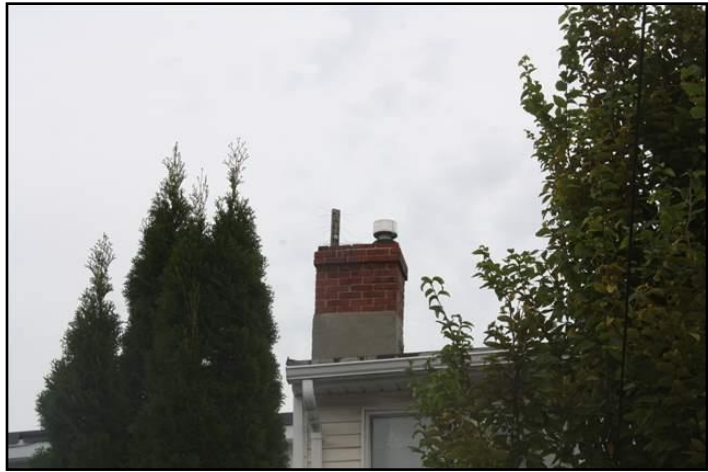
Condition: • [Missing](#)

Implication(s): Chance of water damage to contents, finishes and/or structure | Shortened life expectancy of material

19. Missing

Task: Provide Cap and tuckpoint mortar joints and cracks

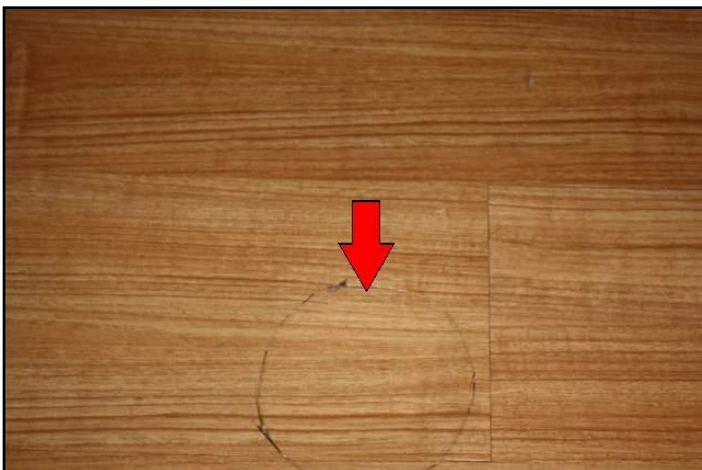
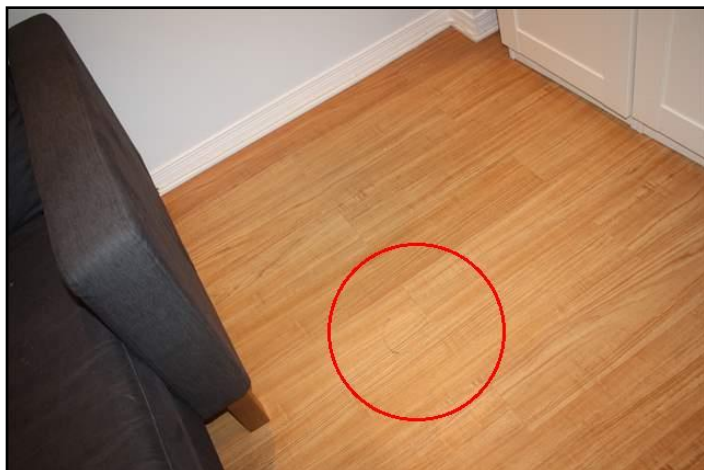
Condition: • Not visible

Seller noted that floor drain is below flooring. Remove and expose floor drain.

Implication(s): Chance of water damage to contents, finishes and/or structure

21. Not visible

22. Not visible

Task: Correct

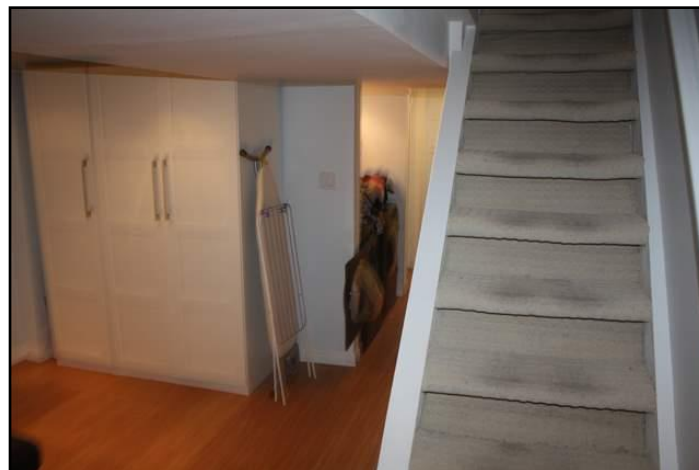
23.

Condition: • [Missing](#)

Implication(s): Fall hazard

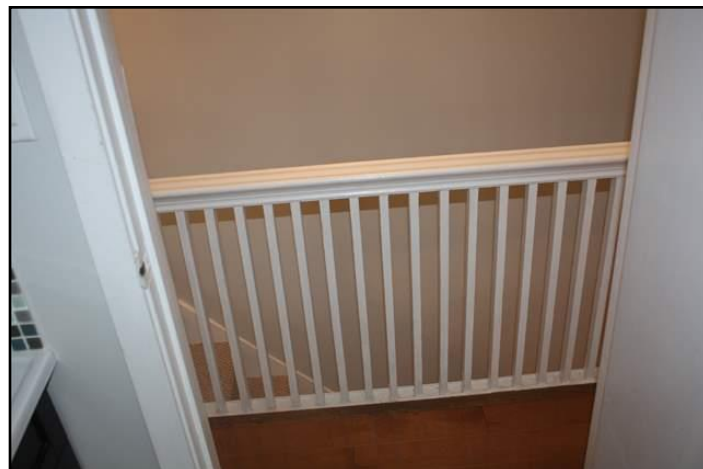
Condition: • [Too low](#)

Implication(s): Fall hazard

24. Too low

Task: Upgrade
Time: Discretionary
