YOUR INSPECTION REPORT

84 Evans Avenue
Toronto, ON M6S 3V8

Monday, September 30, 2019

RE: Report No. 2552, v.2
84 Evans Avenue
Toronto, ON
M6S 3V8

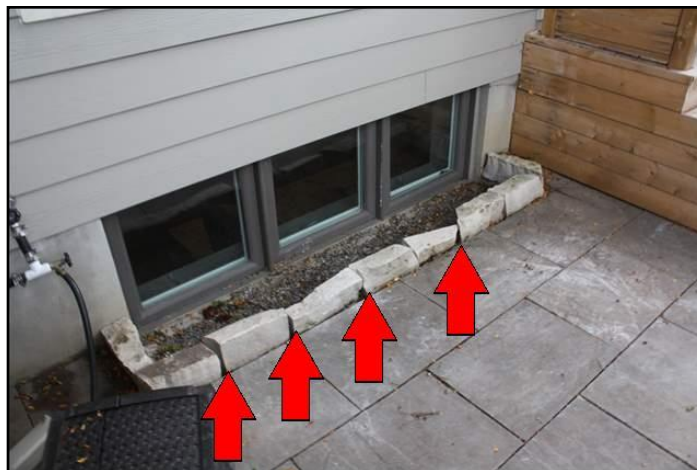
1.

Condition: • Window well retaining wall contains gaps

Location: Rear Exterior

Task: Improve

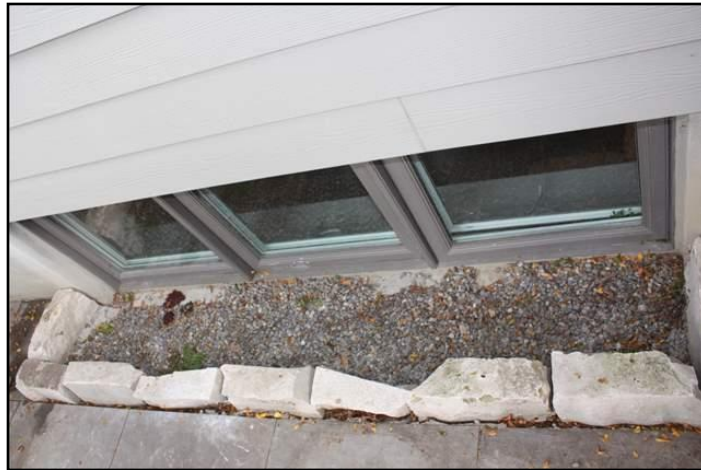
Condition: • Window sill is at or below grade.

Location: Rear Exterior

2. Window sill is at or below grade.

Task: Improve

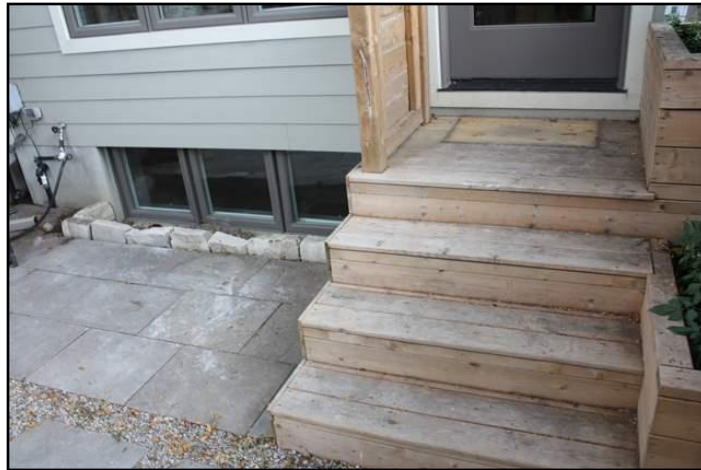
Condition: • [Missing](#)

Implication(s): Fall hazard

Location: Rear Exterior

3. Missing Handrail

Task: Provide Handrail

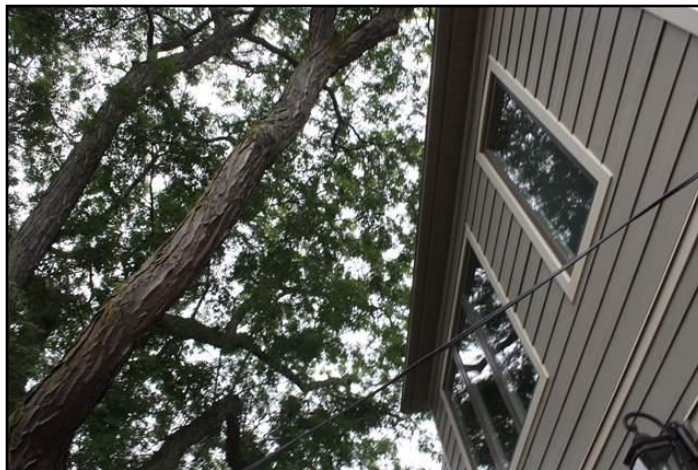
Condition: • [Trees or shrubs too close to building](#)

Implication(s): Chance of water damage to contents, finishes and/or structure | Chance of pests entering building | Material deterioration

Location: Rear Exterior

4. Trees or shrubs too close to building

Keep tree branches trimmed back 3 feet from roof line

Task: Improve

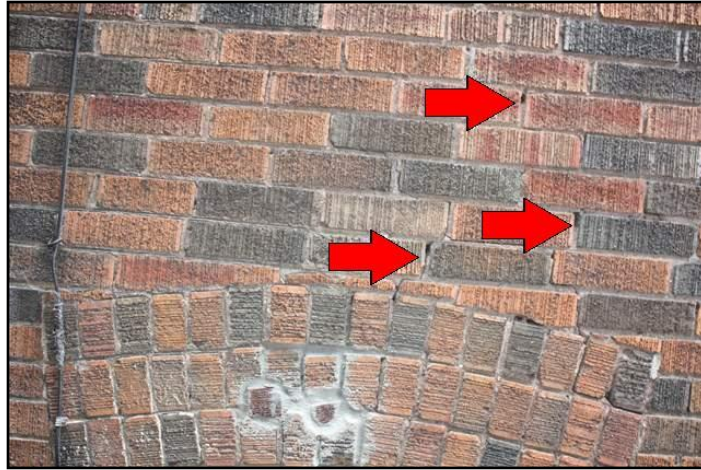
6. Example

Condition: • [Mortar deteriorating](#)

Repointing / Tuck-Pointing needed at various areas. This is common maintenance for homes of this age. Overall. the exterior wall is in good condition and well maintained.

Implication(s): Weakened structure | Chance of structural movement

Location: Various Exterior Wall

Task: Improve

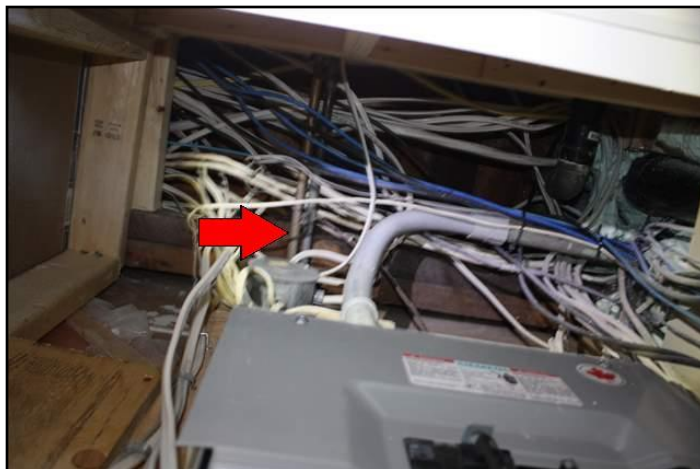
7.

Condition: • Supply plumbing and riser noted over panel area. Consult with electrician to verify if current setup is acceptable.

Location: Basement over panel

Task: Further evaluation / Improve

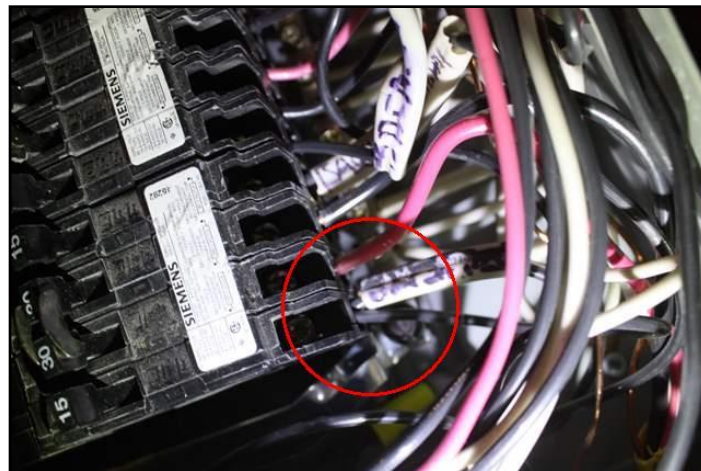
Condition: • [Double taps](#)

Implication(s): Fire hazard

Location: Basement Panel

Double tapping (double lugging)

8. Double taps

Task: Correct

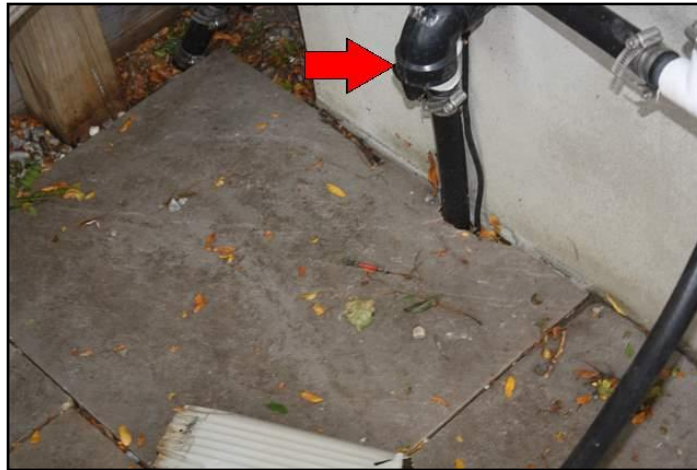
Condition: • [Discharge pipe problems](#)

The discharge pipe of the sump should drain to the exterior of the home, ideally extended to 12 feet away (or a sewer, drainage ditch or dry well.)

Implication(s): Chance of water damage to contents, finishes and/or structure

Location: Rear Exterior

11. Discharge pipe problems

Task: Improve

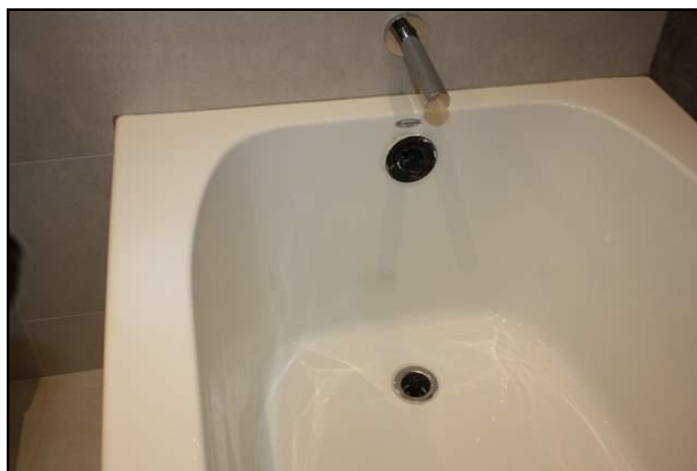
Condition: • [Overflows missing, leak, rust or inappropriate](#)

Overflow cap missing

Implication(s): Chance of water damage to contents, finishes and/or structure

Location: Basement Bathroom

12. Overflows missing, leak, rust or...

Task: Improve

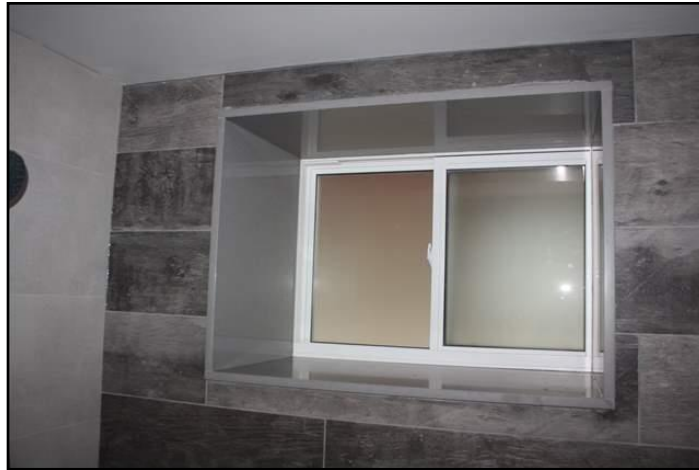
13.

Condition: • window in bathtub area.

Location: Basement Bathroom

Task: Protect window when in use

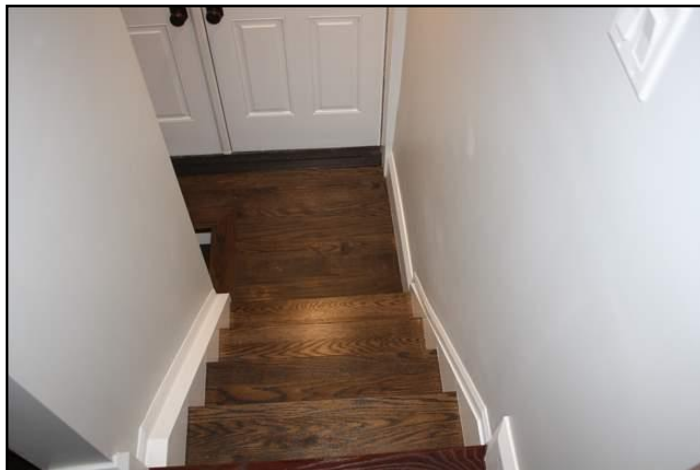
Condition: • [Missing](#)

Implication(s): Fall hazard

14. Missing

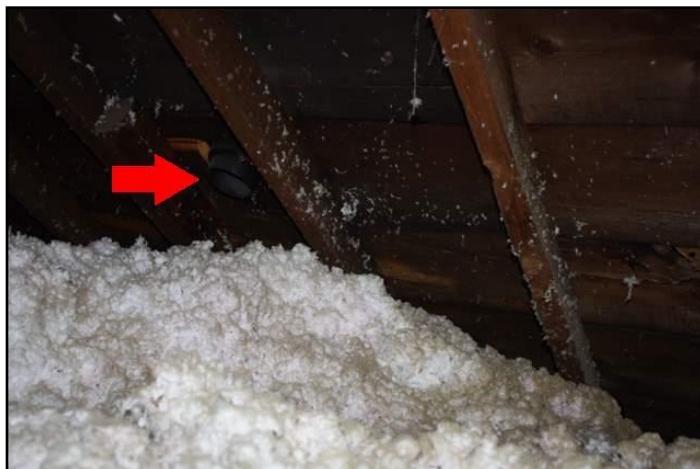
Condition: • [Termination point not found](#)

Exhaust duct from bathroom not observed. Verify that there is a duct from the bathroom which exhausts to the exterior.

Implication(s): Chance of condensation damage to finishes and/or structure

15. Termination point not found

Task: Further evaluation / Correct
