YOUR INSPECTION REPORT

FOR THE PROPERTY AT:
86 Ardagh Street
Toronto, ON M6S 1Y5

RE: Report No. 2642
86 Ardagh Street
Toronto, ON
M6S 1Y5

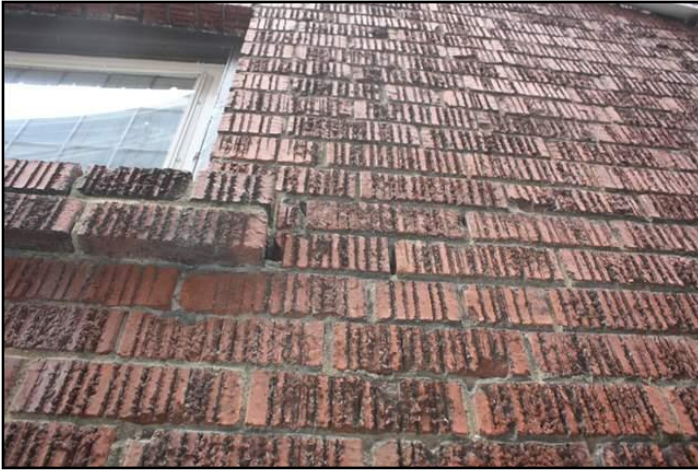
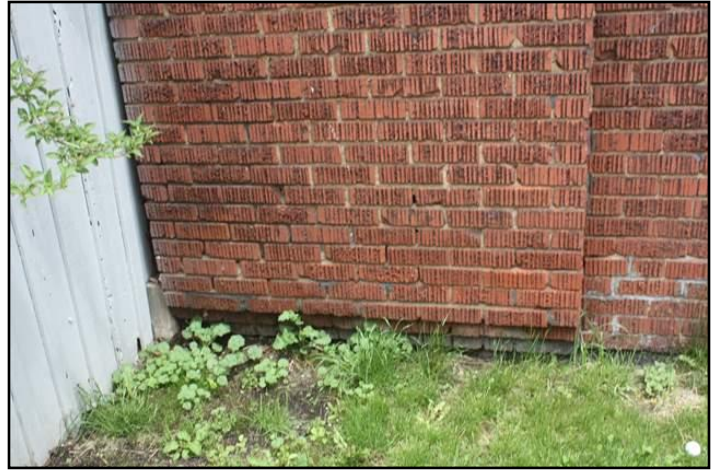
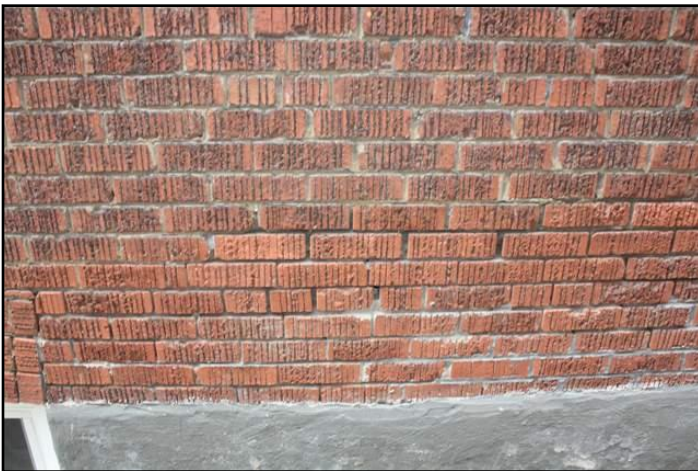
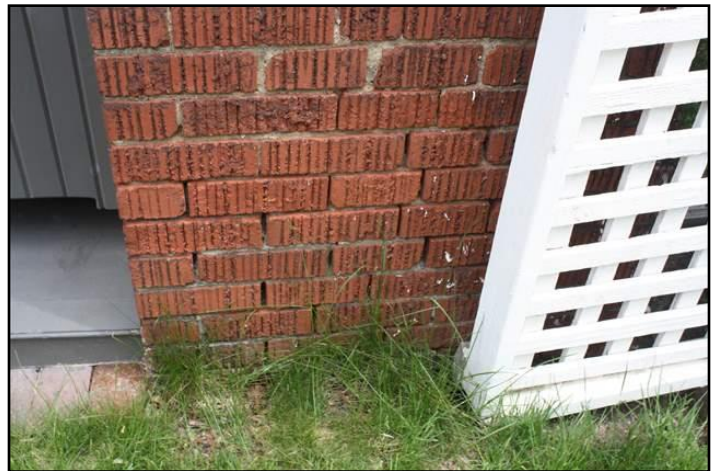
Condition: • [Mortar deterioration](#)

Provide mortar (Repointing, Tuck pointing) at various areas of the exterior brick and window sills and chimney. This is very common maintenance for homes of this age. The photos show a sampling.

Location: Various Exterior Wall and Chimney and window sills

Task: Improve / Provide mortar

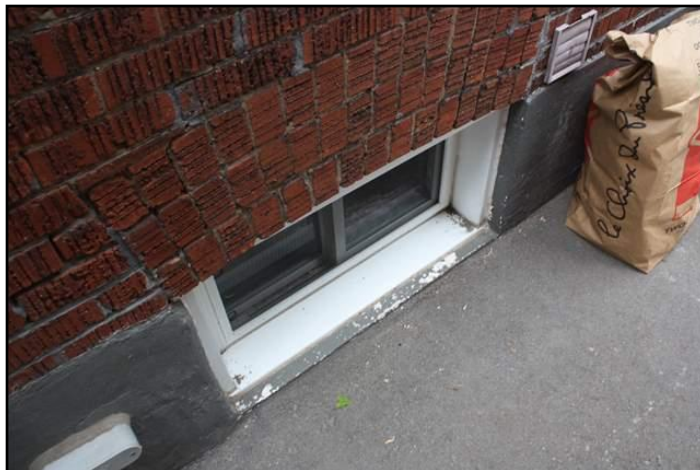
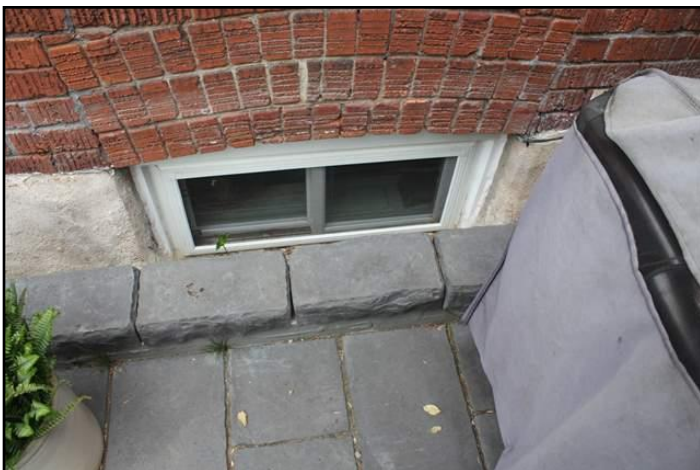
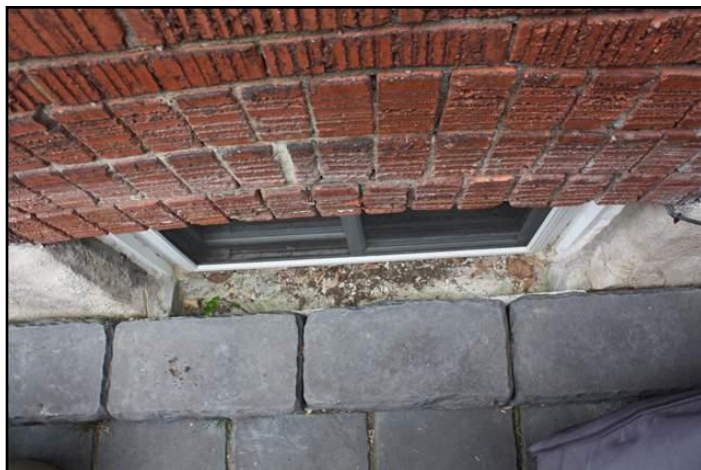
5. Sill - Near or at Grade Level

Condition: • Sill - Near or at Grade Level

Vulnerable area. Monitor to ensure water is not pooling at window. You may consider providing a clear window well cover to prevent moisture from being trapped in this area.

Location: Rear Exterior

Task: Monitor / Improve

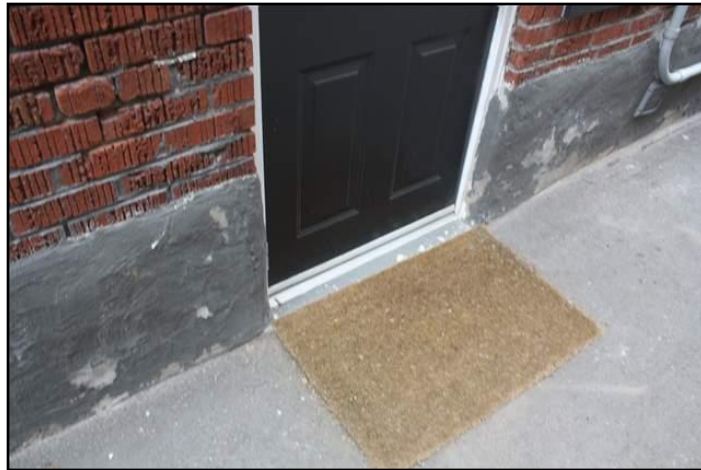
Condition: • Threshold too low

Implication(s): Increased heating and cooling costs

Location: Right Side Exterior

8. Threshold too low

Task: Monitor / Improve

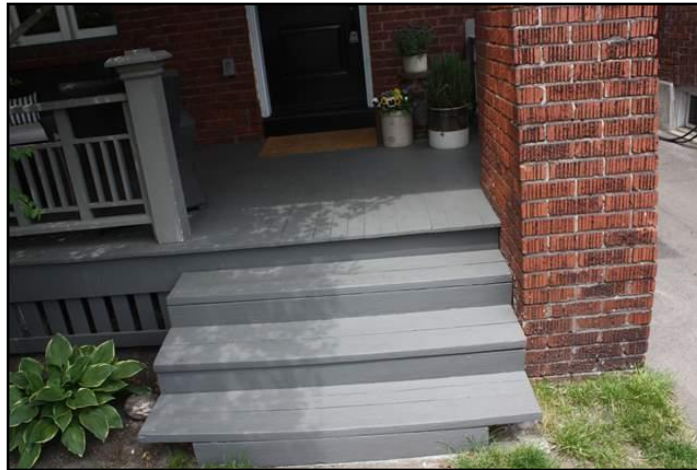
Condition: • [Missing](#)

Implication(s): Fall hazard

Location: Front Exterior Staircase

9. Missing

Task: Provide Handrail

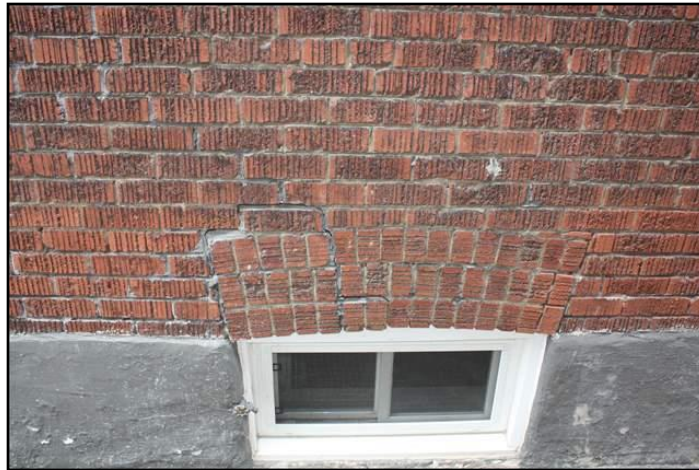
Condition: • [Cracked](#)

Very common to find cracks and settlements at arches above windows. Patch to prevent further damage and/or movement

Implication(s): Weakened structure | Chance of structural movement

Location: Right Side Exterior Wall

10. *Cracked*

Task: Patch

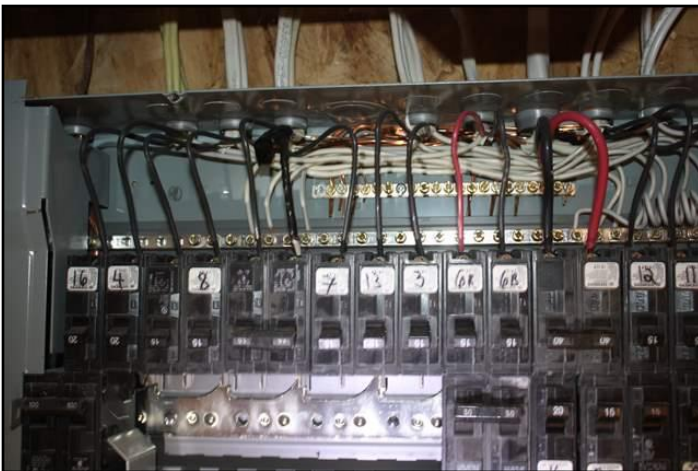
Condition: • [No links for multi-wire circuits](#)

Possible missing links(breaker bridge) (x3) Have electrician confirm if distribution lines are multi-wire 240V circuits. Provide links if necessary.

11. No links for multi-wire circuits

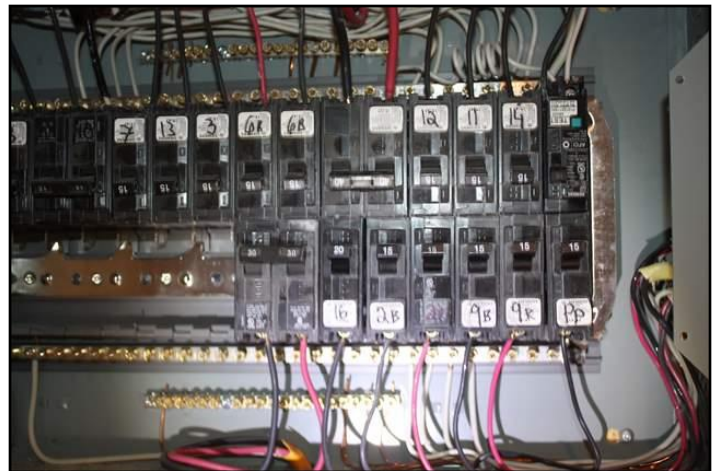
12. No links for multi-wire circuits

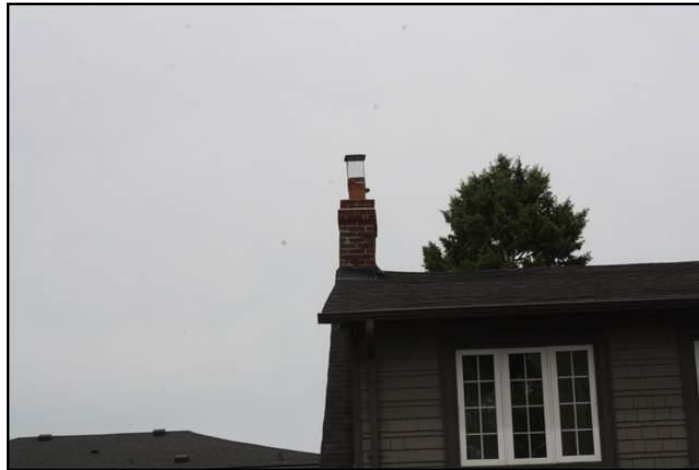
Condition: • [No drip edge on cap](#)

Implication(s): Chance of water damage to contents, finishes and/or structure | Shortened life expectancy of material | Material deterioration

13. No drip edge on cap

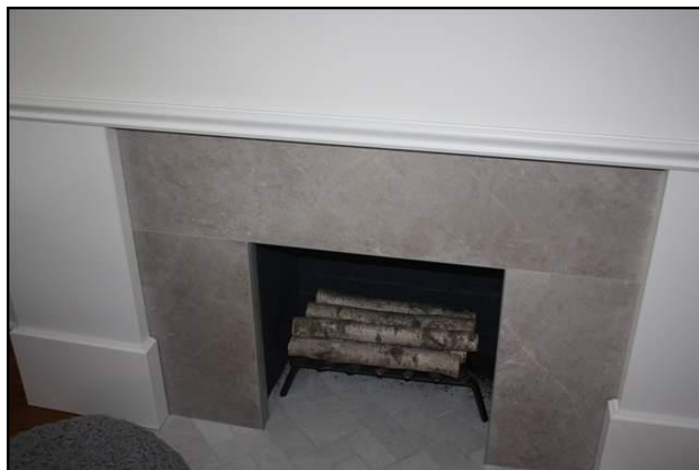
Condition: • [Too small](#)

Implication(s): Fire hazard

14. Too small

Task: Correct

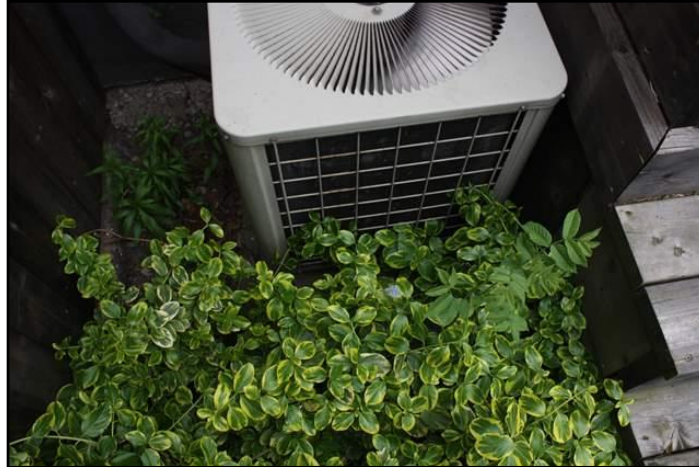
15.

Condition: • Vegetation in contact with A/C unit

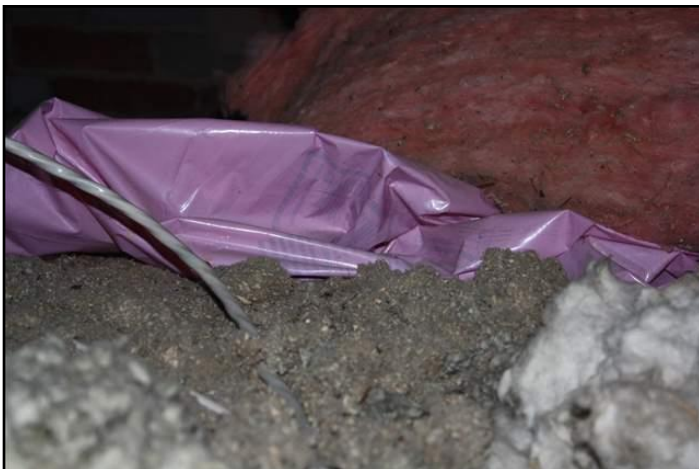
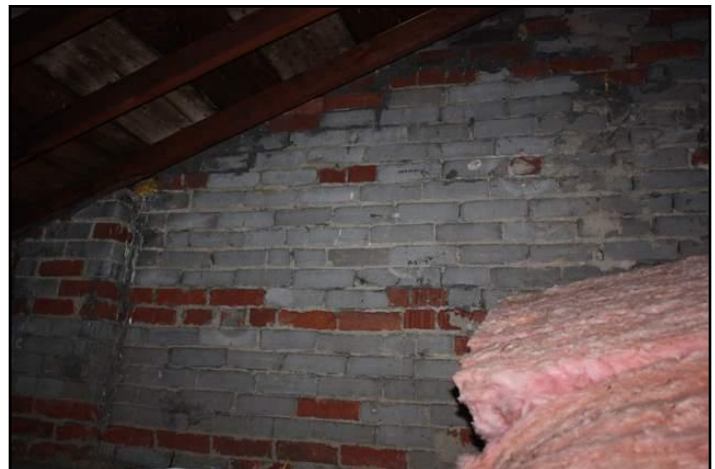
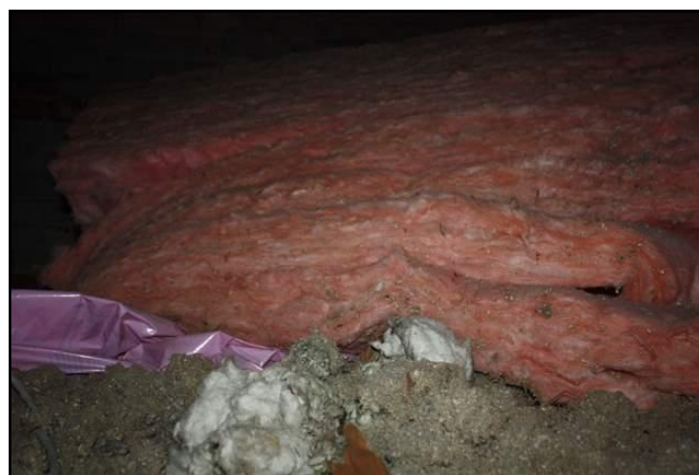
Condition: • Inoperable

Location: Attic

16. Inoperable

Task: see note

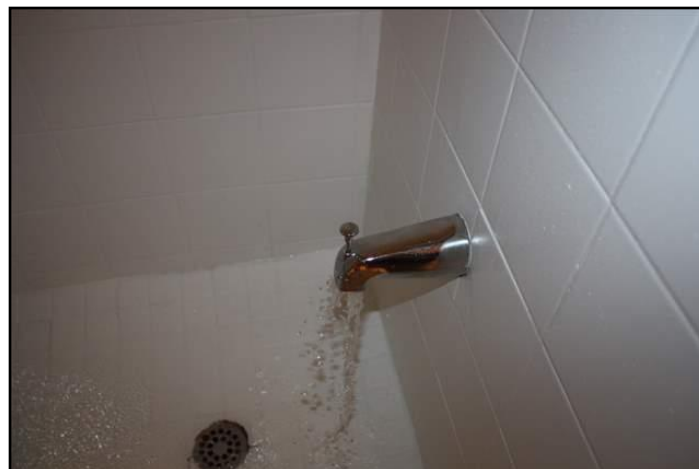
Condition: • [Shower diverter inoperative or defective](#)

Implication(s): Equipment failure

20. *Shower diverter inoperative or defective*

Task: Repair / Replace

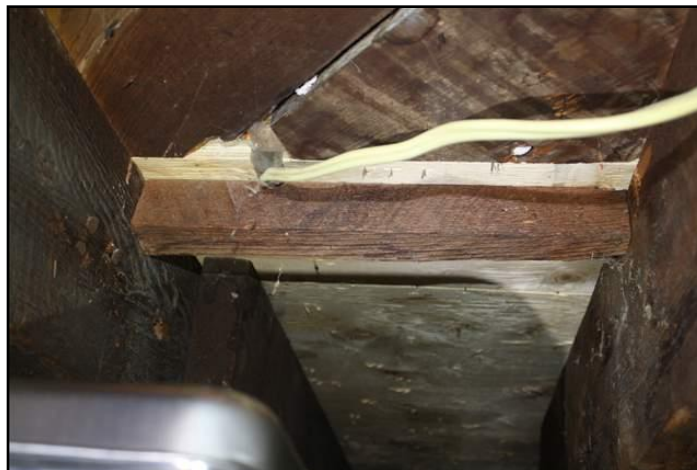
Condition: • [Prior repairs](#)

Location: Basement

21. Example

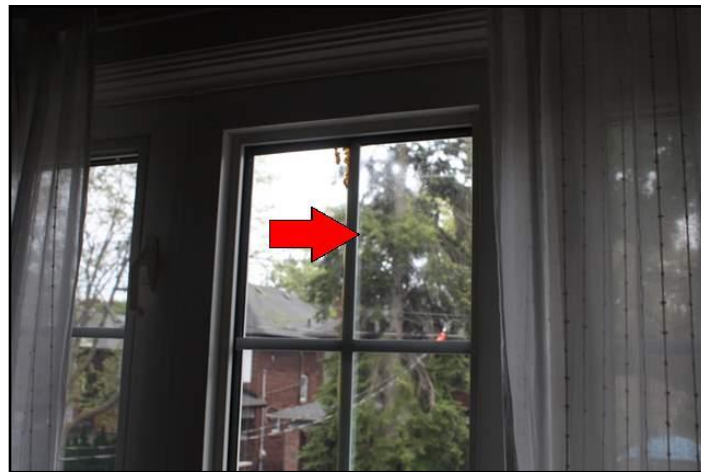
Condition: • [Lost seal on double or triple glazing](#)

22. Lost seal on double or triple glazing

Task: Replace
