# YOUR INSPECTION REPORT

38 Harshaw Avenue  
Toronto, ON M6S 1Y1

INSPECTION DATE:  
Wednesday, August 12, 2020

RE: Report No. 2704, v.3  
38 Harshaw Avenue  
Toronto, ON  
M6S 1Y1

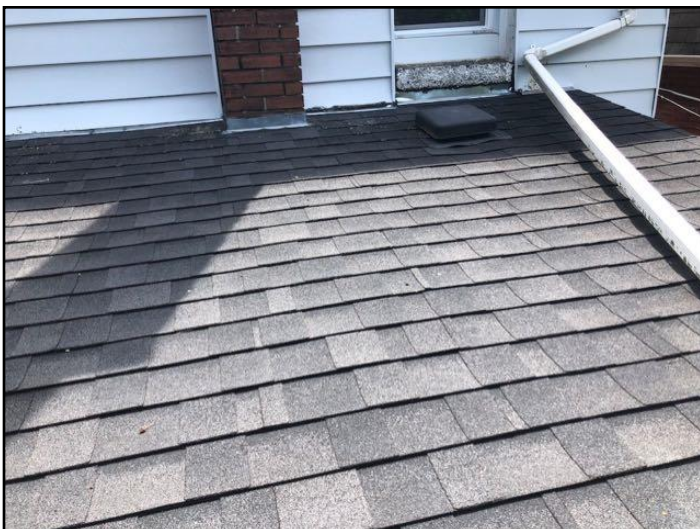
1. Asphalt shingles

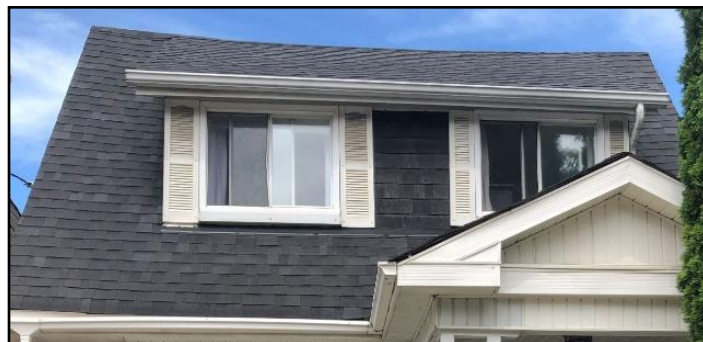
2. Asphalt shingles 5 years old

Sloped roof asphalt shingles at front of home are reported by seller to be 5 years old. Rear sloped age unknown but in fair condition.

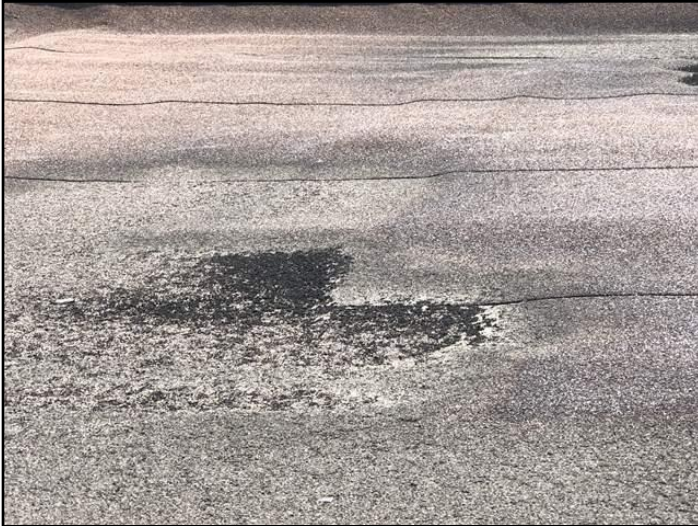
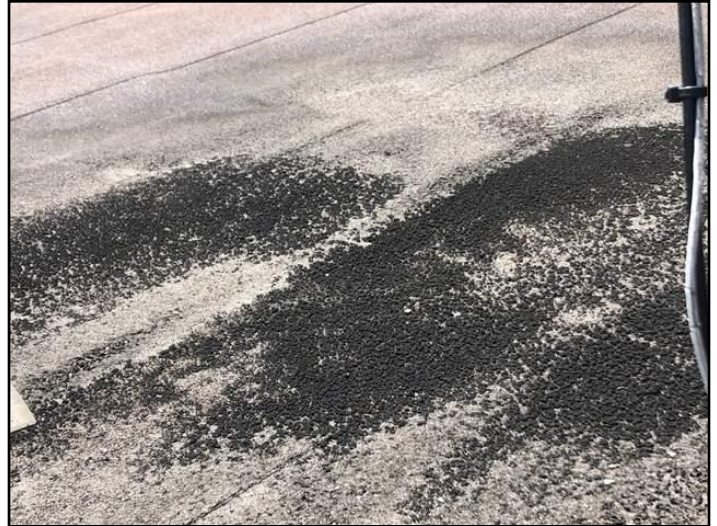
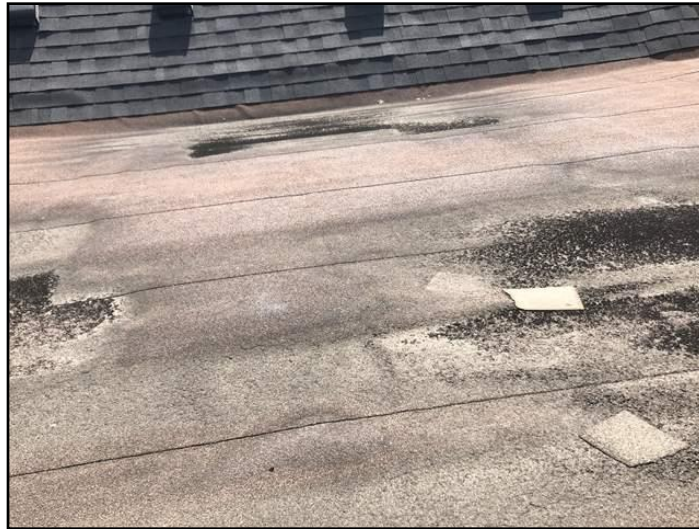
**Condition:** • Aging

3. Aging

4. Aging

5. Aging

**Task:** Repair / Replace

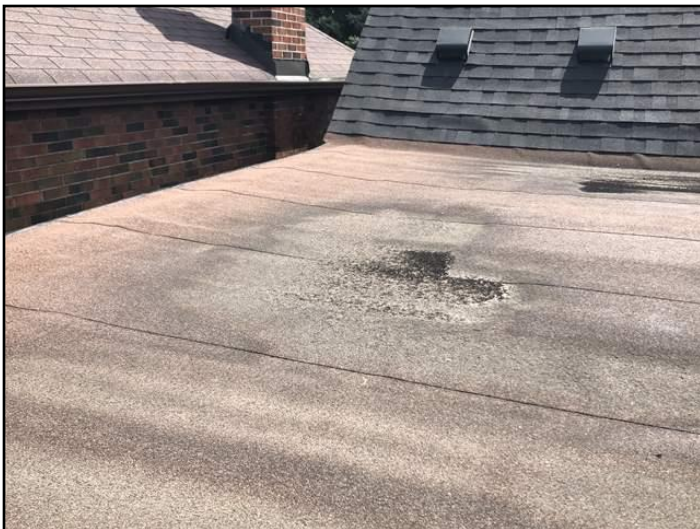
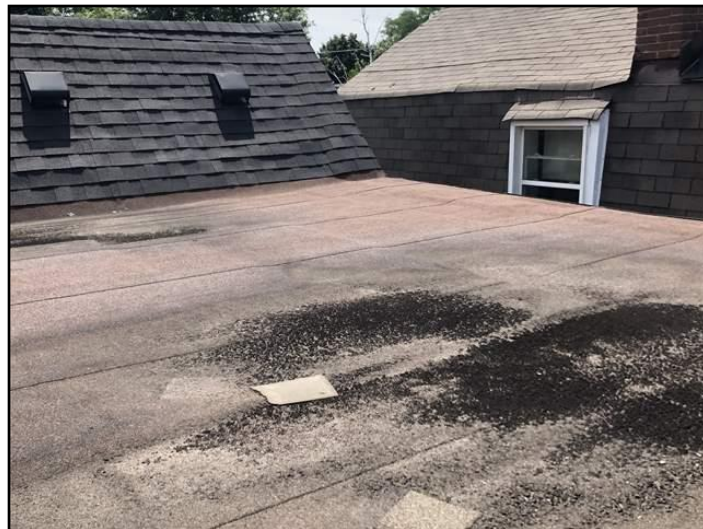
**Condition:** • [Ponding](#)

**Implication(s):** Chance of water damage to contents, finishes and/or structure

**Task:** Repair low areas - see Roofing aging

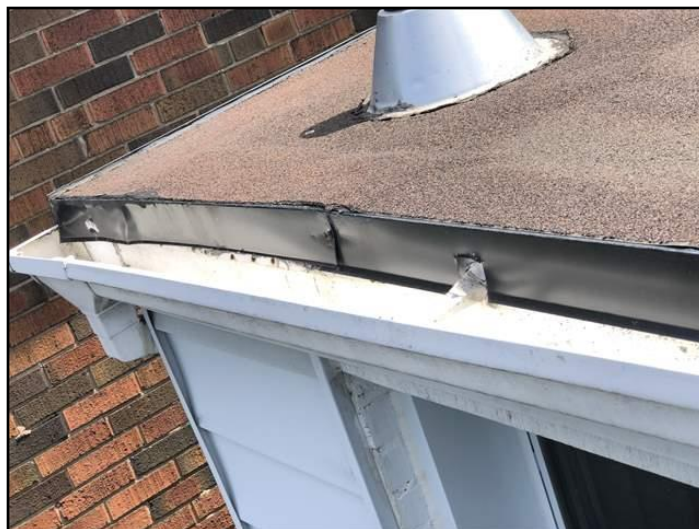
**Condition:** • [Damage, loose, bent](#)

**Implication(s):** Chance of water damage to contents, finishes and/or structure

**Task:** Repair / Replace

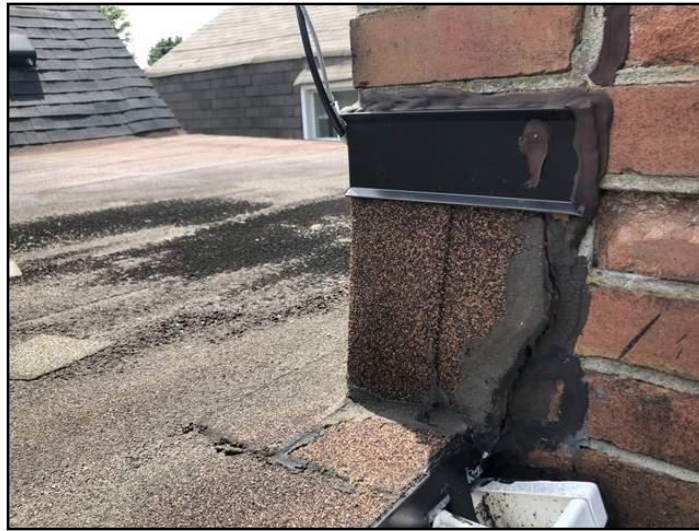
**Condition:** • [Caulking, sealant dried out, cracked](#)

**Implication(s):** Chance of water damage to contents, finishes and/or structure

9. Caulking, sealant dried out, cracked

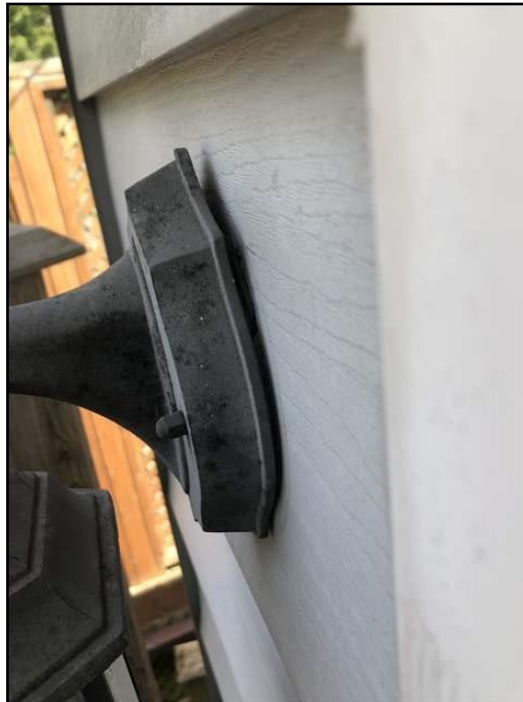
**Condition:** • [Caulking missing or ineffective](#)

**Implication(s):** Chance of water damage to contents, finishes and/or structure

10. Caulking missing or ineffective

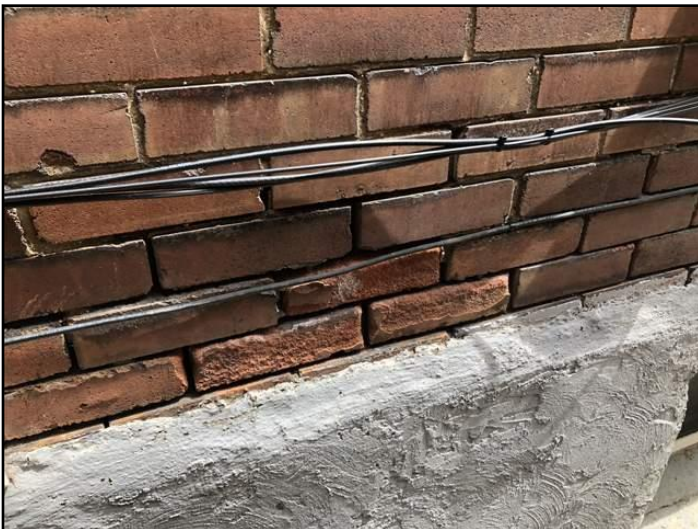
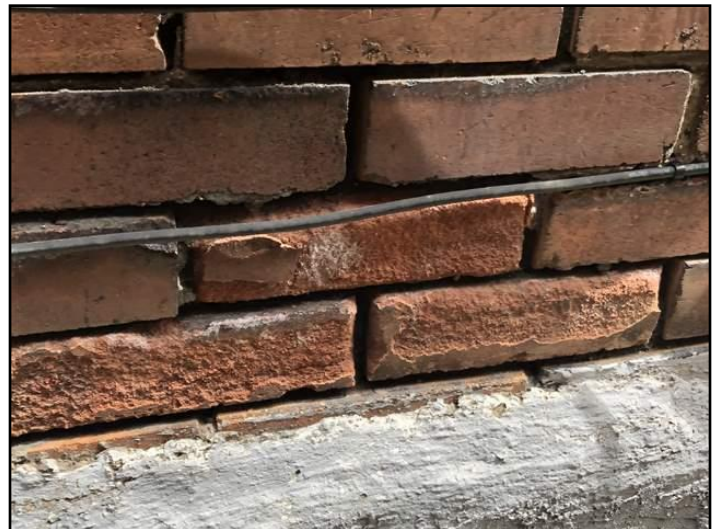
**Condition:** • [Spalling](#)

Spalling at various areas. Repair / Replace / Tuck point masonry/mortar. This is regular maintenance for a home of this age. photos show a sampling

11. Spalling example

12. Spalling example

**Task:** Repair / Replace

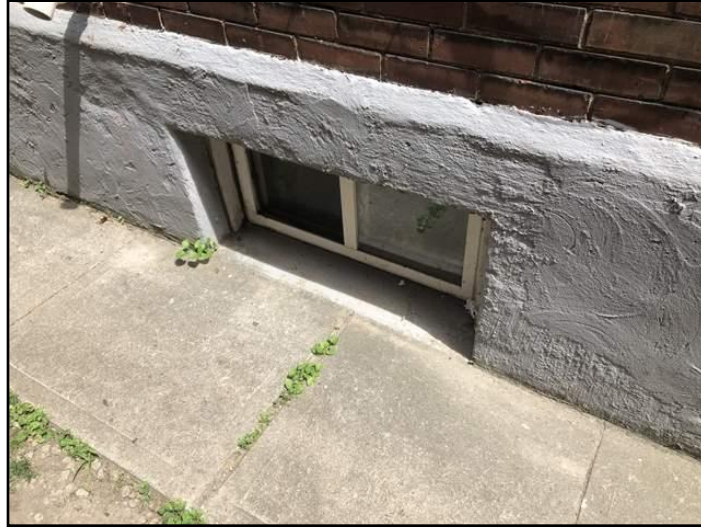
**Condition:** • Sill - Near or at Grade Level

13. Sill - Near or at Grade Level

**Task:** Monitor / Improve

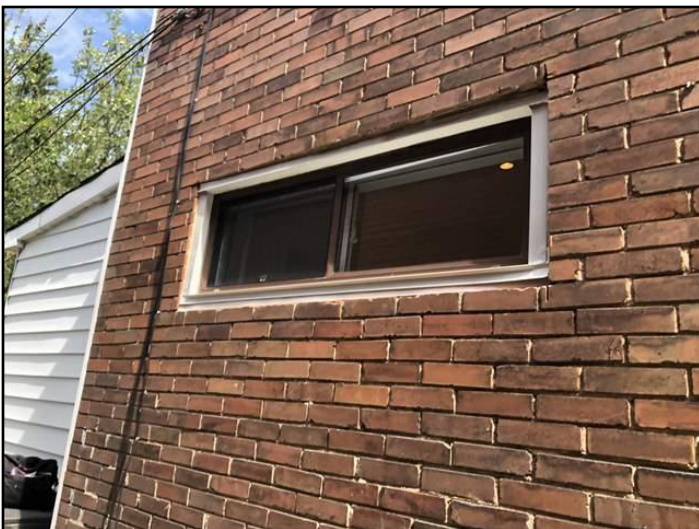
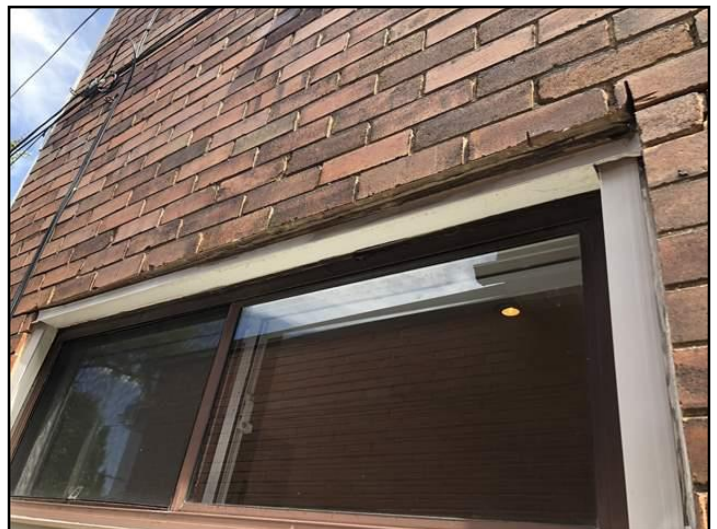
**Condition:** • [Flashing loose, missing or deteriorated](#)

**Implication(s):** Chance of water damage to contents, finishes and/or structure

14. Flashing loose, missing or deteriorated

15. Flashing loose, missing or deteriorated

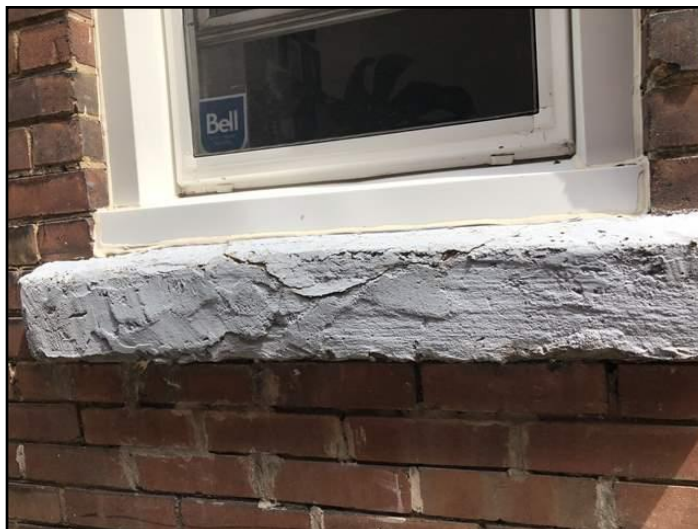
**Condition:** • [Sill deteriorated](#)

**Implication(s):** Material deterioration

16. Sill deteriorated

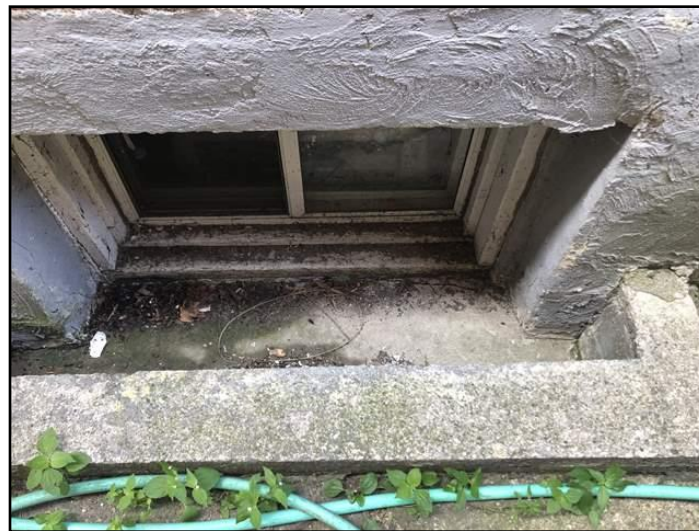
**Condition:** • [Missing](#)

Modern standards require window well drains, as these are typically vulnerable areas for leakage. In the meantime, installing a clear plastic window well cover to help manage the water in this area is recommended. Ensure that you seal the cover to the house.

17. Missing

**Task:** Provide window well drain if regrading in the future

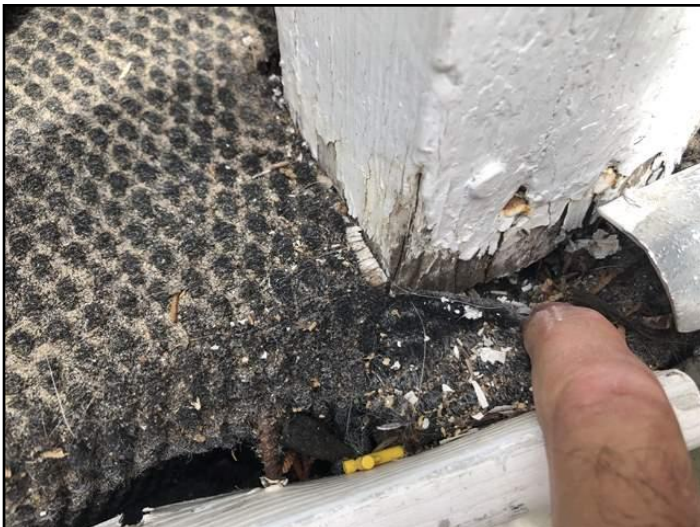
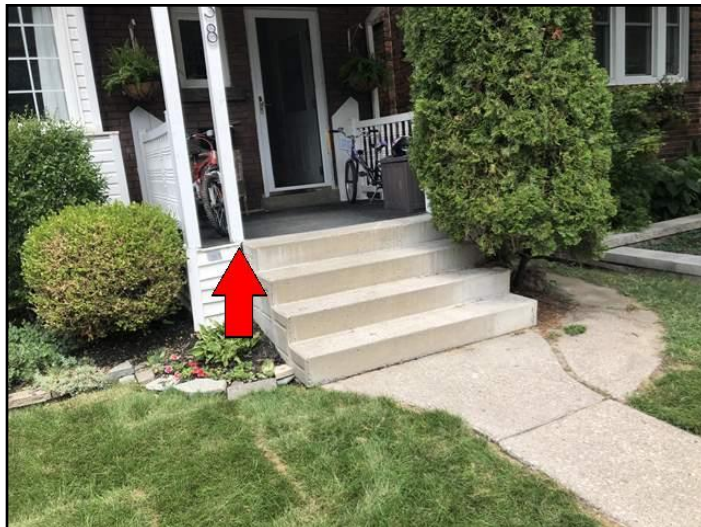
**Condition:** • [Rot](#)

18. Rot

19. Rot

**Task:** Repair / Replace

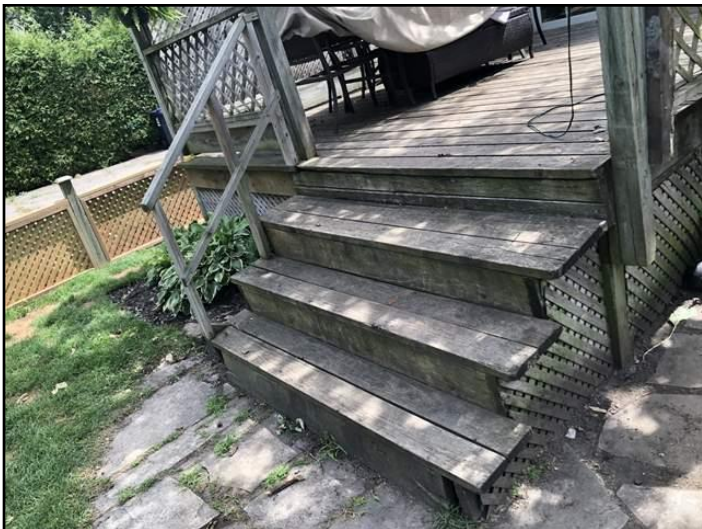
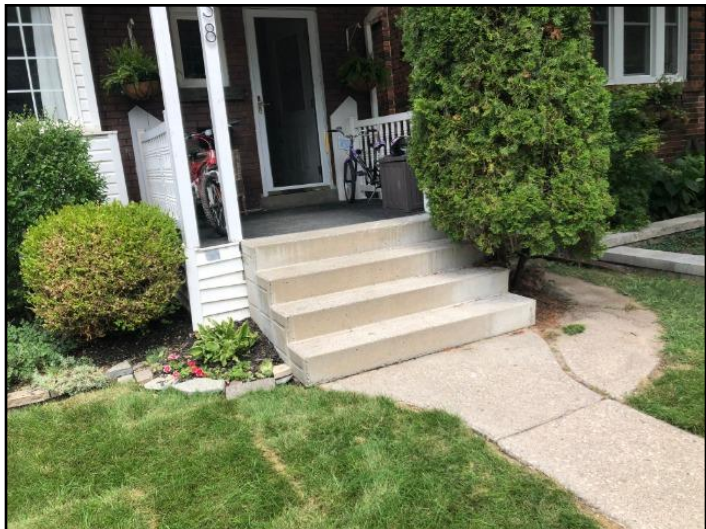
20.

**Condition:** • [Missing](#)

**Implication(s):** Fall hazard

21. Missing

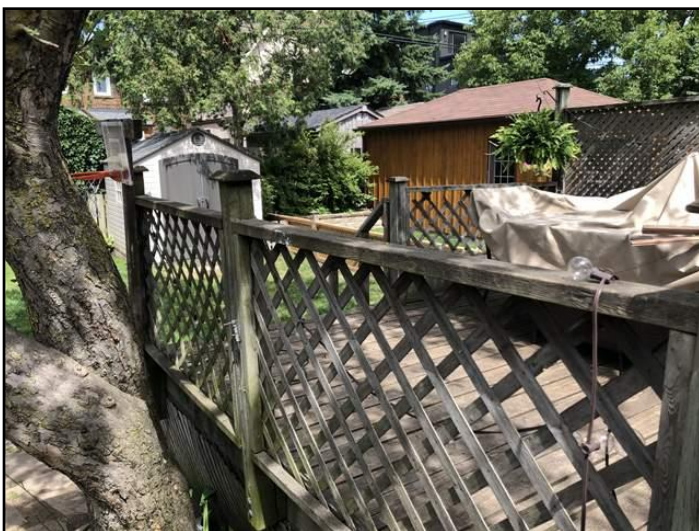
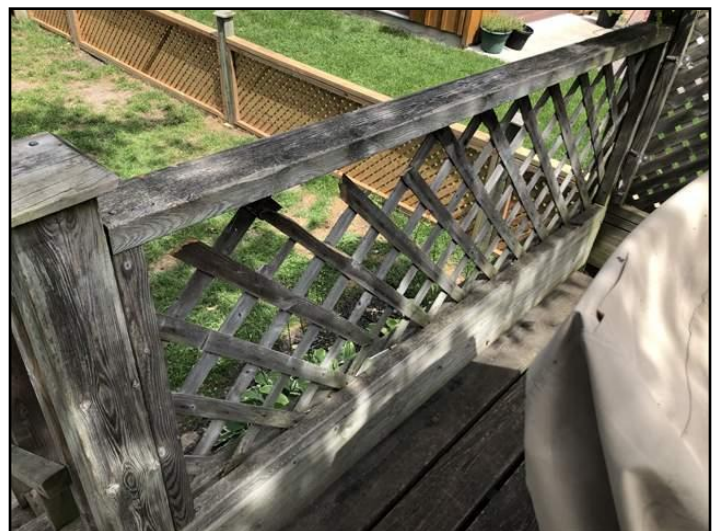
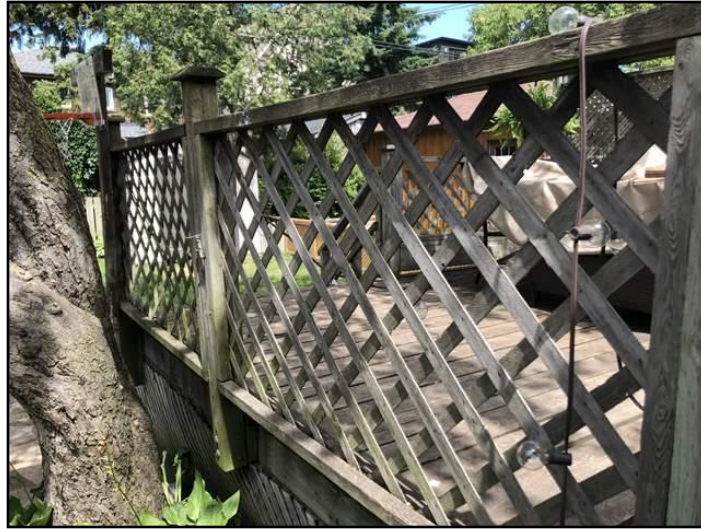
**Condition:** • [Ineffective](#)

The lattice is not effective to prevent falls. Also deck railings are loose. Replacement of Guardrails with spindles is recommended

22. Ineffective

23. Ineffective

24. Ineffective

**Task:** Replace

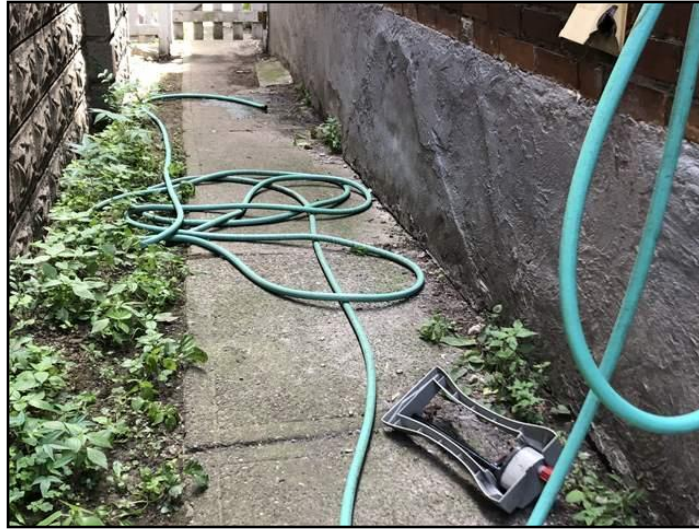
**Condition:** • [Improper slope or drainage](#)

**Implication(s):** Chance of water damage to contents, finishes and/or structure

25. *Improper slope or drainage*

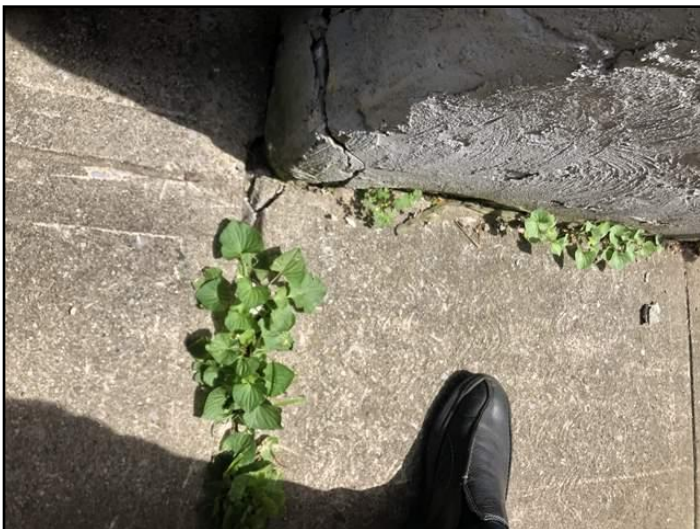
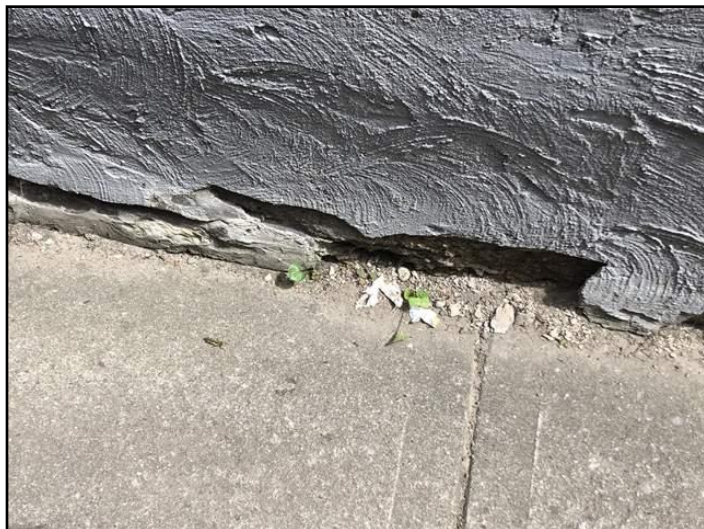
**Condition:** • [Parging damaged or missing](#)

**Implication(s):** Chance of damage to structure | Shortened life expectancy of material

26. Parging damaged or missing

27. Parging damaged or missing

**Task:** Patch

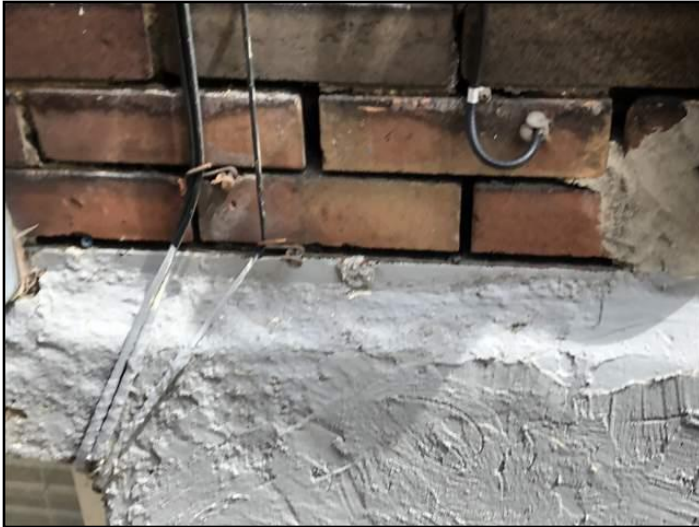
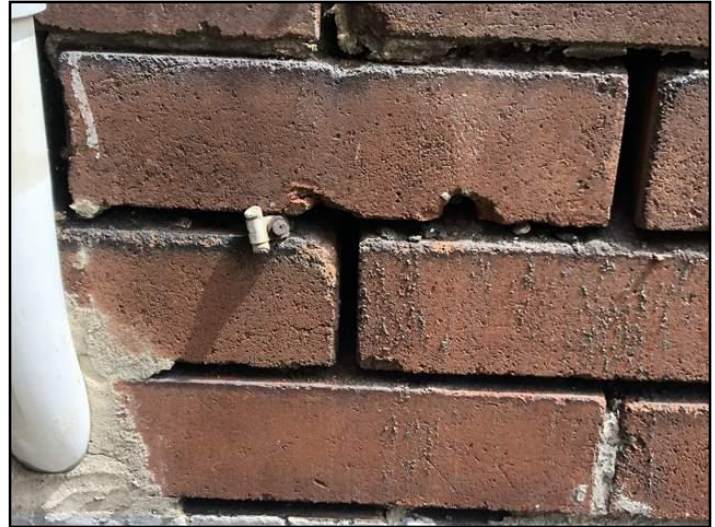
**Condition:** • [Mortar deteriorating](#)

28. Mortar deteriorating

29. Mortar deteriorating

**Task:** Repair

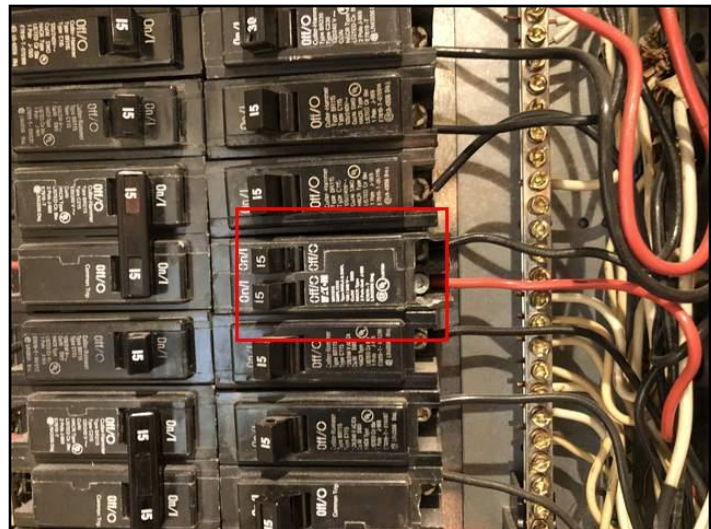
**Condition:** • [Breaker bridge missing](#)

30. Breaker bridge missing

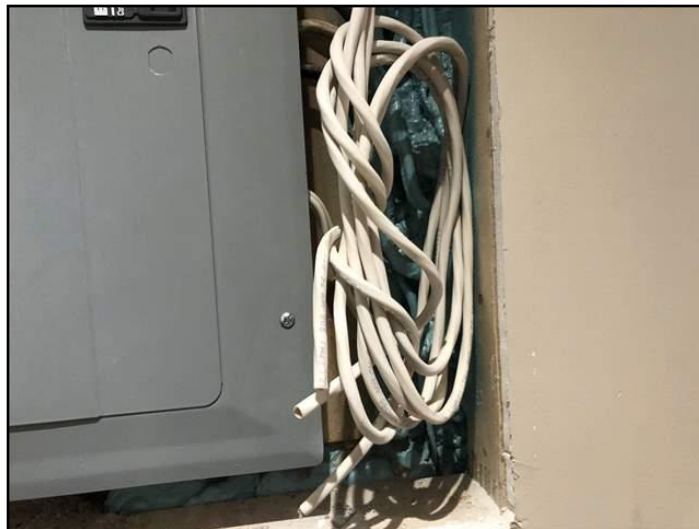
**Condition:** • [Abandoned wire](#)

**Location:** Basement beside panel

31. Abandoned wire

**Task:** Provide junction box or remove.

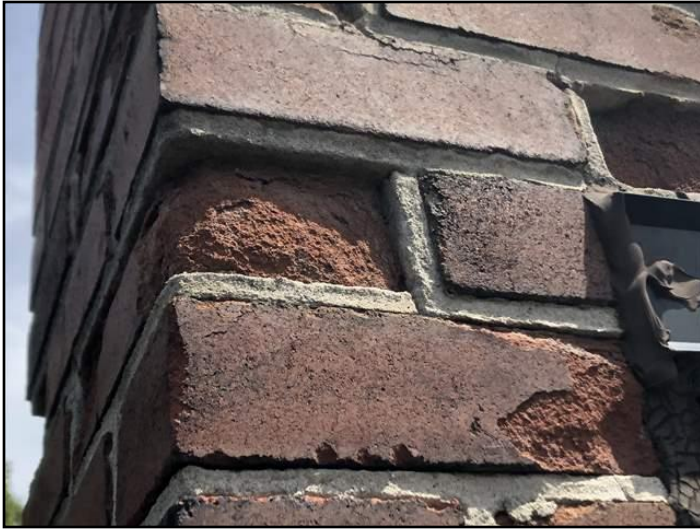
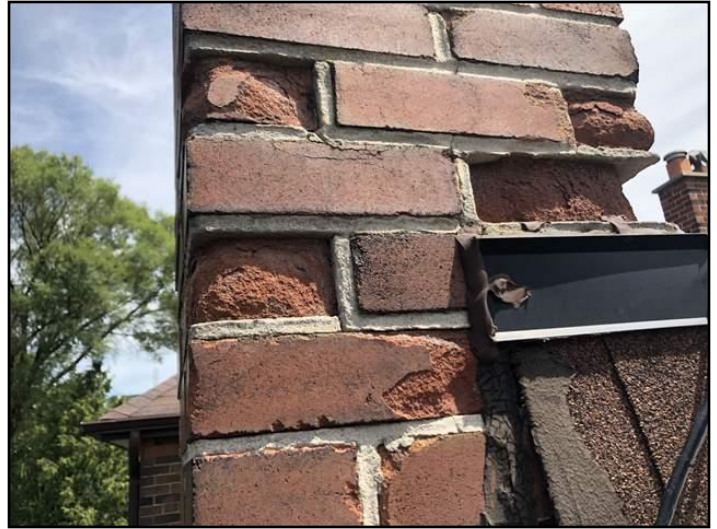
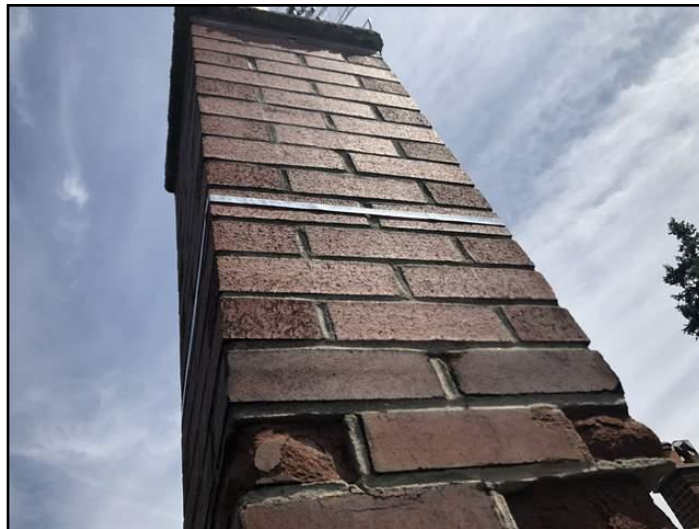
**Condition:** • [Loose, missing or deteriorated masonry](#)

**Implication(s):** Material deterioration

32. Loose, missing or deteriorated masonry

33. Loose, missing or deteriorated masonry

34. Loose, missing or deteriorated masonry

**Task:** Repair / Replace

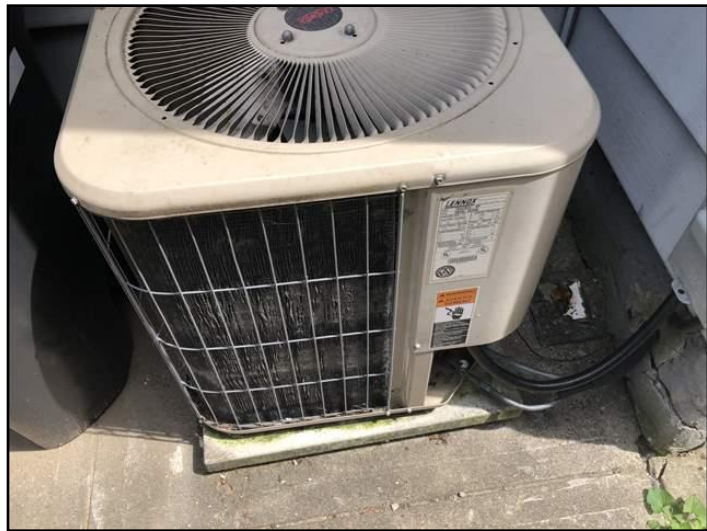
**Condition:** • [Damage](#)

Some of the fins are damaged and dirty. Service annually

35. Dirty

**Task:** Service and clean

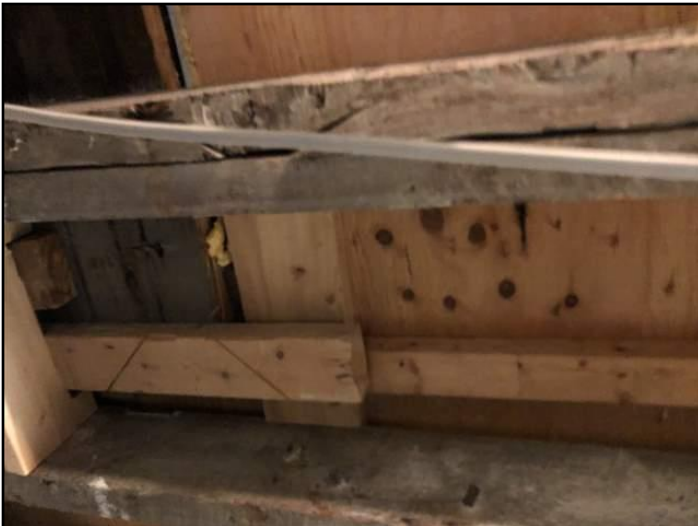
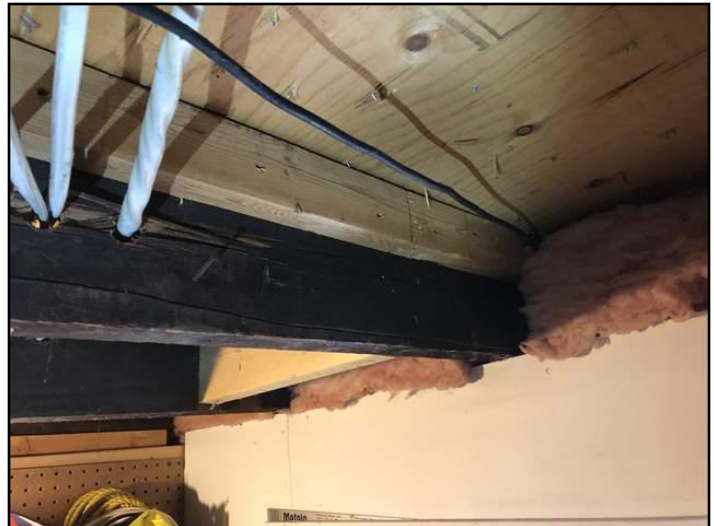
**Condition:** • [Prior repairs](#)

As viewed from furnace room, some areas of the subfloors/joists had prior repairs or were reinforced.

**Location:** Basement Furnace Room

36. Prior repairs

37. Prior repairs

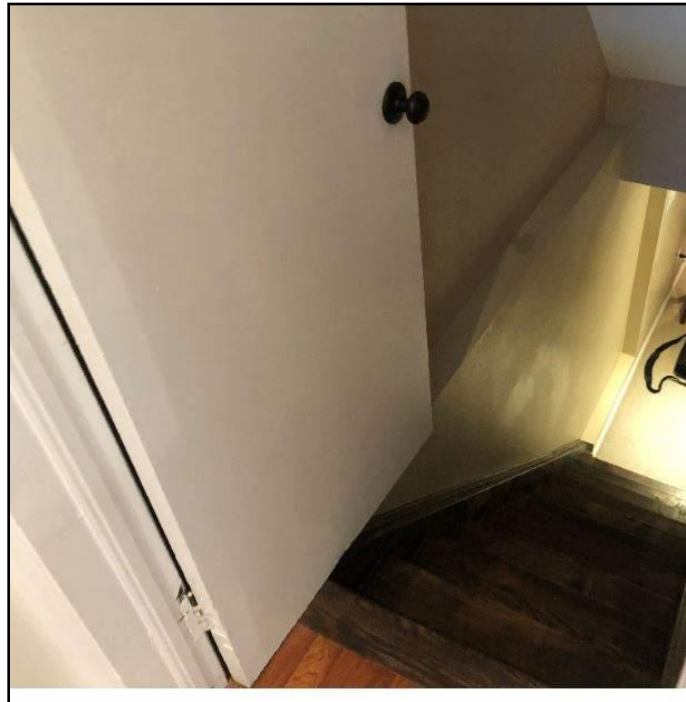
**Condition:** • [Missing](#)

Door opens towards stairs with no landing. This can be a fall hazard to someone standing on the stairs. Providing a landing is costly. Changing the direction that the door opens is a more cost-effective method of improvement.

**Implication(s):** Trip or fall hazard

38. Missing

**Task:** Switch door direction
