## THE TIP SHEET™ AT-A-GLANCE

ADDRESS	DATE	CLIENT NAME	INSPECTOR NAME
16 Brule Cres.	October 14, 2021	Gillian Ritchie Alex Porritt	Adam Hannan
FRONT OF HOME		COMMENTS/HIGHLIGHTS

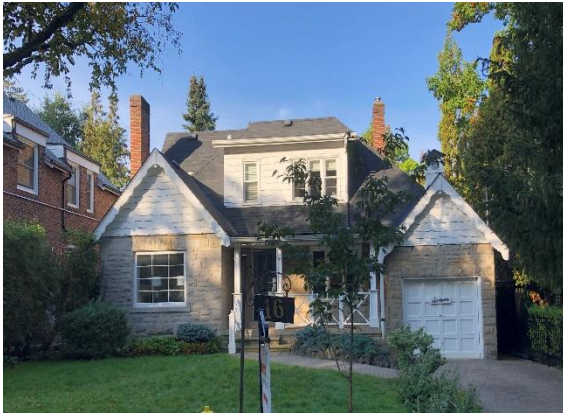
<p>This solid masonry home is in average/good condition overall as compared to homes of similar age and style. The brick and foundations observed appear to be in good condition. Most of the windows at the first and second floors are reported to have been installed 2014-2017 and are premium single-hung, double-glazed energy efficient units. The roof coverings are in good condition overall and reported to be 6 years old. A sump pump has been installed. There is a backwater valve, which helps prevent sewer backup, installed at the front of the basement. Both the furnace and air conditioner have been replaced in 2017 with premium high efficient units. As is typical for homes of this age, there is a mix of newer and older systems and components</p>
