# YOUR INSPECTION REPORT

16 Brule Crescent  
Toronto, ON M6S 4H9

INSPECTION DATE:  
Thursday, October 14, 2021

RE: Report No. 2953, v.2  
16 Brule Crescent  
Toronto, ON  
M6S 4H9

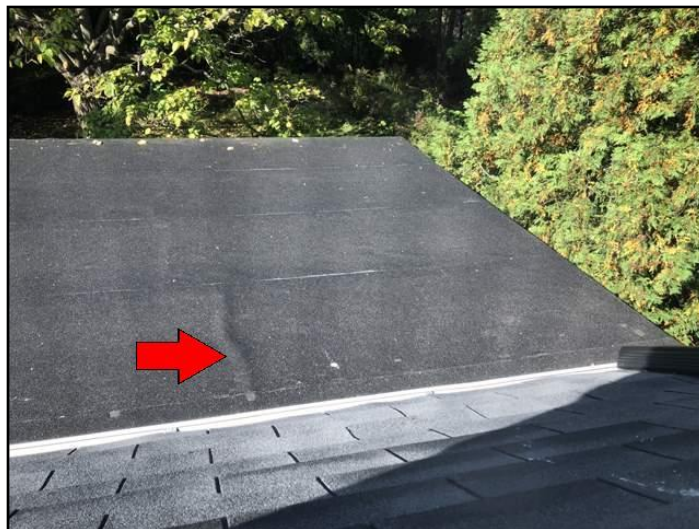
1. Blisters

**Condition:** • [Blisters](#)

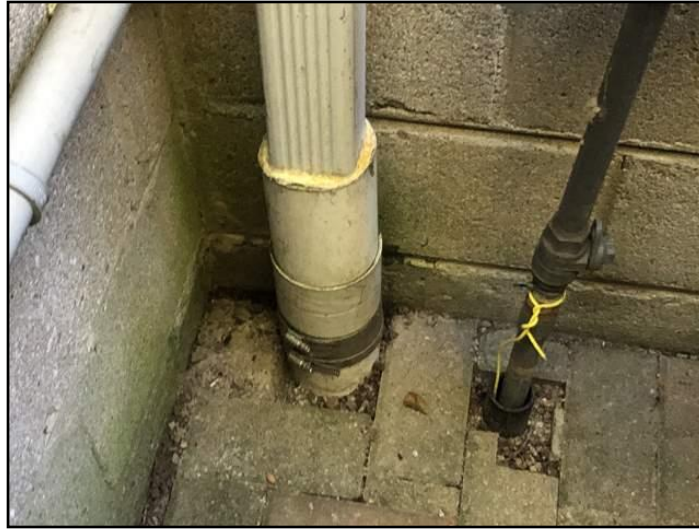
2. Discharge below grade

**Condition:** • Discharge below grade

**Task:** Monitor / Improve

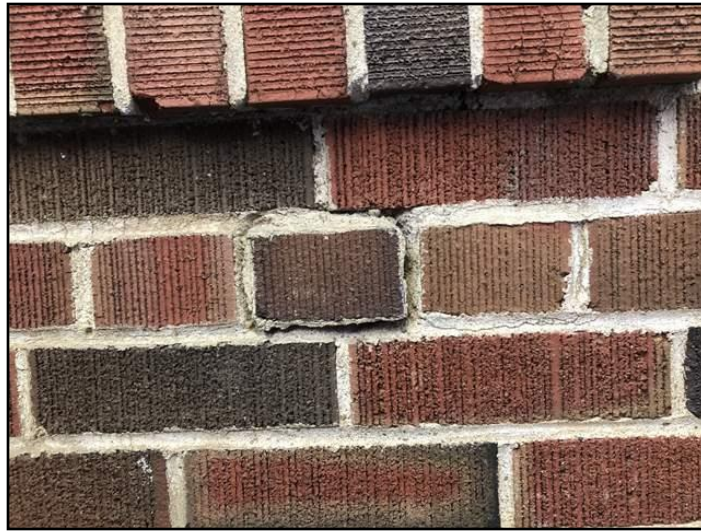
3. Mortar deterioration

**Condition:** • [Mortar deterioration](#)

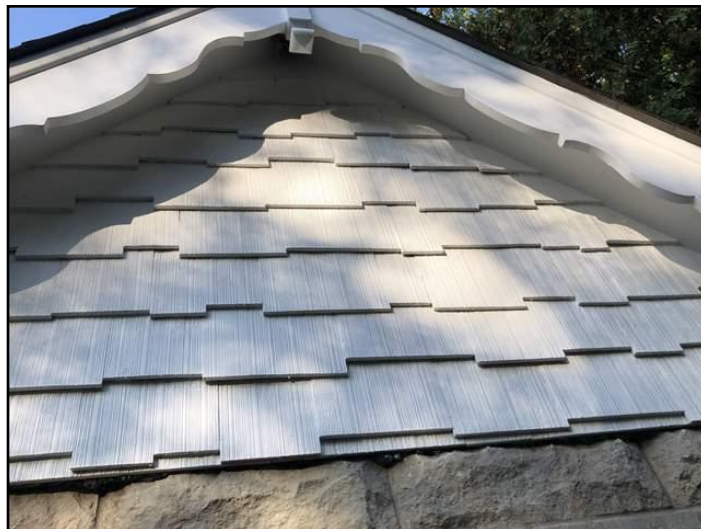
4. example

**Condition:** • We noted a white painted cladding material on various areas of the exterior. This cladding may be wood, fiber cement or asbestos cement fiber. If working on the siding in the future - sanding, cutting, disturbing, etc. test the material prior to disturbing. If asbestos, take health precautions. If replacing, ensure that workers are aware of potential presence of asbestos so that the necessary health precautions are followed. Further information can be found here: <https://www.canada.ca/en/health-canada/services/air-quality/indoor-air-contaminants/health-risks-asbestos.html>

**Task:** Further evaluation

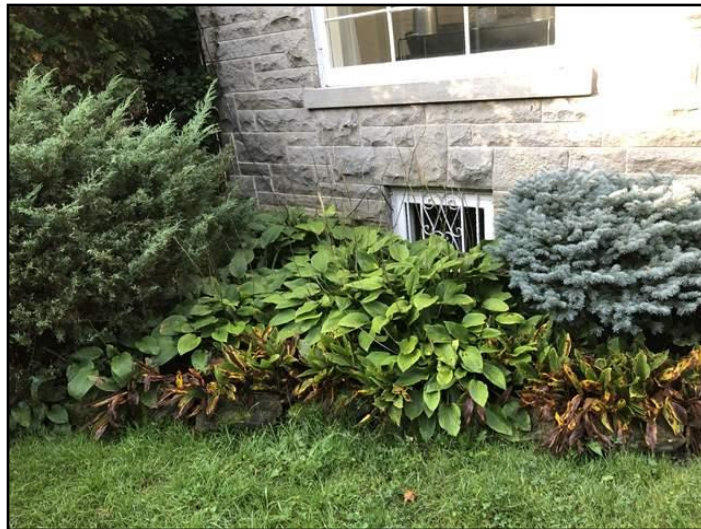
5. Planters and gardens against walls

**Condition:** • [Planters and gardens against walls](#)

**Task:** Monitor / Improve

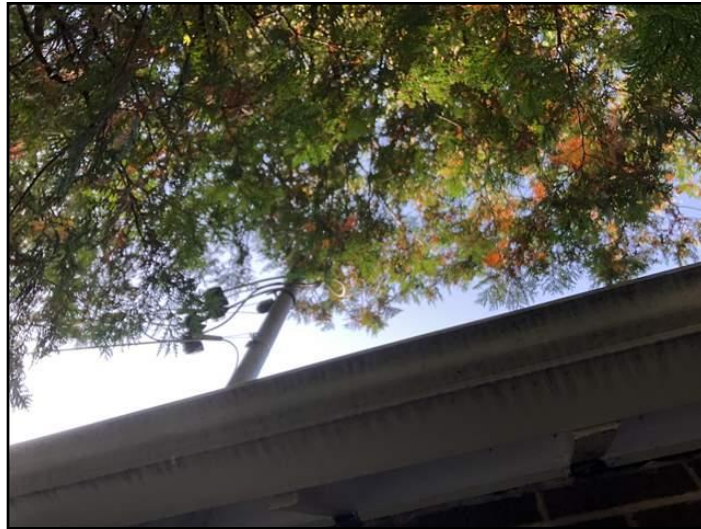
6. example

**Condition:** • Tree Branch Maintenance

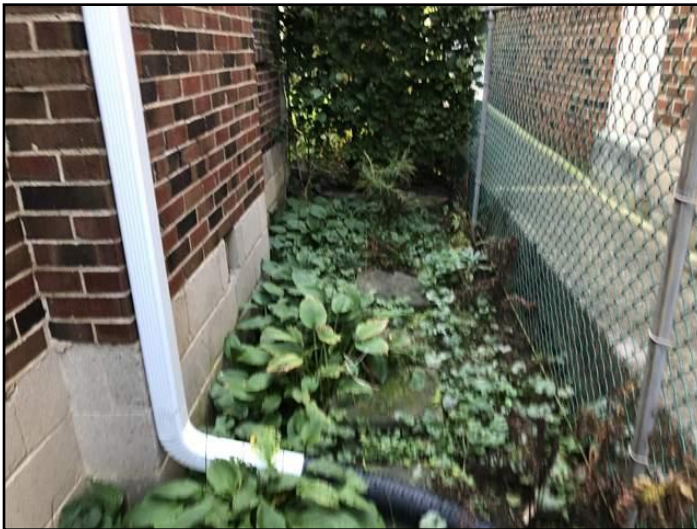
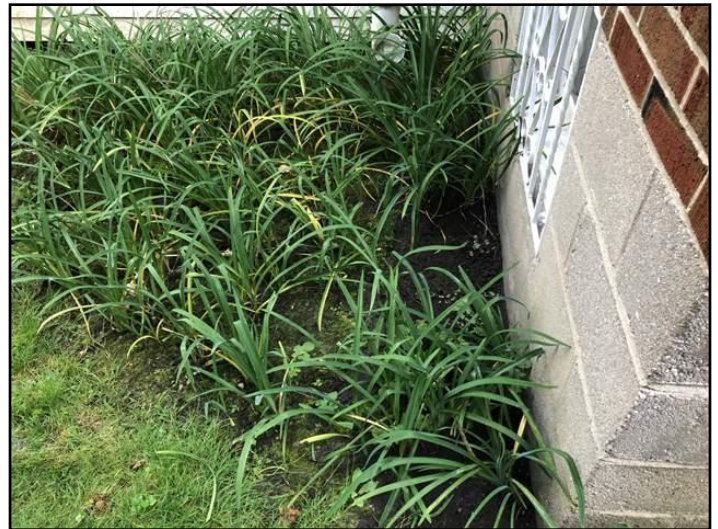
**Condition:** • [Improper slope or drainage](#)

A very important factor in preventing basement/crawlspace leakage is to maintain the grading that is nearest the home to promote good drainage away from the home for at least 6 feet. "Water management" is an important role for homeowners.

**Condition:** • During rainfall, walk the exterior to view if any water is draining towards the home. Improve these areas as needed

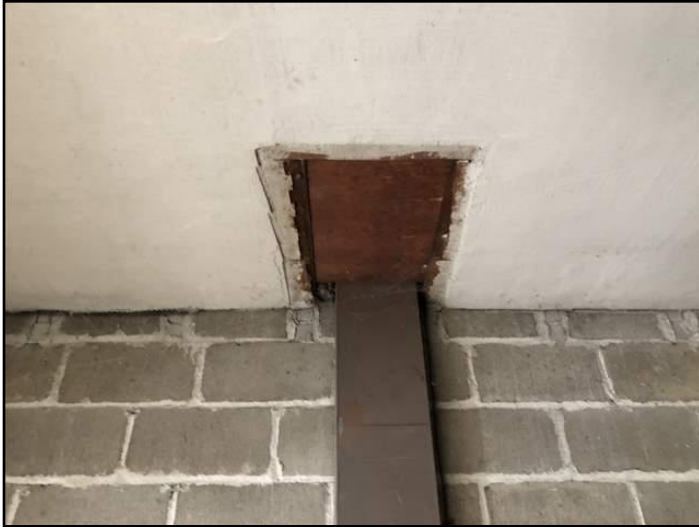
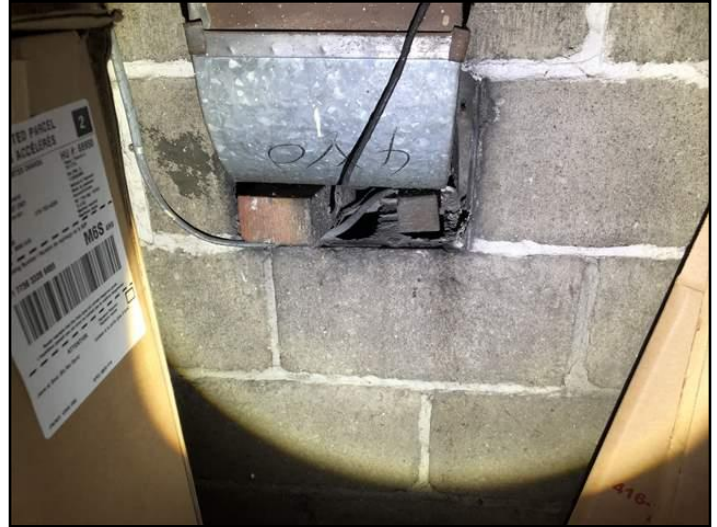
**Condition:** • Not gastight

opening at wall and ceiling. Duct observed in garage. Duct or vents of any kind should not run through the garage as they may provide an entrance point into the house (for carbon monoxide and other possible chemicals that might be present

**Task:** Correct

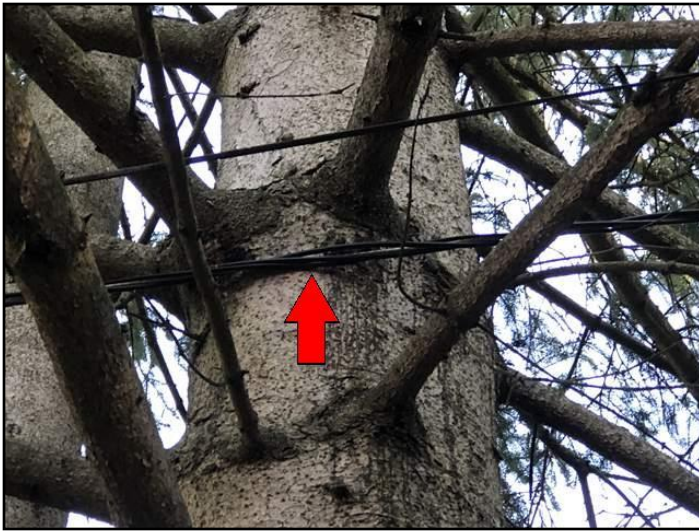
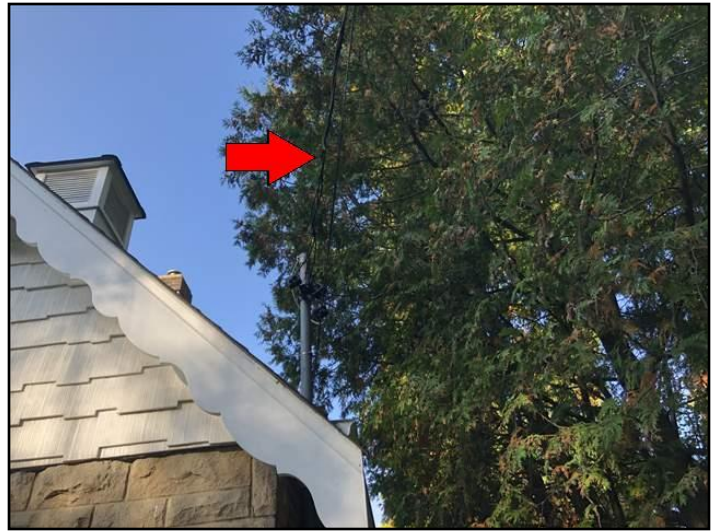
**Condition:** • [Branches / vines interfering with wires](#)

Monitor Service Drop electrical wires to ensure that wires are not being interfered/damaged by tree branches. Have specialist trim branches back from wires where needed. This is a common recommendation in Toronto with overhead wiring and mature trees.

**Task:** Further evaluation / Monitor / Improve

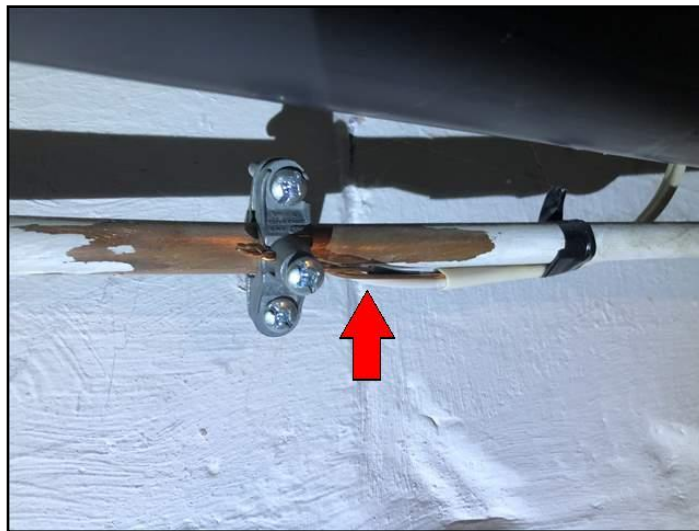
13.

**Condition:** • Bonding wire may be undersized (single strand wire not typically used as bonding wire)

**Task:** Further evaluation

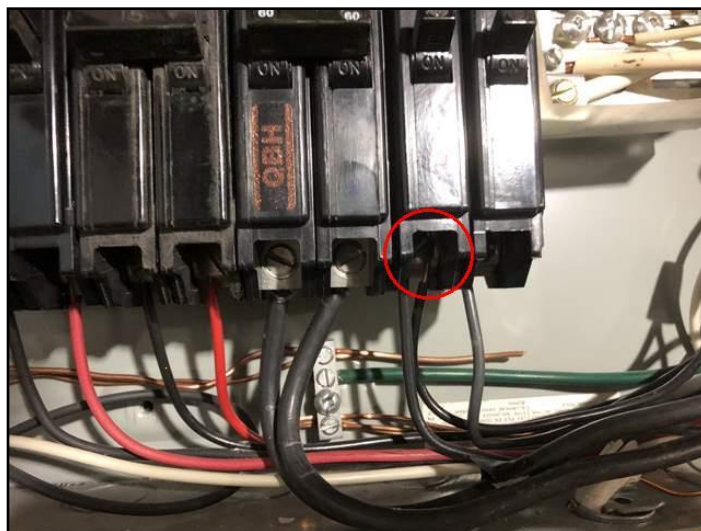
14. Double taps

**Condition:** • [Double taps](#)

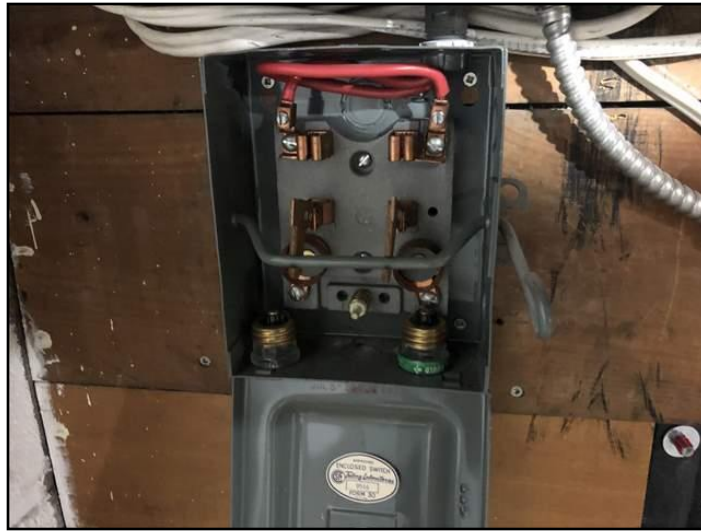
15.

**Condition:** • Abandoned sub panel

**Task:** Remove

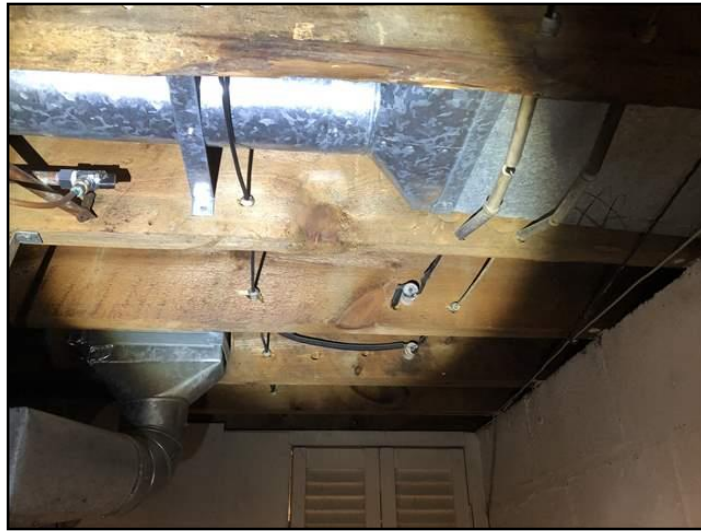
16. example

**Condition:** • [Outdated -](#)

There is a mix of newer and older wiring throughout the home. We noted some knob and tube wiring in various areas. Knob and tube wiring was installed pre-1950 in all homes. Most of the wiring in the home is behind walls and ceilings and not observed.

The ESA authority does not consider this wiring unsafe. However, Knob and tube wiring may be an insurance issue as many insurers require that this wiring be upgraded. Some insurers will require an audit to estimate the percentage of knob and tube wiring still present. Consult with your insurance company for their requirements and/or acceptable limits. We have an arrangement with David Slack Insurers regarding homes with knob and tube wiring. Please contact David Slack for details (800) 971-1363.

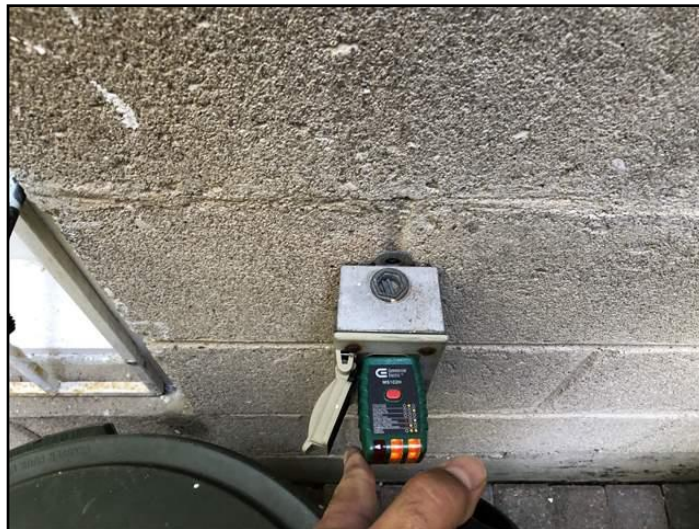
17. GFCI/GFI needed (Ground Fault Circuit...

**Condition:** • [GFCI/GFI needed \(Ground Fault Circuit Interrupter\)](#)

**Task:** Replace

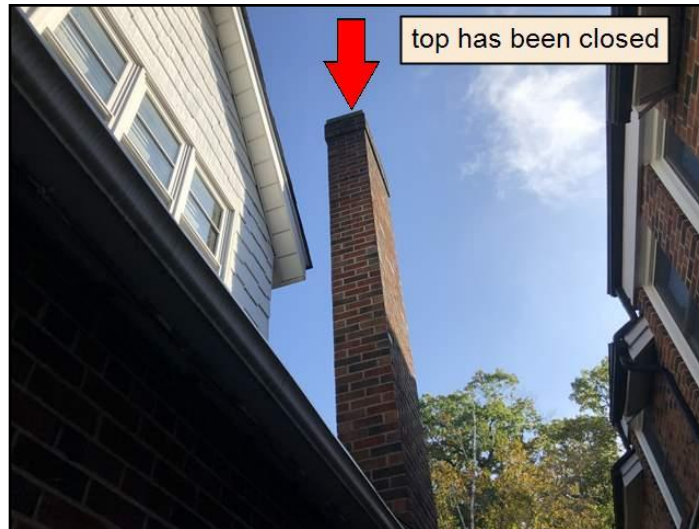
20. Not functional

**Condition:** • Not functional

Chimney has been closed at top. Do not use wood fireplaces. If you plan to use in future, consult with chimney specialist and repair/upgrade fireplace, flue and chimney to modern standards.

**Task:** Do not use/ Service and repair if planning to use in the future

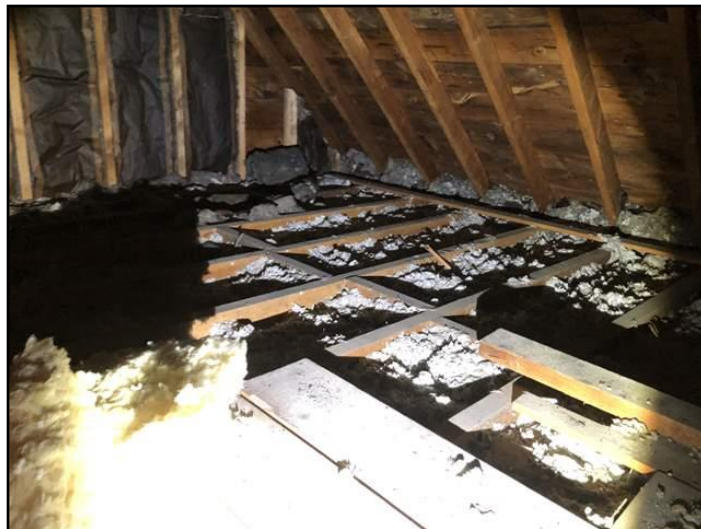
21. Amount less than current standards

Condition: • [Amount less than current standards](#)

Task: Upgrade

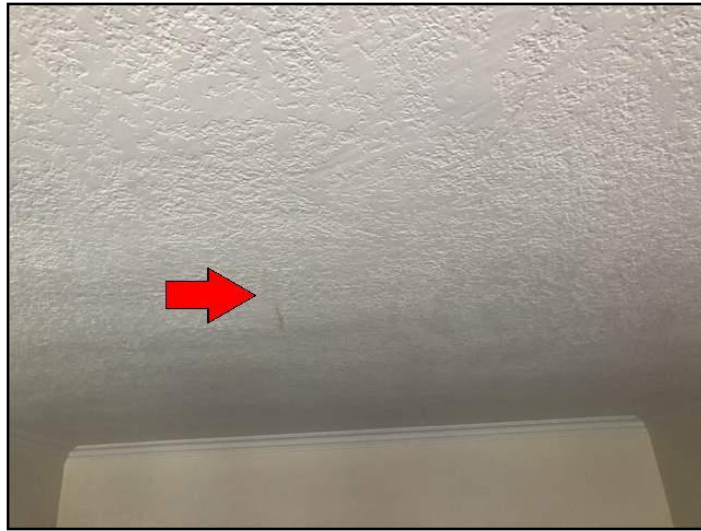
24. Stains

**Condition:** • Stains

Tested with moisture meter. Dry at time of inspection

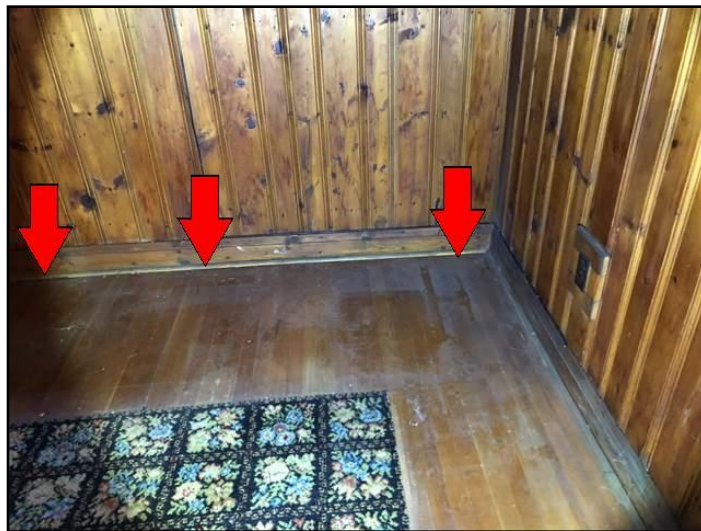
25. Springy

Condition: • [Springy](#)

Task: Repair / Replace

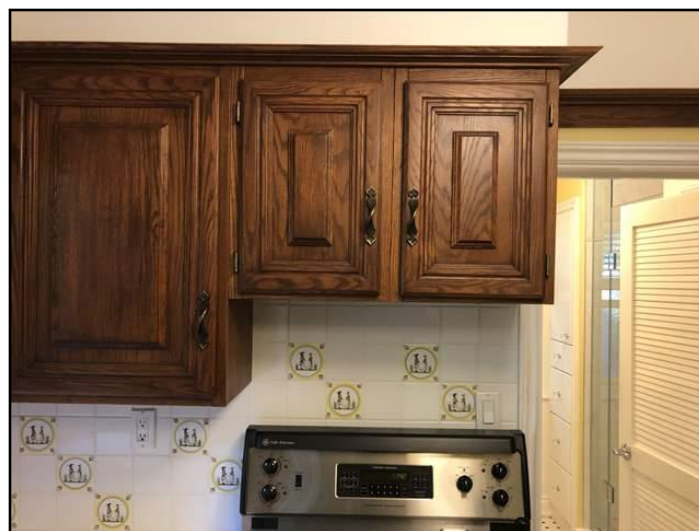
26. Missing

**Condition:** • Missing

Oven hoods are important for fire prevention (pot fires) as it offers protection to the cabinet above the stove. Secondary reason is to provide exhaust to help eliminate moisture.

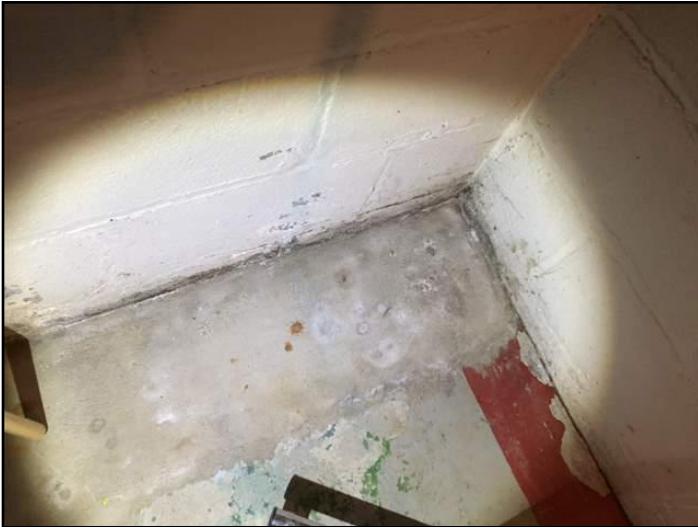
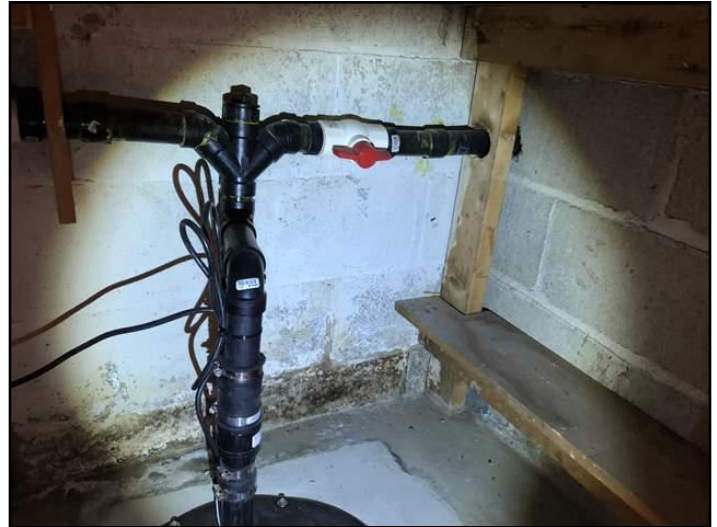
**Condition:** • [Stains](#)

Water stains noted in various areas. It is very common to find stains in the basement of a home of this age. Some have likely been present for many years and they are often the result of condensation or leakage. Prudent to monitor, especially through the Spring or after heavy rainfalls. No standing water was found in basement during the inspection. Typical of older foundations of stone or brick, moisture can be expected from time to time. A perfectly dry basement in a home of this age is not realistic unless an exterior or interior waterproofing system is installed.

**Task:** For Your Information / Monitor

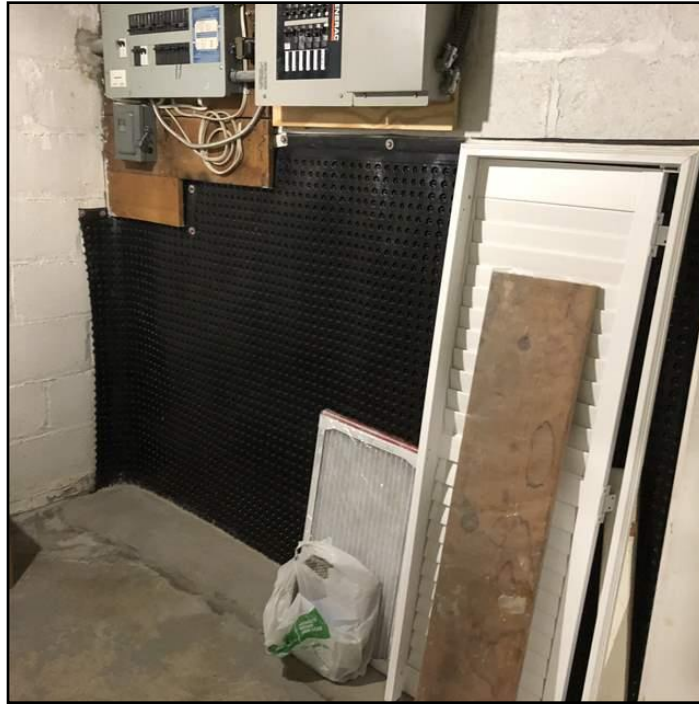
29. Drainage membrane

**Condition:** • [Drainage membrane](#)

Drainage membrane and sump observed at basement. The drainage membrane assists with managing moisture intrusion in areas where they are installed. These are good improvement measures.

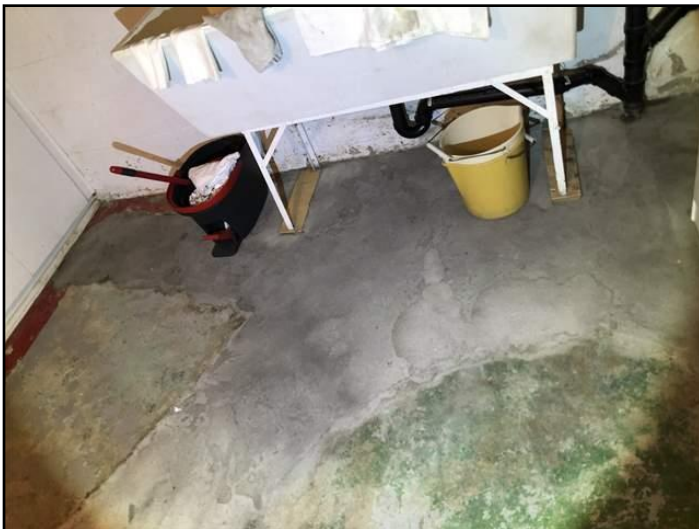
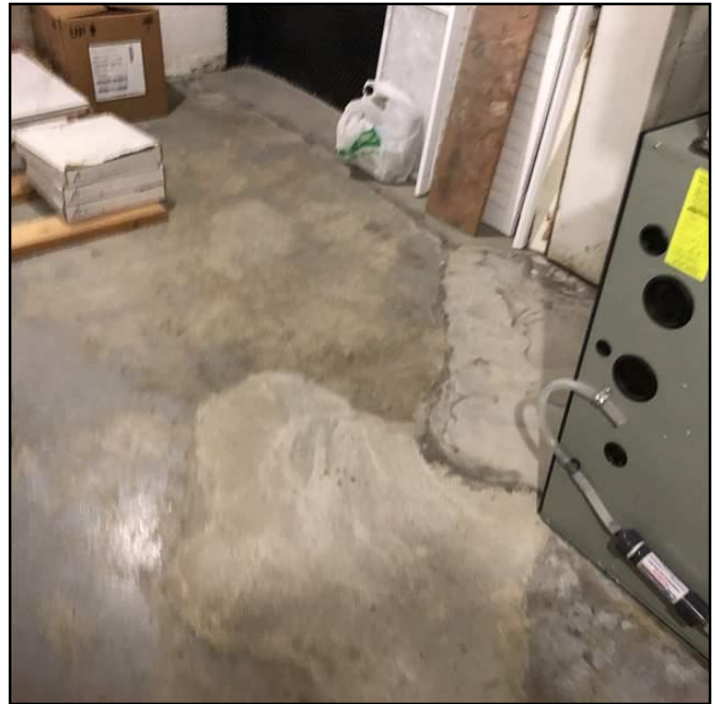
**Condition:** • [Prior repairs](#)

We noted prior repairs to various areas of the basement concrete floors. These are typically performed when repairs/replacements are performed on waste lines. Seller reported that waste line from house to street was replaced last year

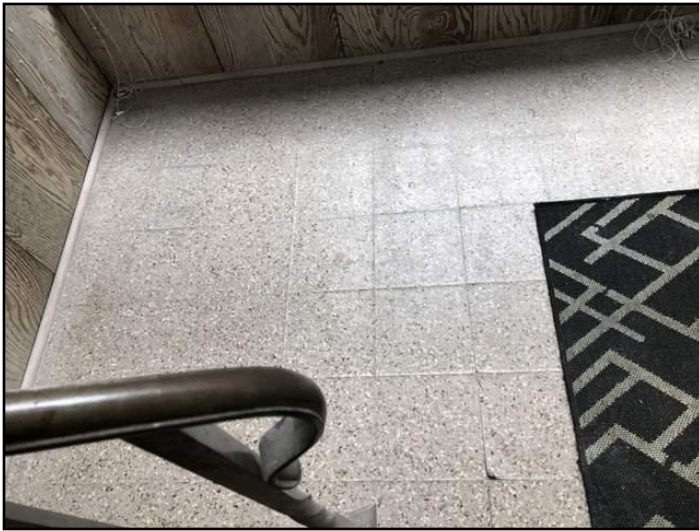
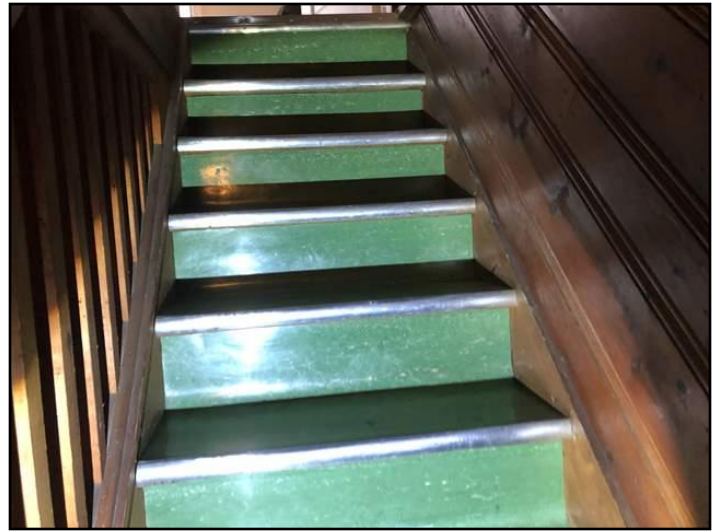
**Condition:** • Possible asbestos containing materials

Old 9"x 9" resilient floor tiles or the mastic glue often contain some asbestos. This type of floor tile is commonly found in older homes. Further evaluation is recommended before removing/disturbing these tiles. According to Health Canada, there are no significant health risks if materials containing asbestos in your home are: tightly bound in products and are in good condition sealed behind walls or floorboards isolated and left undisturbed. More information can be found here: <https://www.canada.ca/en/health-canada/services/publications/healthy-living/asbestos-home-infographic-2018.html> AND here <https://www.canada.ca/en/health-canada/services/air-quality/indoor-air-contaminants/health-risks-asbestos.html>

**Time:** Prior to disturbing material
