THE TIP SHEET™ AT-A-GLANCE

ADDRESS	DATE	CLIENT NAME	INSPECTOR NAME
269 Martin Grove Rd	November 6, 2023	Karla Wardle Emir Dickson	Adam Hannan

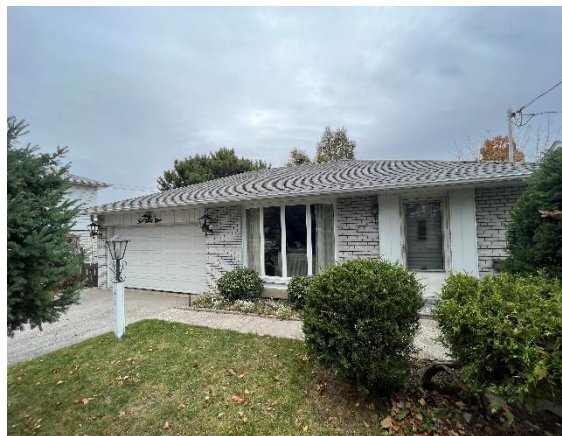
FRONT OF HOME

This 1960's solid masonry home, resting on concrete block foundations, appears well-built and is generally in good condition compared to homes of a similar age and style. The exterior masonry is in good condition. The electrical service size is 100-amp. Copper wiring was noted. The high-quality roofing materials are 10 years old and in good condition. Both the furnace and A/C are premium 7-year-old units. The double-glazed windows at main and upper floor were in good condition overall. As is typical for homes of this age, there is a mix of newer and older systems and components.
