YOUR INSPECTION REPORT

FOR THE PROPERTY AT:
251 Driftwood Avenue
Toronto, ON M3N 2N6

PREPARED FOR:
KARLA WARDLE
EMIR DICKSON
INSPECTION DATE:
Friday, September 5, 2025

RE: Report No. 8537
251 Driftwood Avenue
Toronto, ON
M3N 2N6

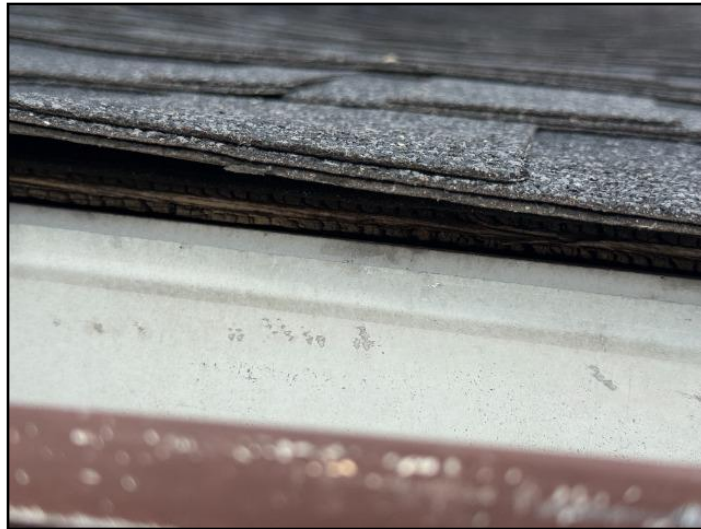
5. Missing

Condition: • [Missing](#)

Implication(s): Chance of water damage to structure, finishes and contents

Task: For Your Information

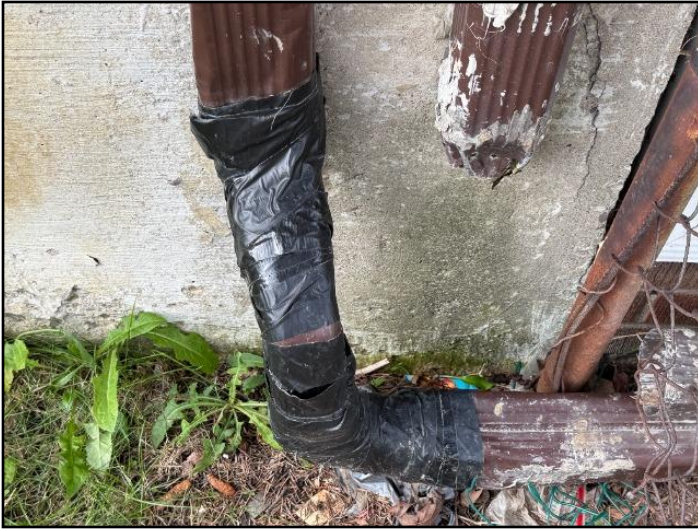
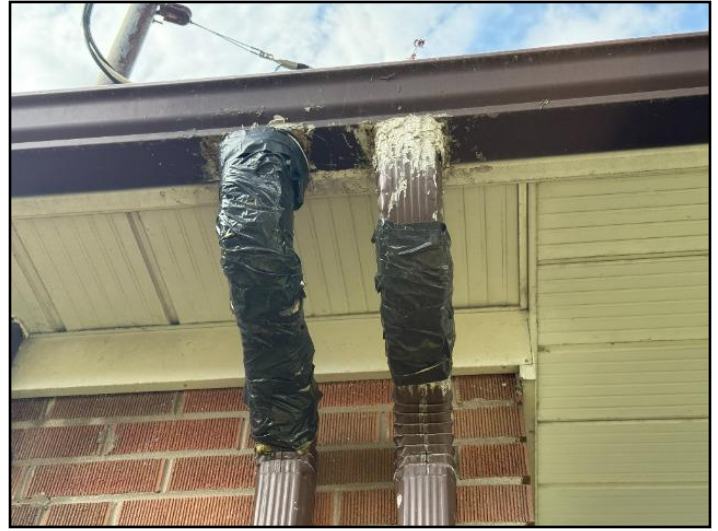
Condition: • [Damage](#)

Implication(s): Chance of water damage to structure, finishes and contents

6. Damage

7. Damage

Task: Replace

Time: Less than 6 months

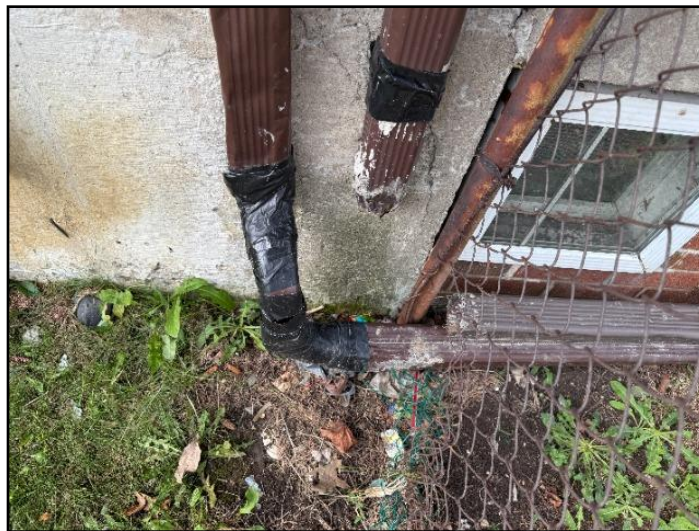
Condition: • [Should discharge 6 feet from building](#)

Implication(s): Chance of water damage to structure, finishes and contents

8. Should discharge 6 feet from building

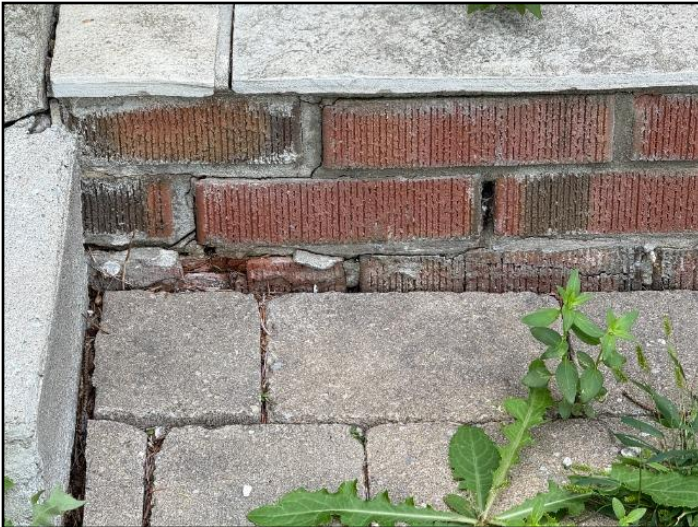
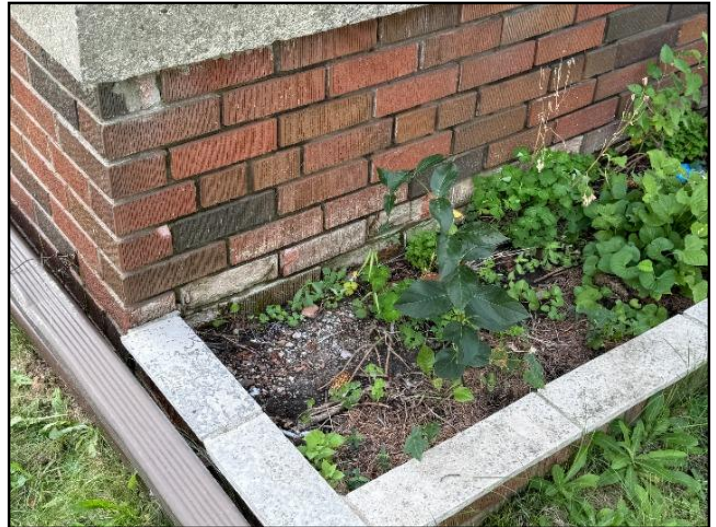
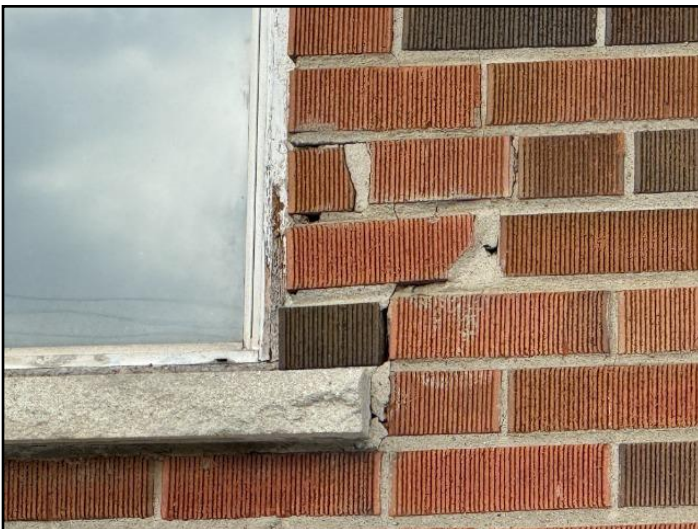
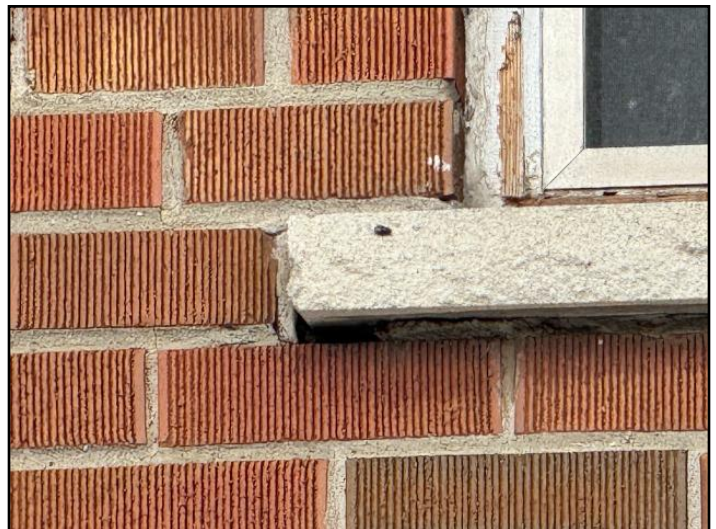
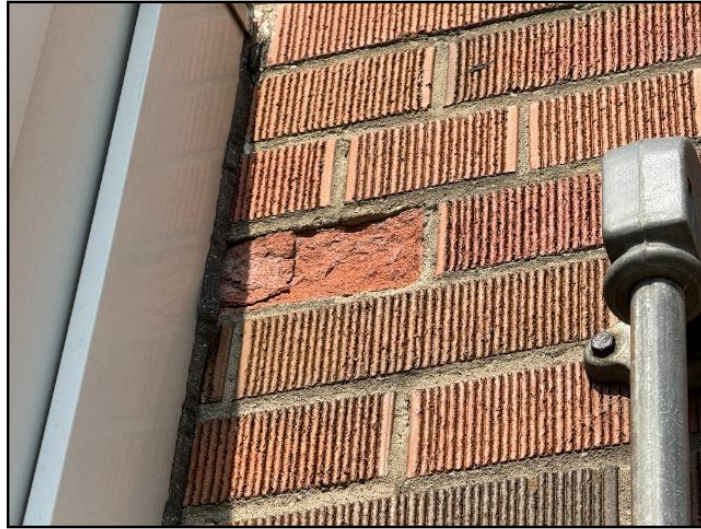
Condition: • Masonry and/or mortar deterioration

10. Masonry and/or mortar deterioration

11. Masonry and/or mortar deterioration

12. Masonry and/or mortar deterioration

13. Masonry and/or mortar deterioration

14. Masonry and/or mortar deterioration

Tuckpoint / Repoint mortar and patch/repair spalled masonry. This is typical maintenance for a home of this age.

Task: Repair

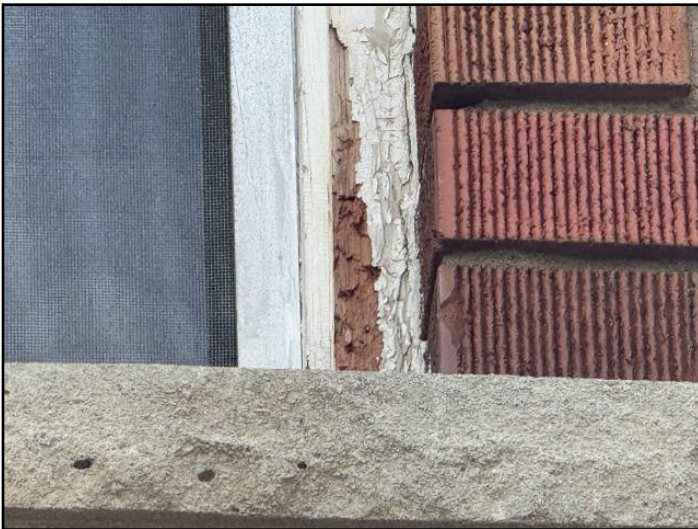
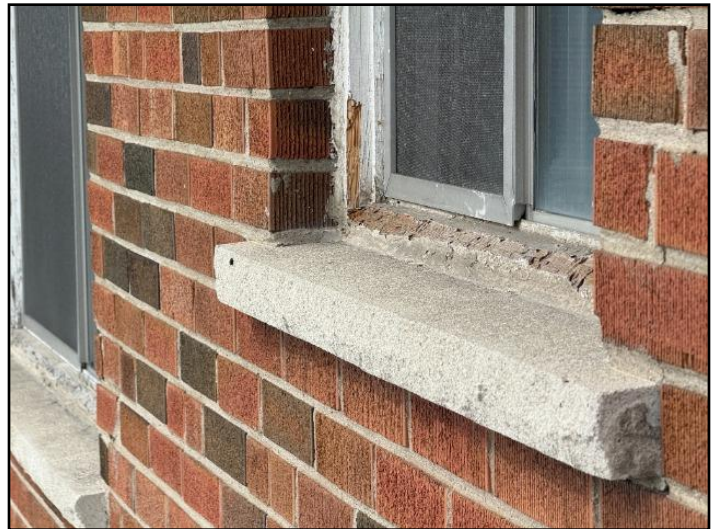
Condition: • [Damage](#)

Implication(s): Chance of water damage to structure, finishes and contents

Location: Various Exterior

Task: Replace throughout when replacing windows

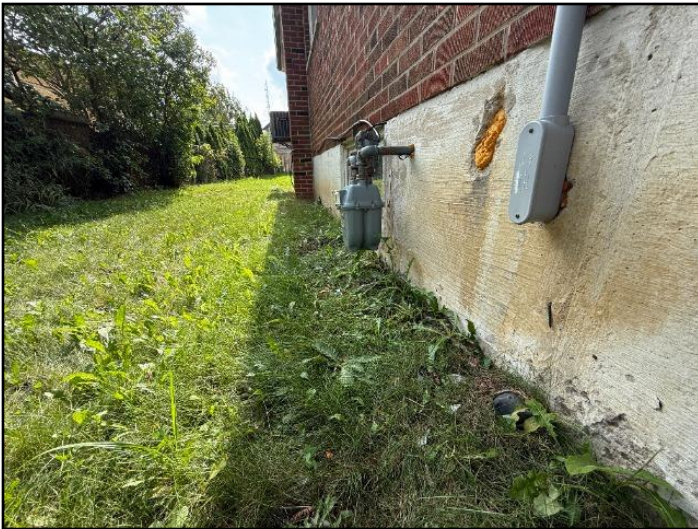
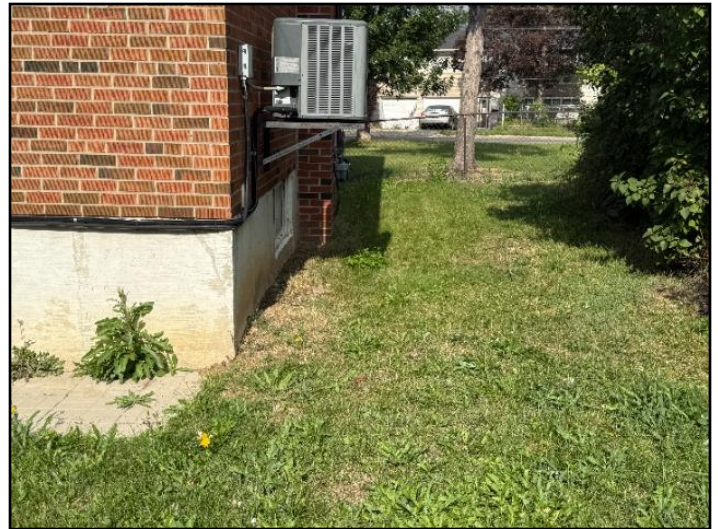
Condition: • [Improper slope or drainage](#)

Areas of grading near the home are sloping toward the home. A very important factor in preventing moisture intrusion is to maintain the grading that is nearest the home to promote good drainage away from the home. "Water management" is an important role for all homeowners. Improve all low areas and grading so that water drains away from the home for at least 6 to 12 feet.

17. Improper slope or drainage

18. Improper slope or drainage

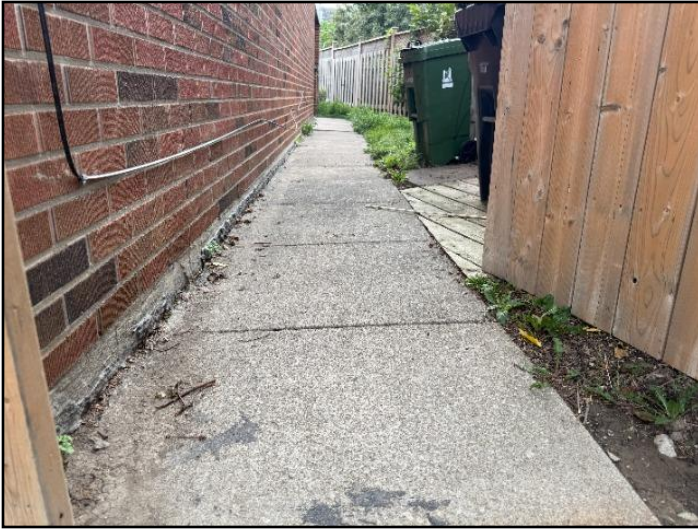
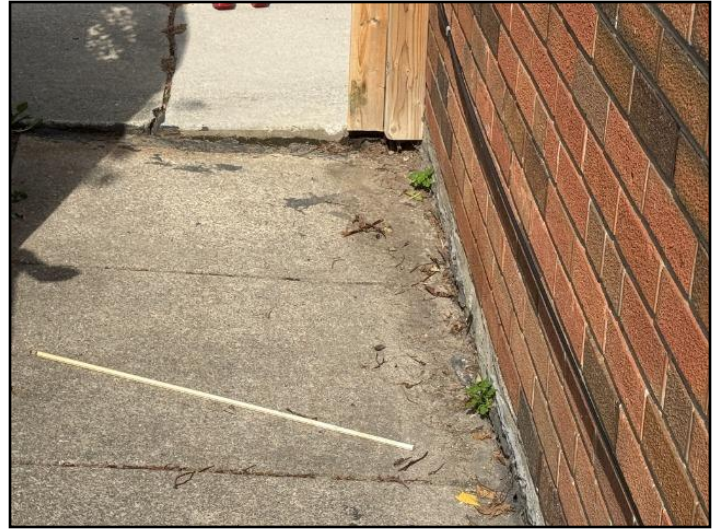
Condition: • [Improper slope or drainage](#)

Implication(s): Chance of water damage to structure, finishes and contents

19. Improper slope or drainage

20. Improper slope or drainage

Time: As soon as practical

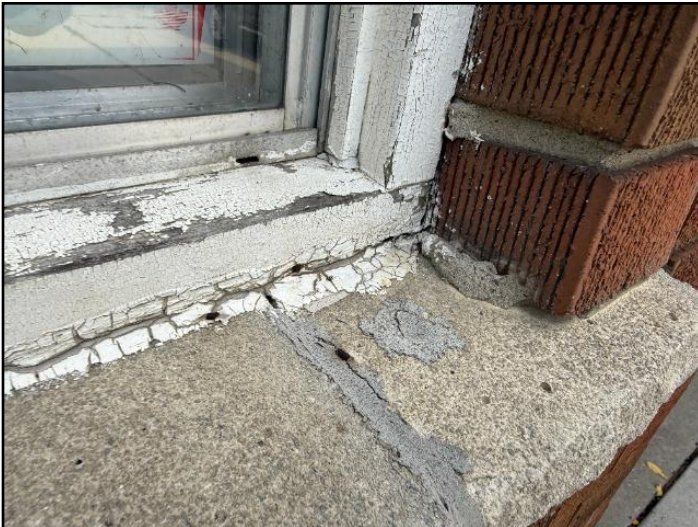
22. windows trims

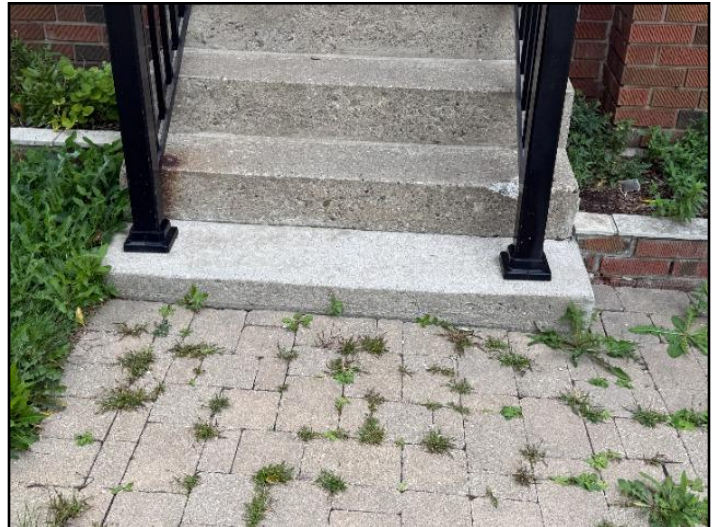
23. front step rise not uniform

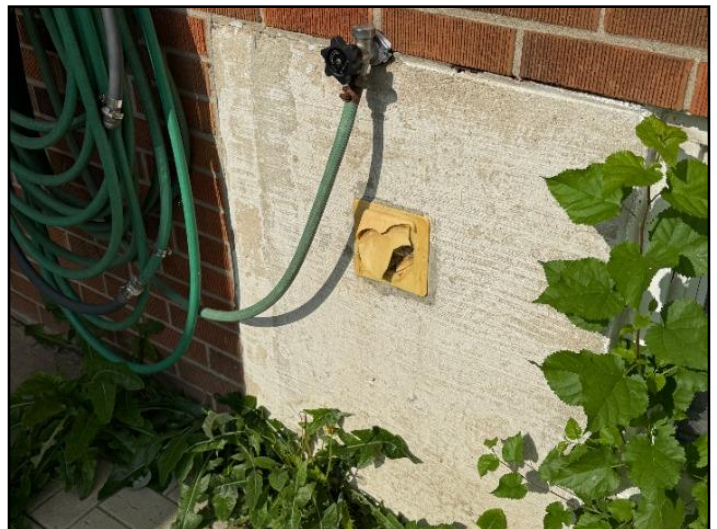
25. damaged vent

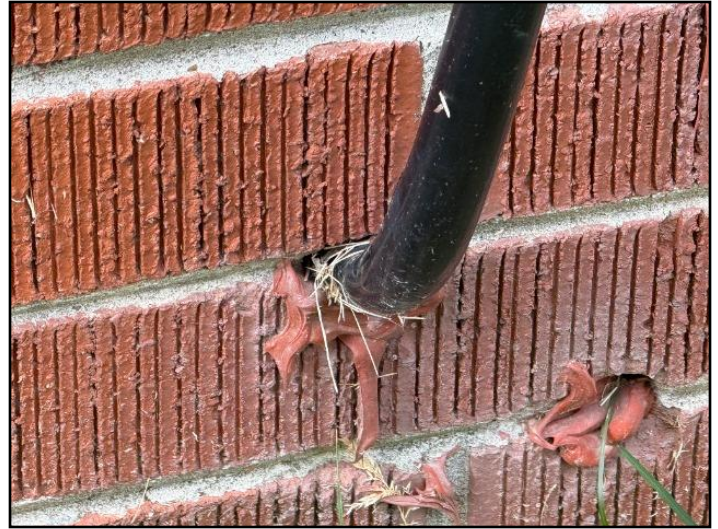
27. Caulking missing

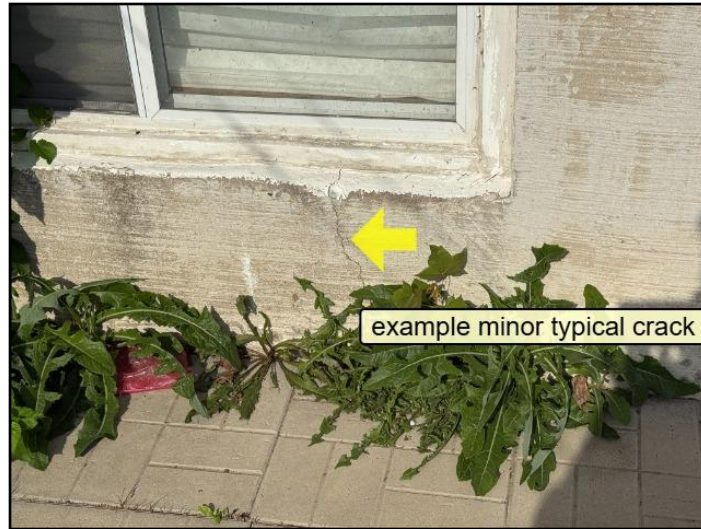
Condition: • Typical minor cracks

Almost all houses with poured concrete foundations have minor settlement and/or shrinkage cracks. Monitor all cracks for movement and nuisance water leakage. Repair cracks only if necessary

28. Typical minor cracks example

Task: Monitor / Repair

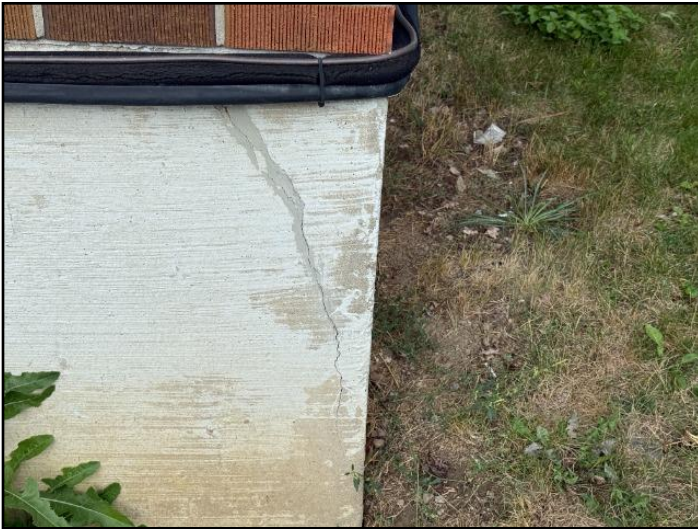
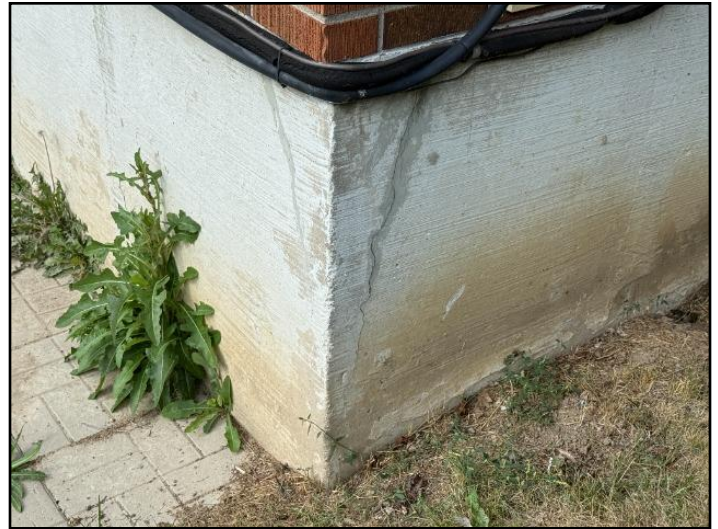
Condition: • Typical Wedge Cracks

These types of corner cracks (also known as wedge cracks) are VERY COMMON. Patch / Repair to prevent water entry and further damage.

29. Typical Wedge Cracks

30. Typical Wedge Cracks

Time: Less than 2 years

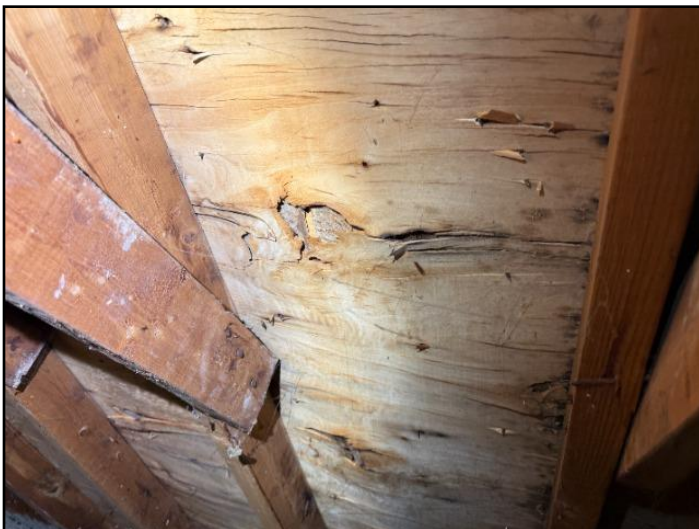
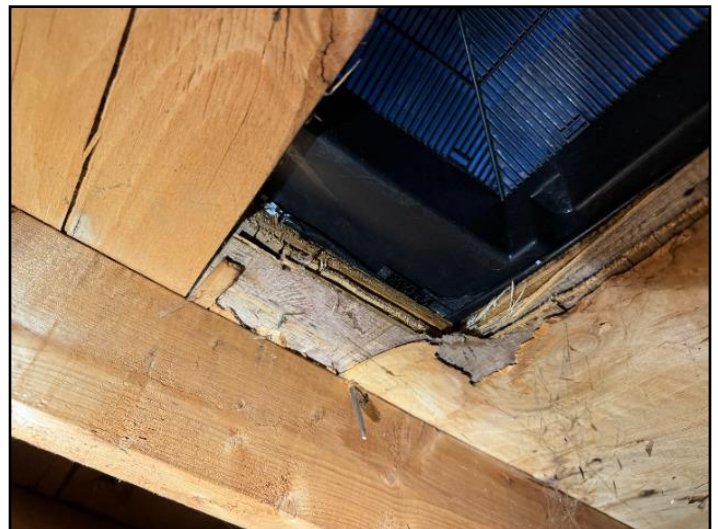
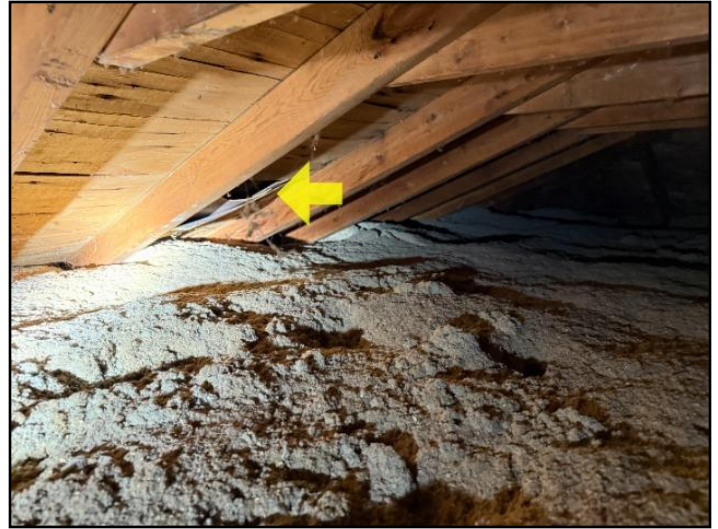
Condition: • [Delaminated](#)

32. Delaminated

33. Delaminated

35. Delaminated

Task: Replace sheathing at next roof replacement

Cost: \$150-\$300 per sheet installed

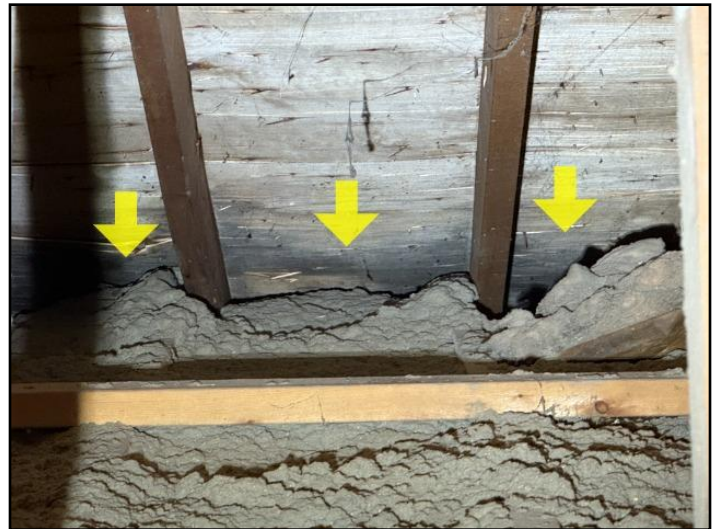
Condition: • Mold / Fungi - localized area(s)

Observed at localized areas of sheathing. Mold assessment is outside our scope of work. Consult specialist or contact us for list of service providers.

37. Mold / Fungi - localized area(s)

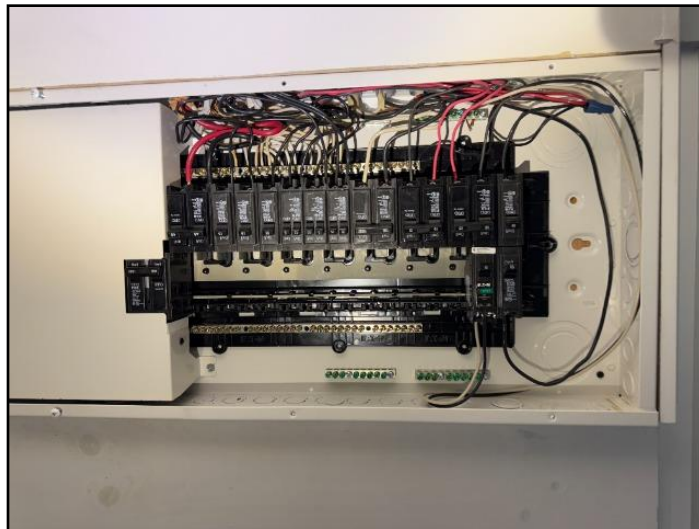
Good condition overall

38. Breakers - basement

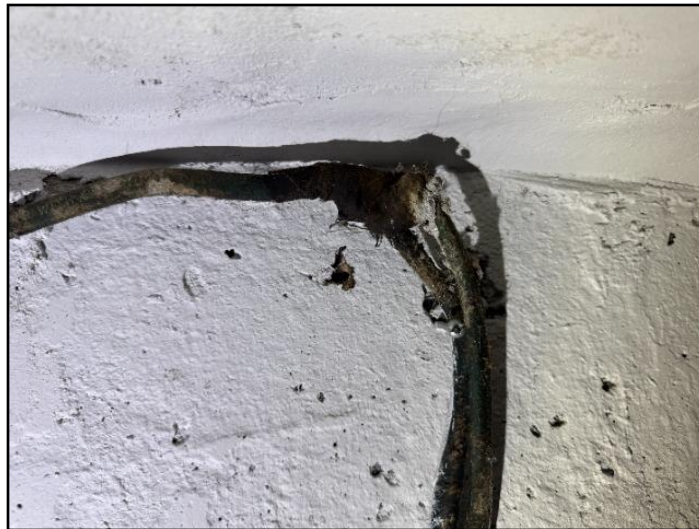
Condition: • [Open splices](#)

Implication(s): Electric shock | Fire hazard

41. Open splices

Time: As Soon As Possible

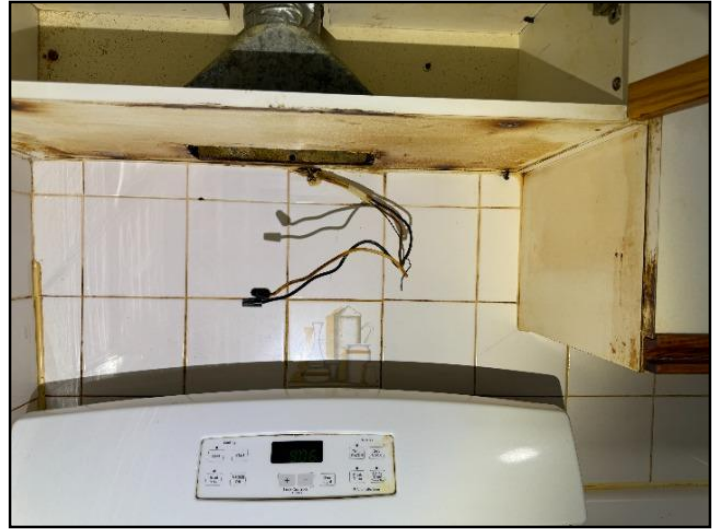
Condition: • [Abandoned wire](#)

43. Abandoned wire

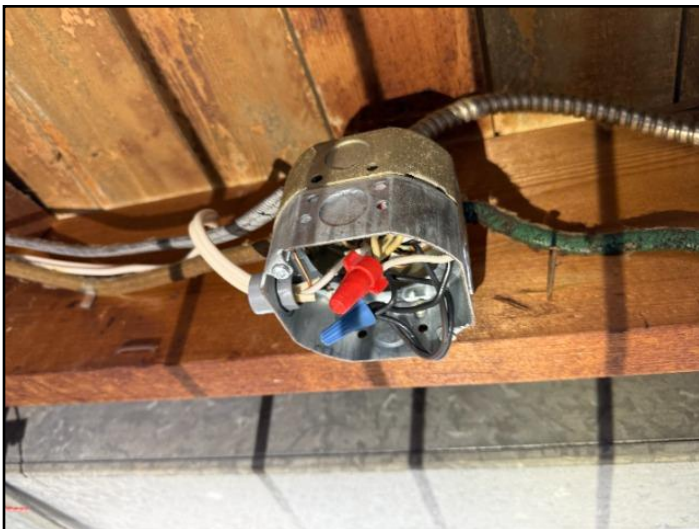
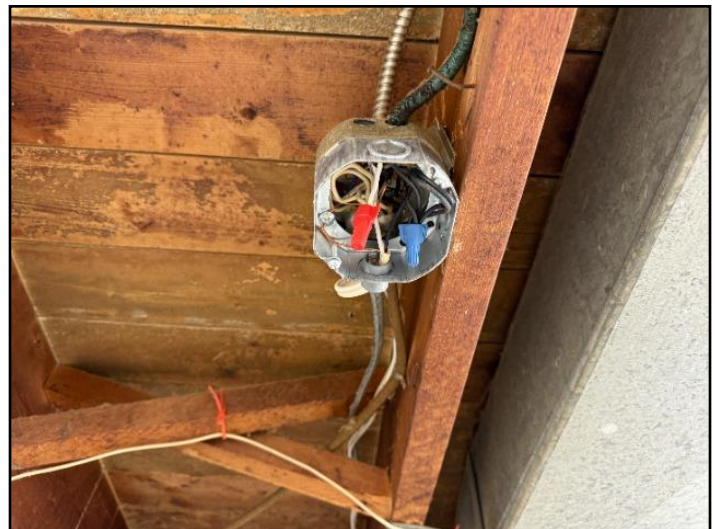
Condition: • Cover missing

Implication(s): Electric shock, Fire hazard

44. Cover missing

45. Cover missing

Time: As Soon As Possible

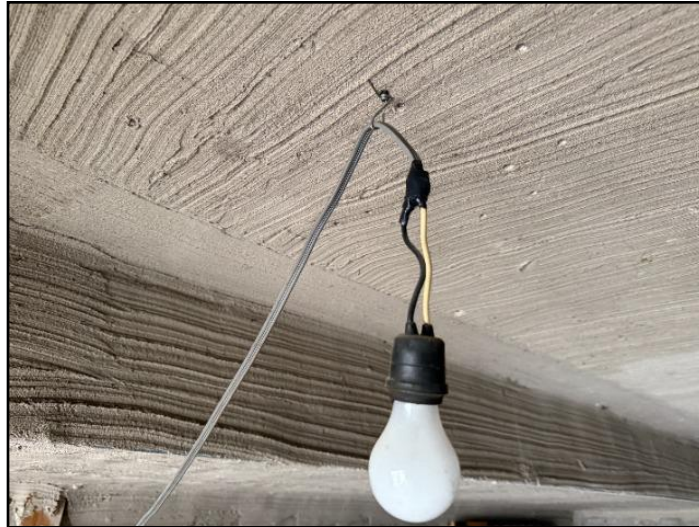
Condition: • [Damage](#)

Implication(s): Electric shock | Fire hazard

46. Damage

Time: Before using

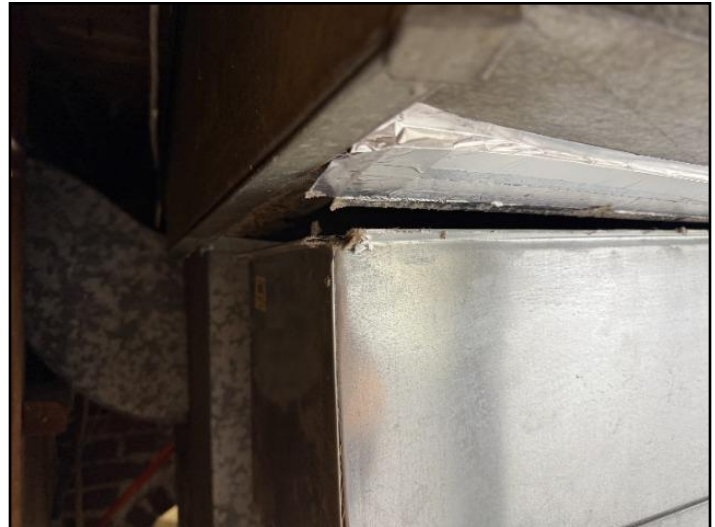
Condition: • [Disconnected ducts](#)

Return ducting not secured. Entire section loose

49. Disconnected ducts

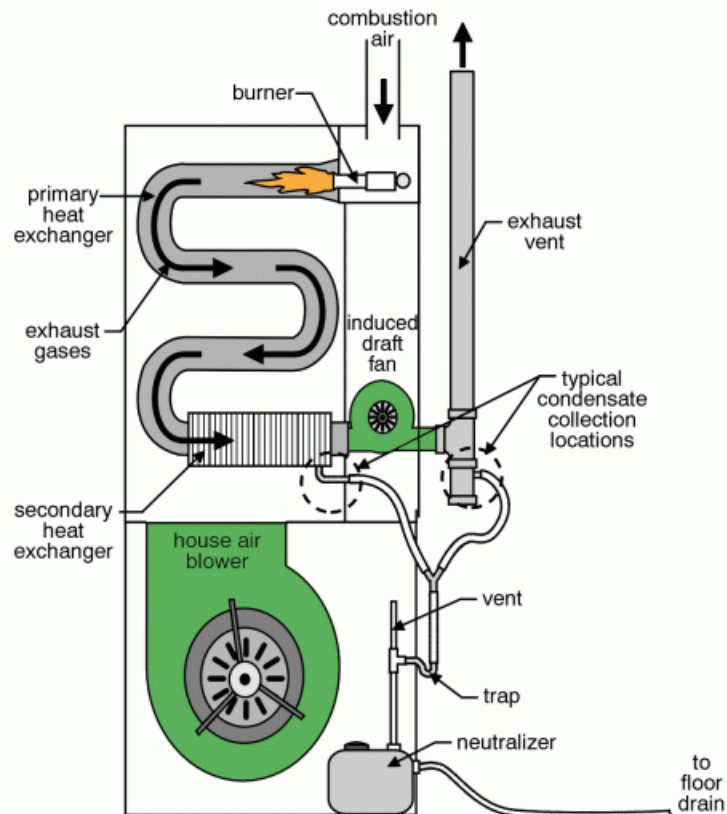
Condition: • [Condensate problems](#)

Various areas of rust and evidence of prior condensate leak noted inside furnace cabinet. Dry at time of inspection. Unknown if issue is resolved, active or intermittent. Have HVAC technician service the unit and check all interior components including heat exchanger for rust.

Implication(s): Chance of water damage to structure, finishes and contents | Reduced system life expectancy

50. Condensate problems

Time: Less than 6 months

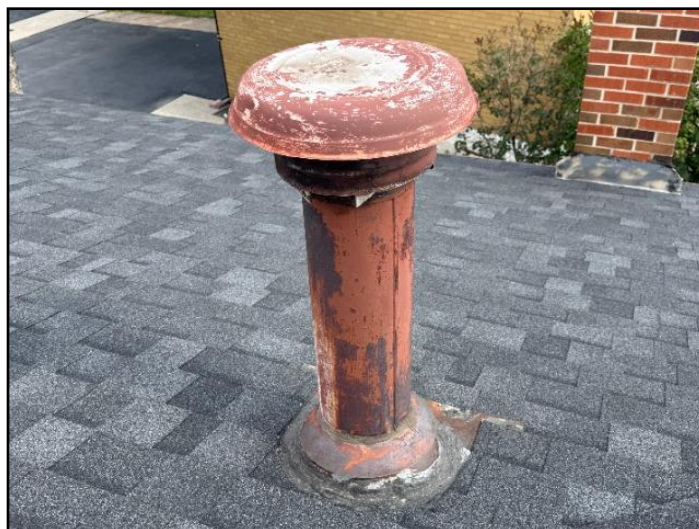
Condition: • Chimney walls rusting and treated with rust-proof type application

The metal chimney shows signs of prior rusting but appears to have been treated with rust-inhibiting paint to slow further deterioration.

Implication(s): Chance of movement | Hazardous combustion products entering home

51. Chimney walls rusting and treated with...

Time: Ongoing

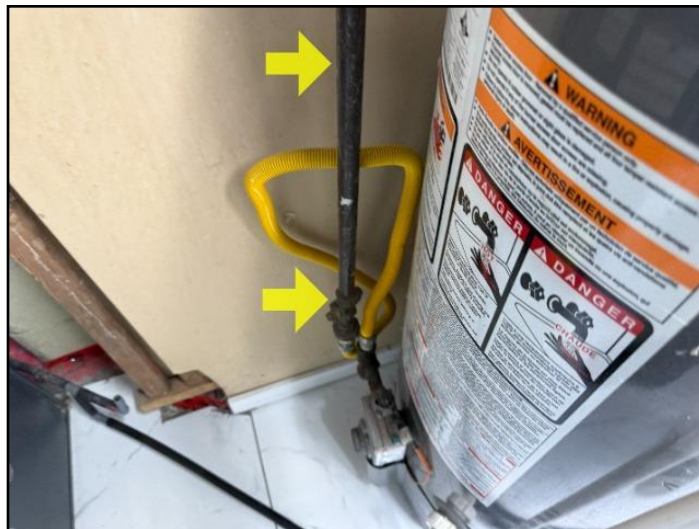
Condition: • [Inadequate support](#)

54. Inadequate support

Task: Correct

Time: As Soon As Possible

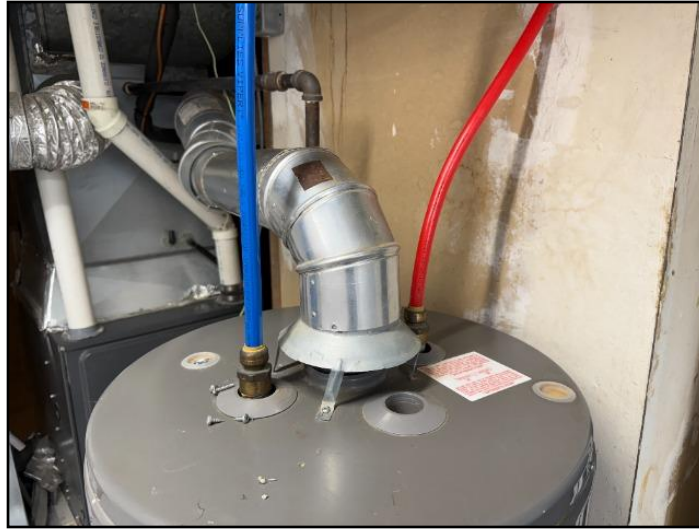
55. PEX (cross-linked polyethylene) is connecte...

Task: Further evaluation / Correct

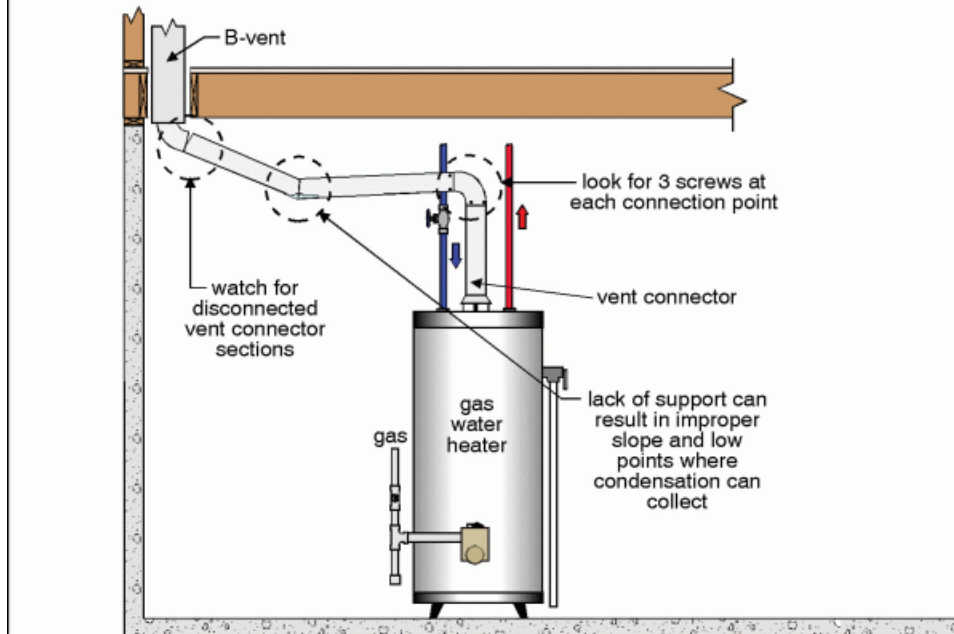
Condition: • [Poor slope](#)

Implication(s): Equipment not operating properly | Hazardous combustion products entering home

56. Poor slope

Time: As Soon As Possible

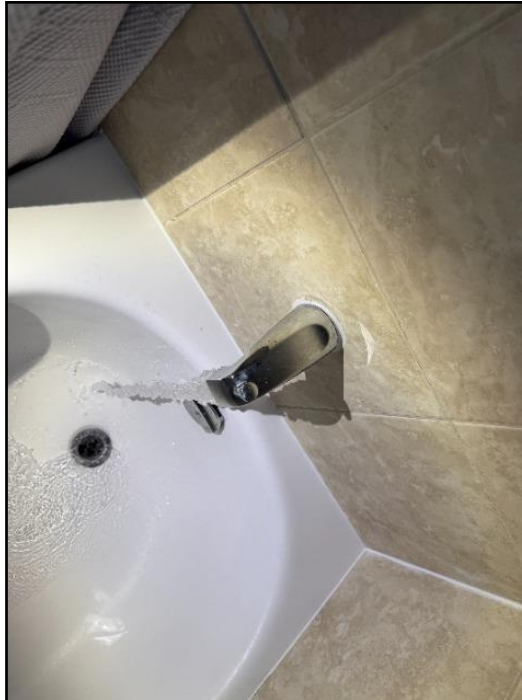
57. Loose

Task: Secure and seal

Time: Prior to first use

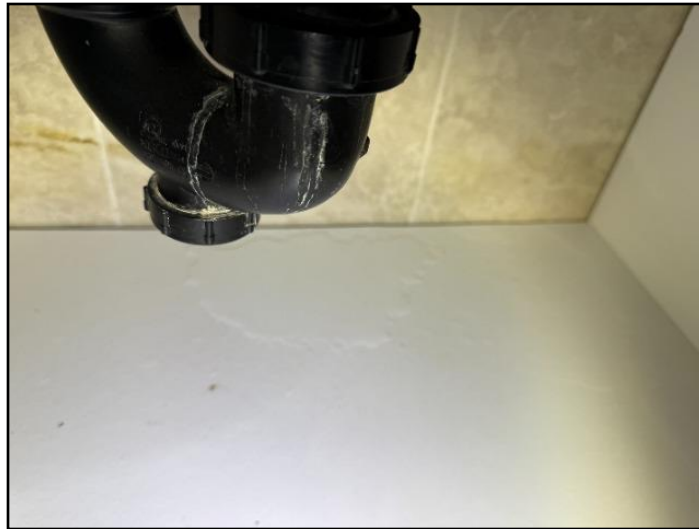
58. Leak

Time: Before using

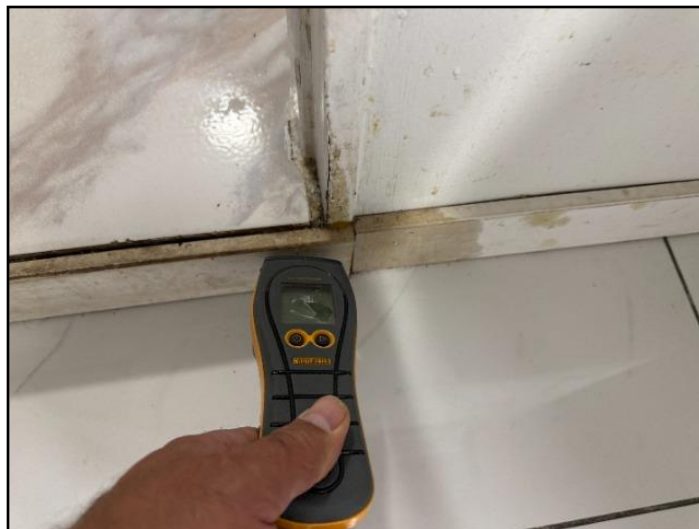
Location: Various Basement

59. Water stains

Task: Monitor for moisture / water intrusion

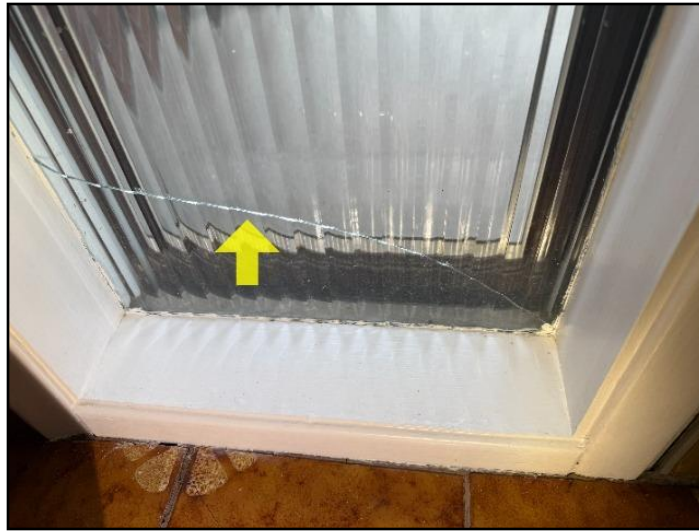
60. Cracked

Time: As Soon As Possible

Cost: \$300 - \$600

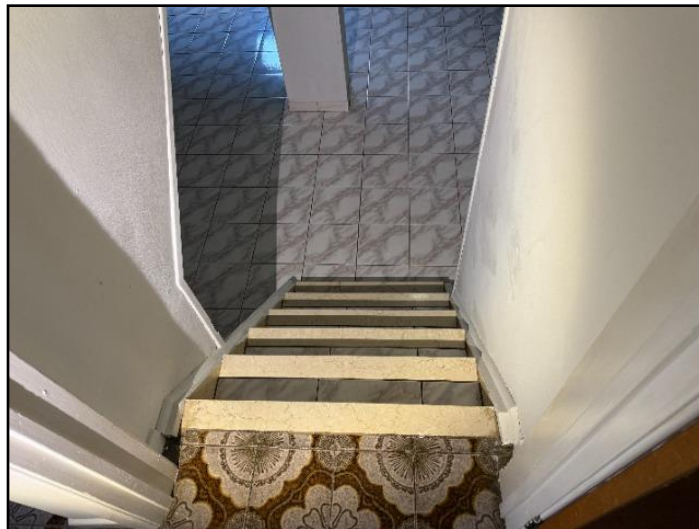
61. Missing

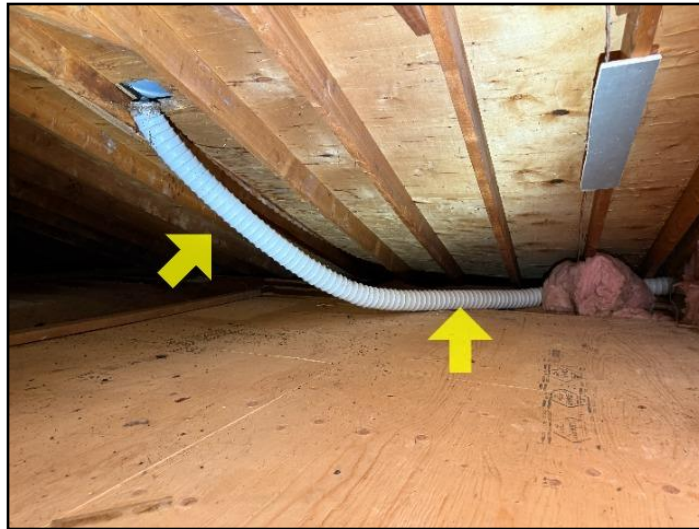
62. Not insulated in unconditioned space

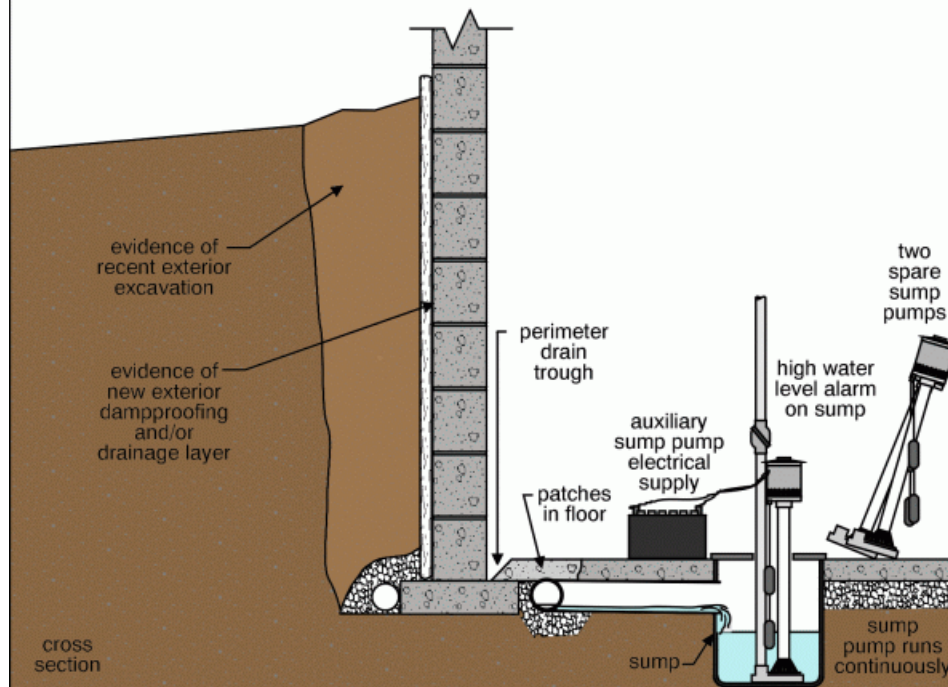
63. Water marks

Task: Monitor for moisture / water intrusion

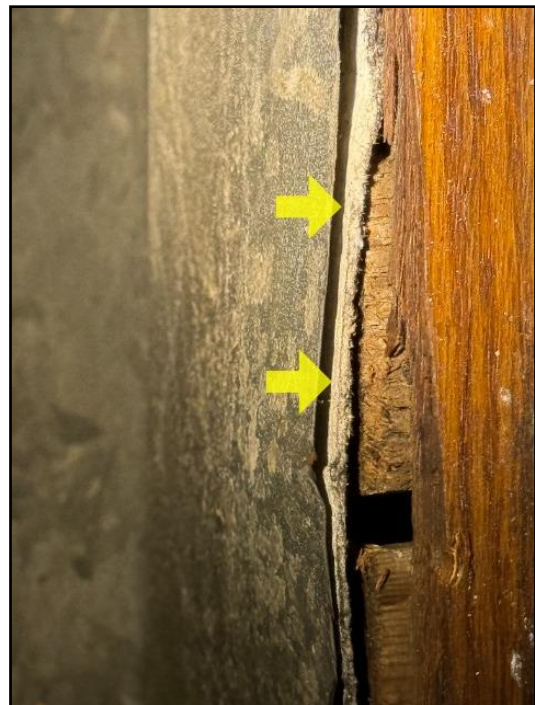
Condition: • Possible asbestos containing materials

In homes of this age, it was common to wrap floor registers and vent penetrations (such as around a water heater or furnace vent passing through ceilings or walls) with insulation to reduce heat transfer. These wraps may contain asbestos; however, confirming asbestos content is outside the scope of a home inspection. Health Canada advises that suspected asbestos materials be left undisturbed. If renovations are planned or if there are concerns, consult a qualified specialist for testing and recommendations.

65. Possible asbestos containing materials
