# INSPECTION REPORT

**58 PAULINE AVENUE**

TORONTO, ON M6H 3M8

Report No. 3658, v.3

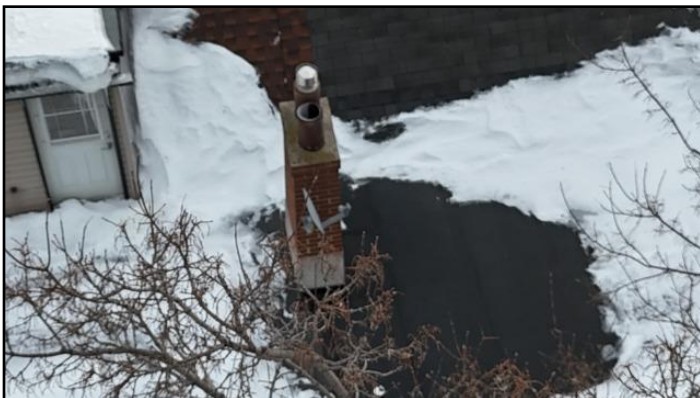
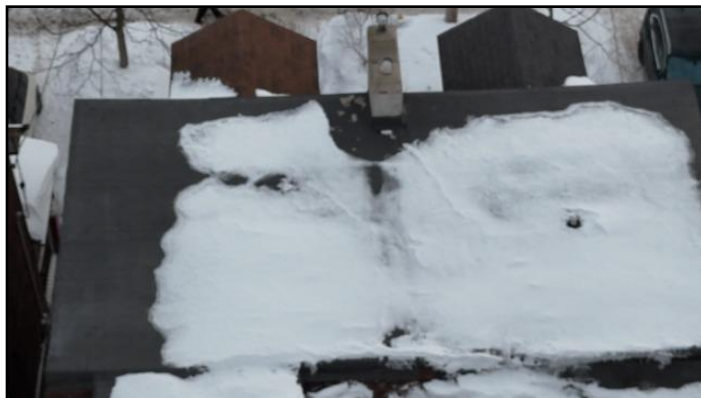
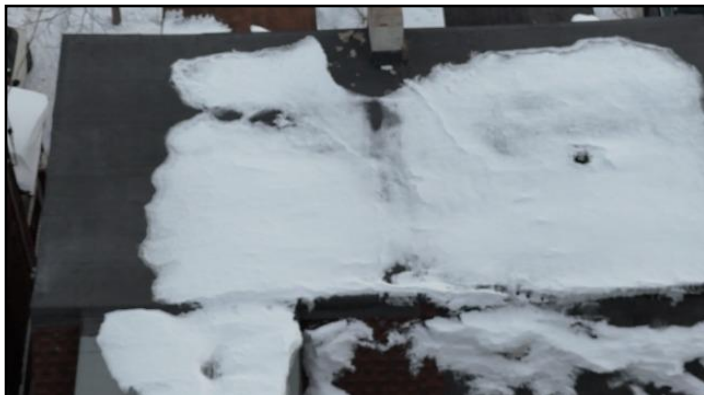
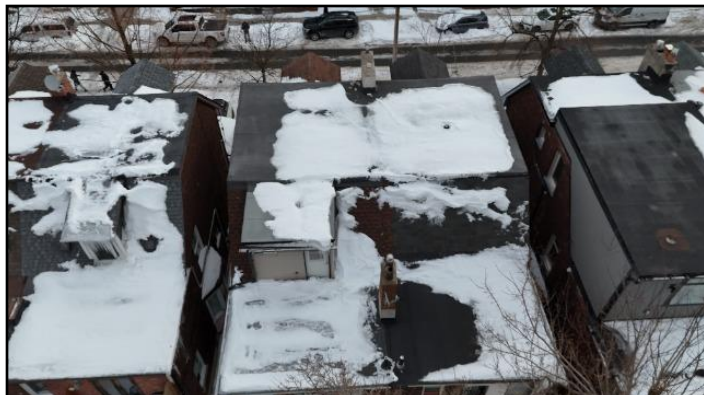
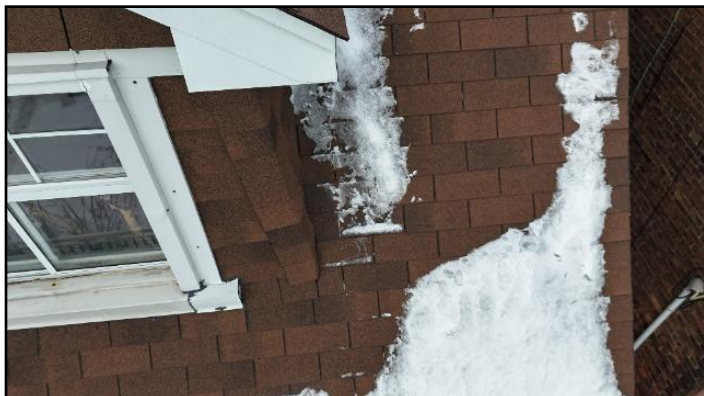
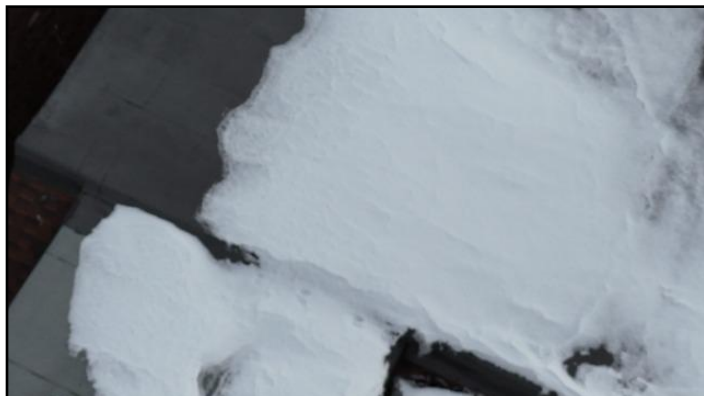
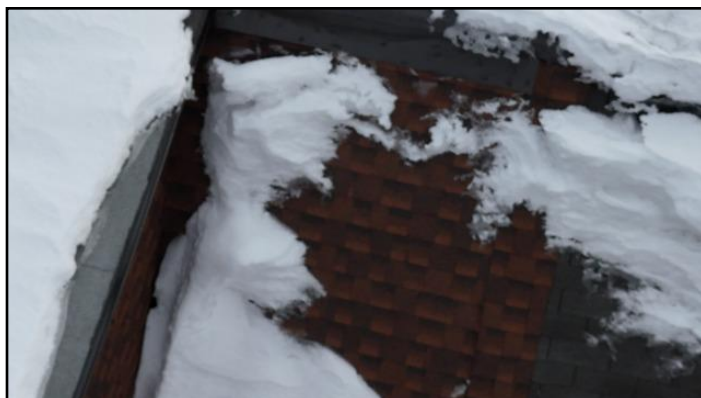
During the inspection, snow accumulation on the roof limited access and visibility, which restricted a full assessment of its condition.

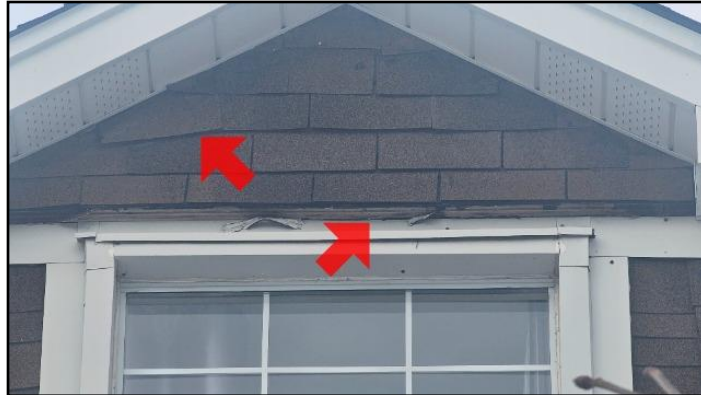
**1. Condition:** • Vulnerable areas

**Implication(s):** Chance of water damage to structure, finishes and contents

15. *Vulnerable areas*

**Task:** Repair the Vulnerable Area

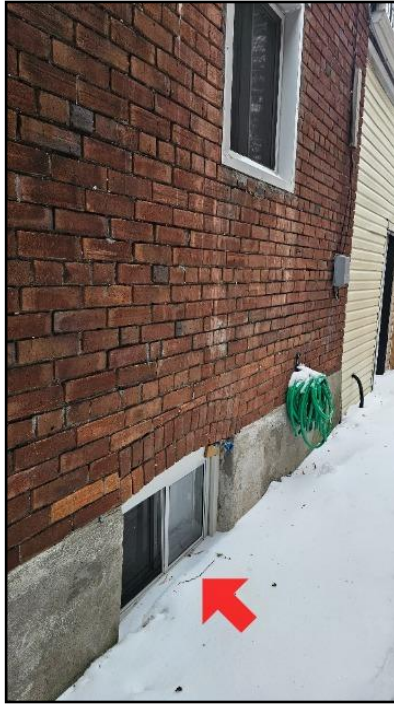
**2. Condition:** • Missing

**Implication(s):** Chance of water damage to structure, finishes and contents | Material deterioration

**16.** *Missing Window Wells*

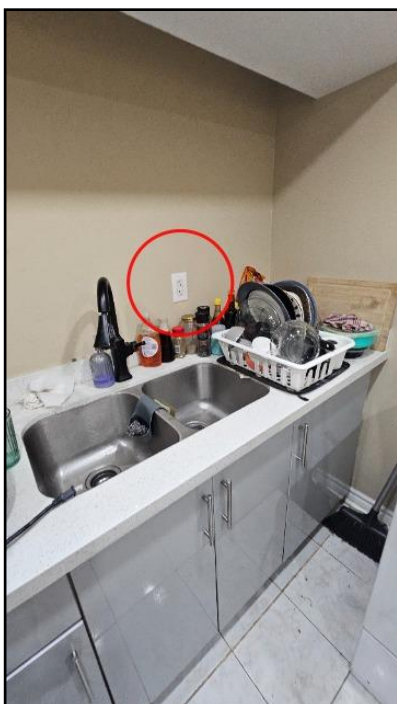
**3. Condition:** • GFCI/GFI needed (Ground Fault Circuit Interrupter)

It is recommended that GFCIs be installed in areas where appliances and power tools are used in close proximity to water. Tap water or wet objects are able to conduct electricity very easily and can connect your body to a ground potential, thus increasing your chances of receiving a shock from a ground fault.

24. GFCI/GFI needed (Ground Fault Circuit...

**Task:** Replace the Outlets with GFCI

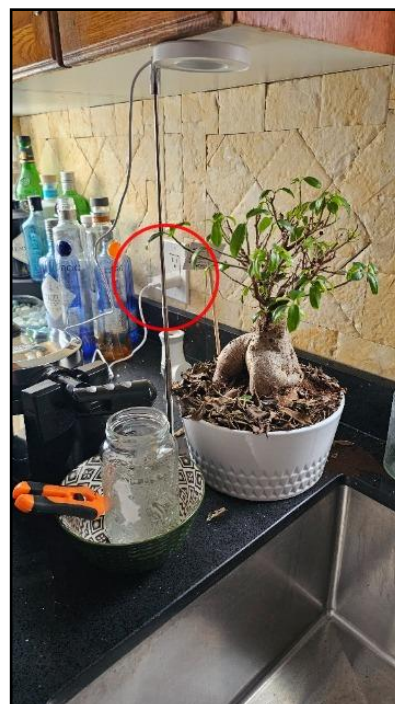
25. GFCI/GFI needed (Ground Fault Circuit...

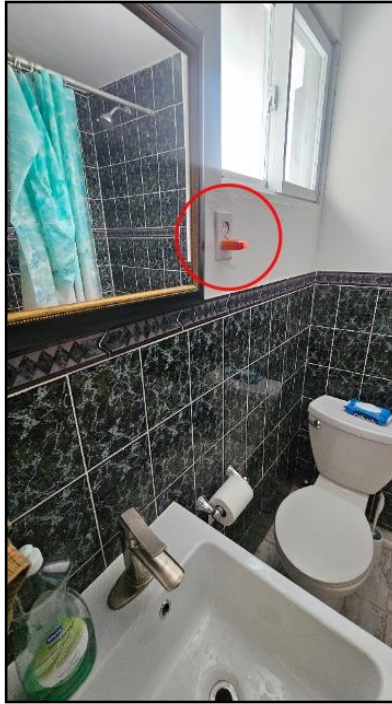
26. GFCI/GFI needed (Ground Fault Circuit...

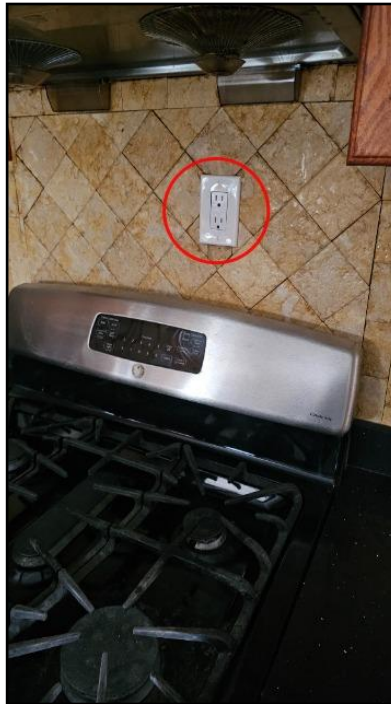
**4. Condition:** • Poor Location

27. Poor Location

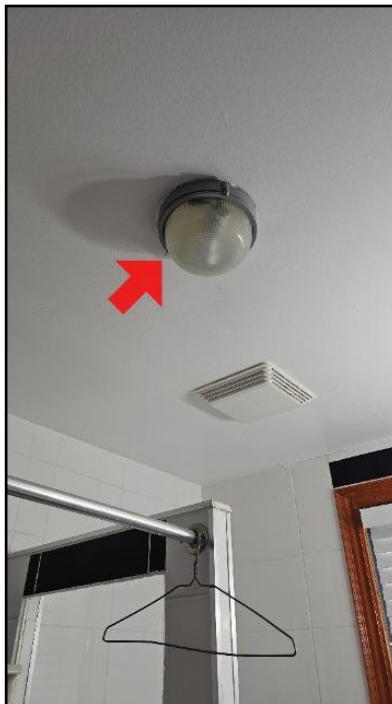
**5. Condition:** • Inoperative

**Implication(s):** Inadequate lighting

28. Inoperative Light

**Task:** Replace the Light

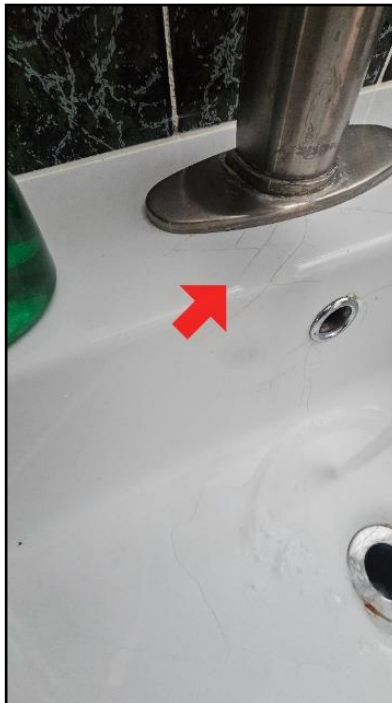
**8. Condition:** • Surface defects

**33.** *Surface defects*

**Task:** Replace Sink

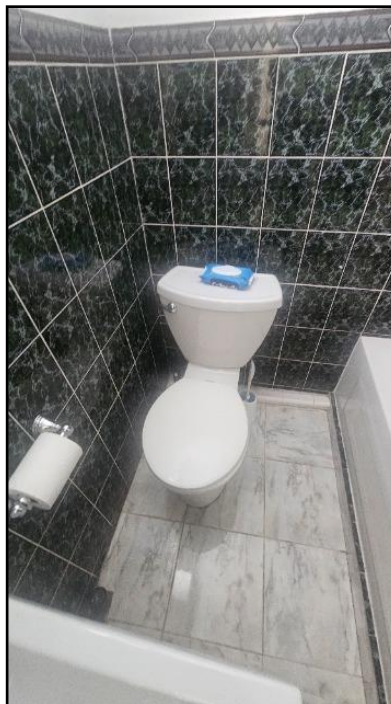
**9. Condition:** • Loose

**Implication(s):** Chance of water damage to structure, finishes and contents | Sewage entering the building | Possible hidden damage

34. Loose Toilet Seat

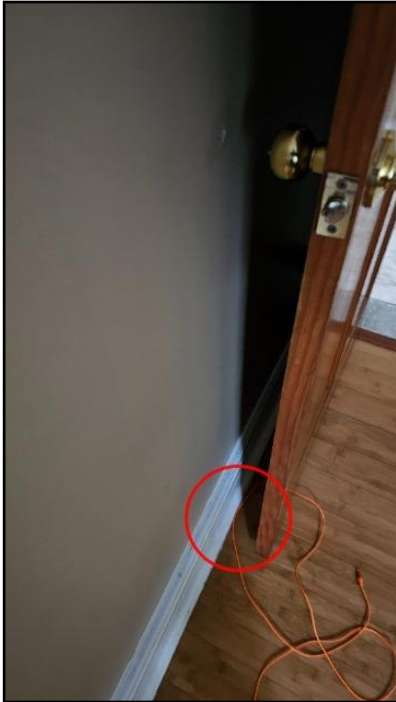
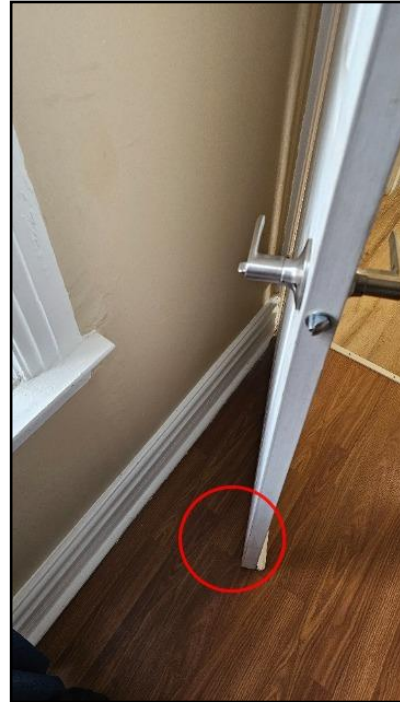
**10. Condition:** • Door Stoppers recommended

Door stoppers were observed to be missing. It is recommended that they be installed promptly to prevent damage to walls and doors.

43. Door Stoppers recommended

44. Door Stoppers recommended

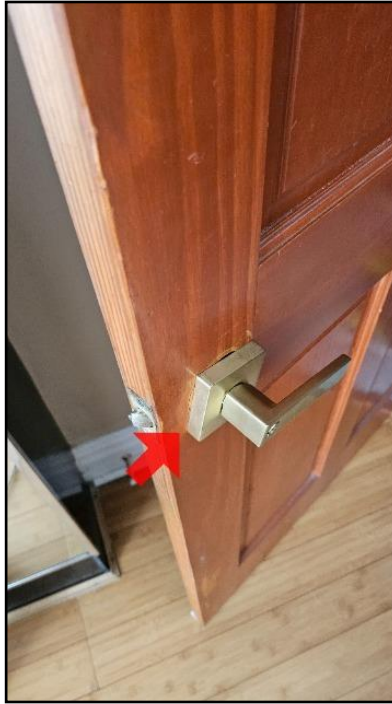
**11. Condition:** • Loose Handles

45. Loose Handle

**Task:** Repair the Loose Handle

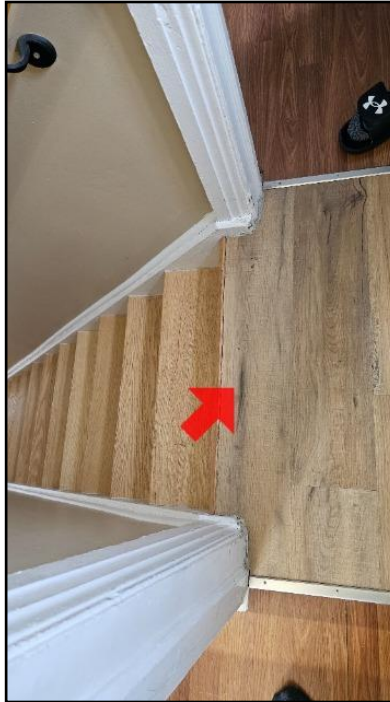
**12. Condition:** • Slopy

46. Slopy landing

**Task:** Repair the Slopy Landing

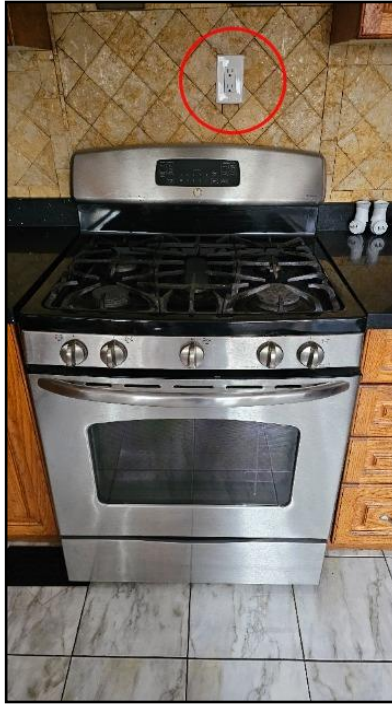
**13. Condition:** • Inoperative

At the time of inspection , the oven was disconnected and it was not inspected as a part of inspection . It is recommended to connect it & Check the functionality.

**47.** *Inoperative Oven*
