YOUR INSPECTION REPORT

53 Woodside Avenue
Toronto, ON M6P 1L9

INSPECTION DATE:
Thursday, November 8, 2018

RE: Report No. 2370
53 Woodside Avenue
Toronto, ON
M6P 1L9

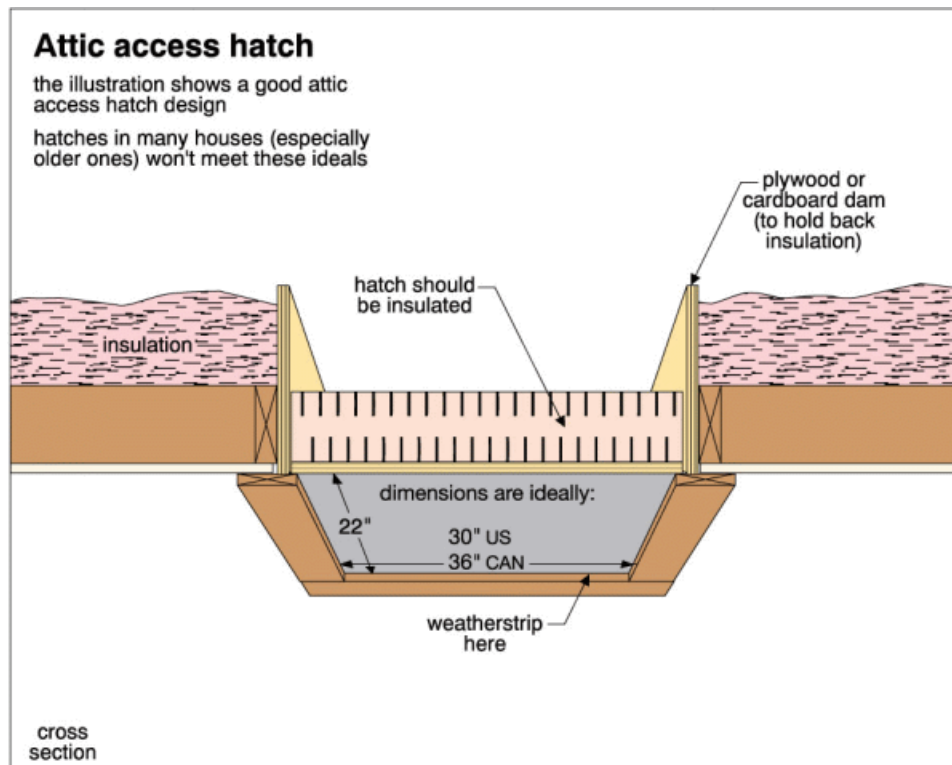
Condition: • [Inaccessible](#)

The attic hatch opening is too small and fastened shut, therefore we could not observe the attic. Attics are important areas. Provide larger access and inspect attic for issues with structure, insulation, water damage, vermiculite asbestos, and mold.

Task: Provide access and inspect

Time: As soon as possible
