# YOUR INSPECTION REPORT

38 Harshaw Avenue  
Toronto, ON M6S 1Y1

INSPECTION DATE:  
Wednesday, August 12, 2020

RE: Report No. 2704, v.3  
38 Harshaw Avenue  
Toronto, ON  
M6S 1Y1

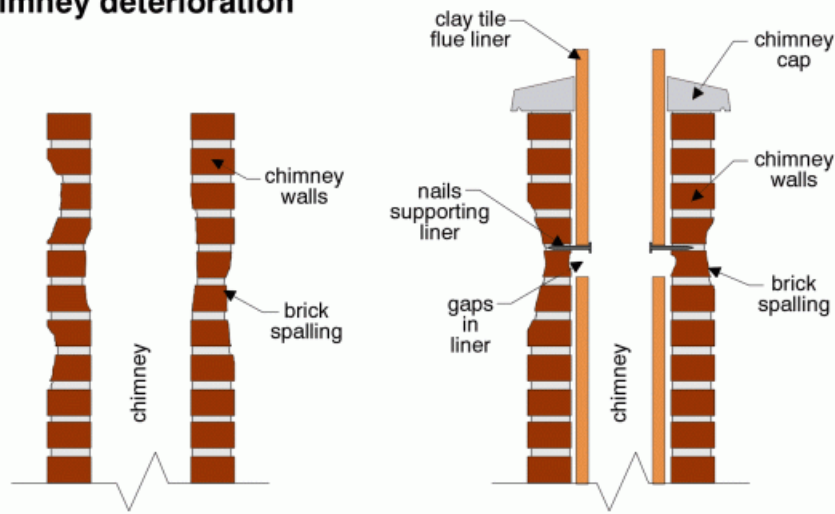
## Chimney deterioration

unlined chimneys are particularly prone to damage caused by condensation of flue gases - the damage tends to be worse near the top of the chimney

even lined chimneys can suffer from condensation related brick damage

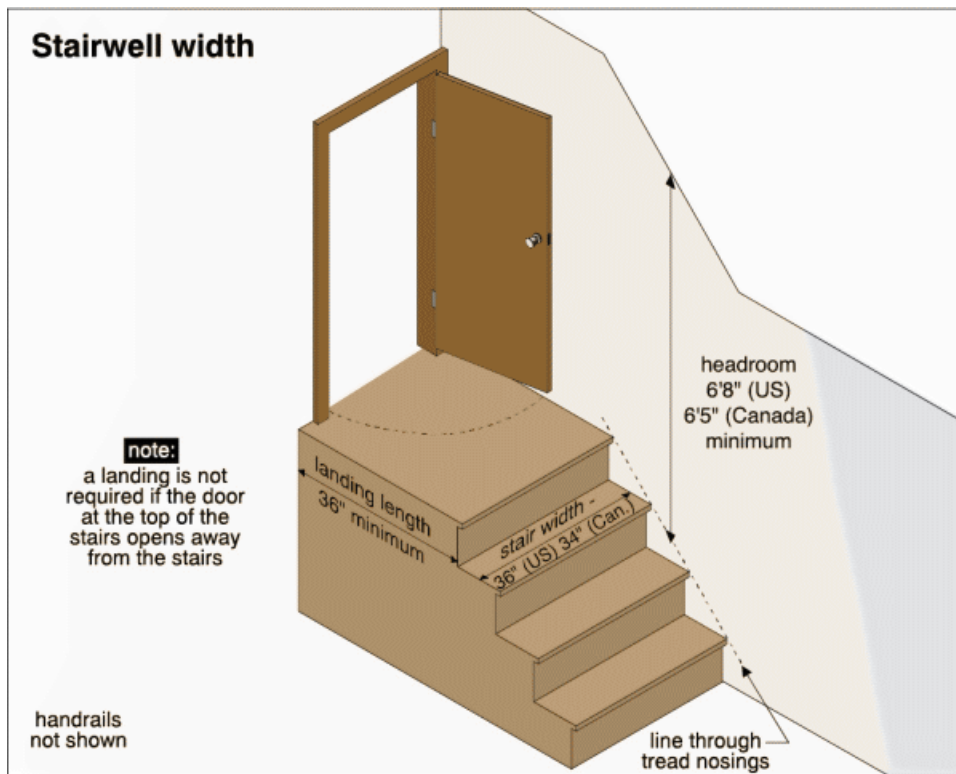
**Task:** Switch door direction
