YOUR INSPECTION REPORT

FOR THE PROPERTY AT:
251 Driftwood Avenue
Toronto, ON M3N 2N6

PREPARED FOR:
KARLA WARDLE
EMIR DICKSON
INSPECTION DATE:
Friday, September 5, 2025

RE: Report No. 8537
251 Driftwood Avenue
Toronto, ON
M3N 2N6

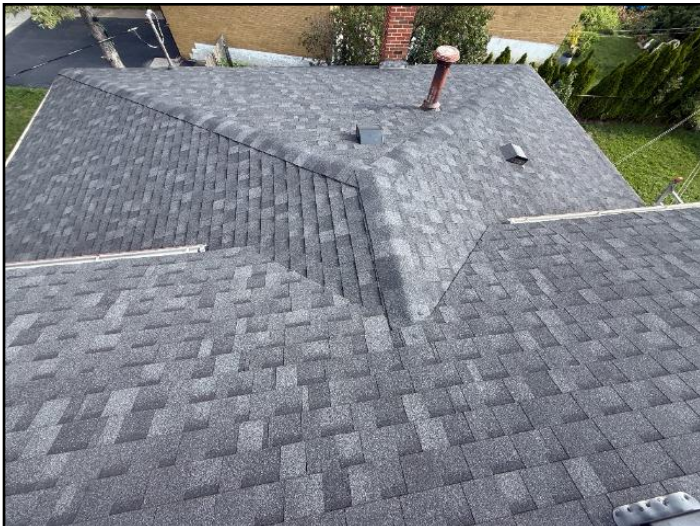
1. Asphalt shingles -- Good condition

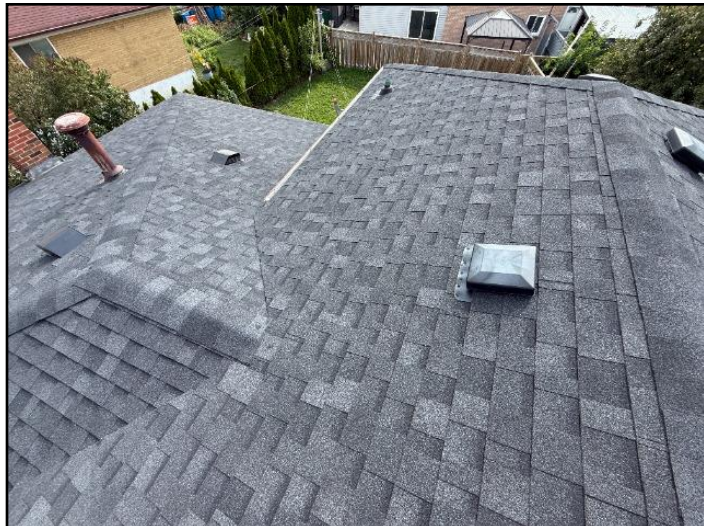
2. Asphalt shingles -- Good condition

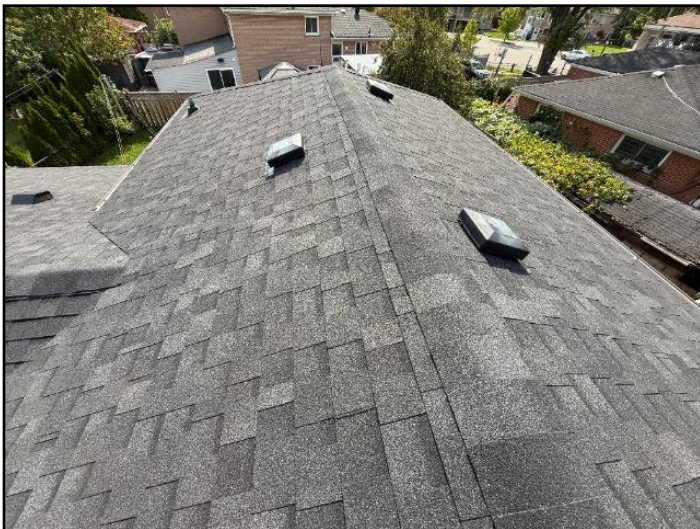
3. Asphalt shingles -- Good condition

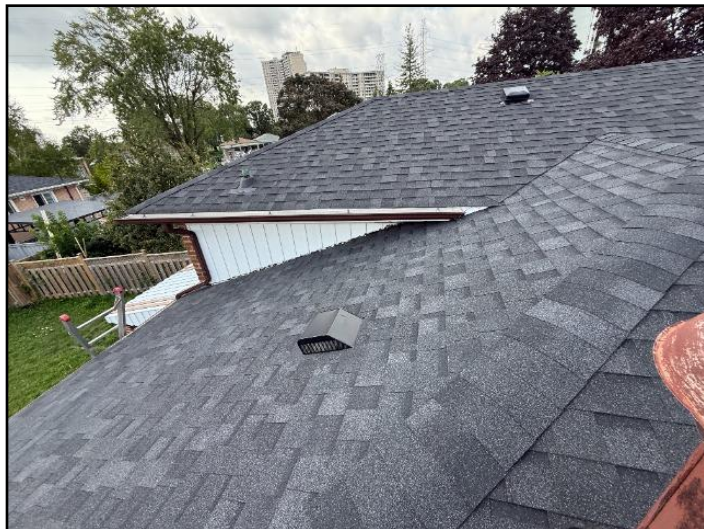
4. Asphalt shingles -- Good condition

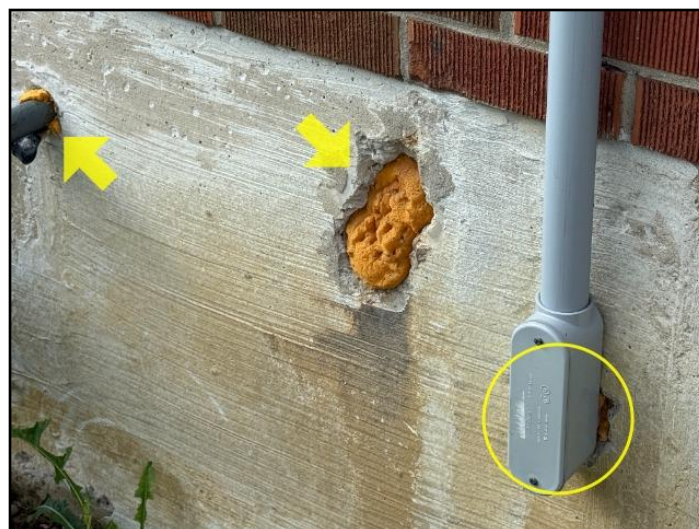
9. example

Condition: • [Caulking missing or ineffective](#)

Task: Correct

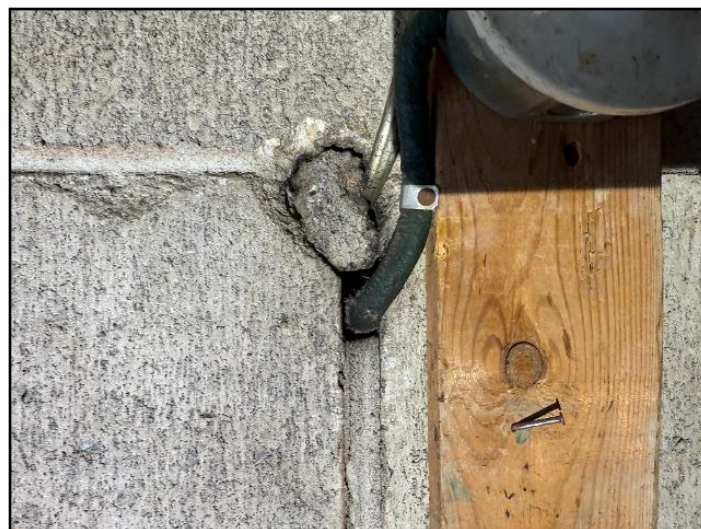
21. Not gastight

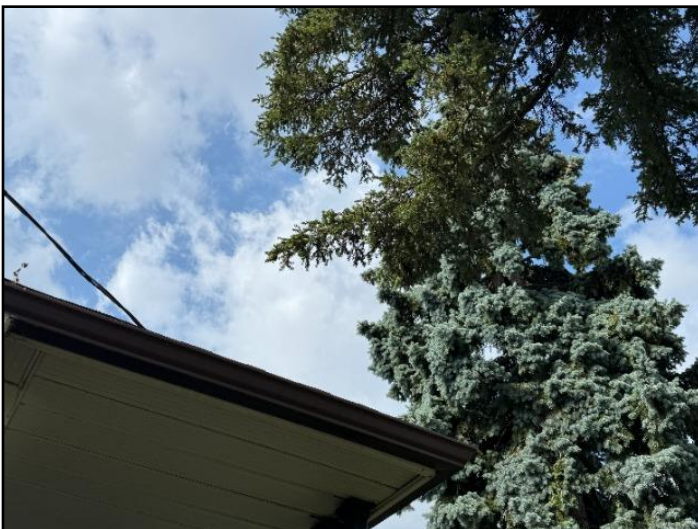
24. trim trees

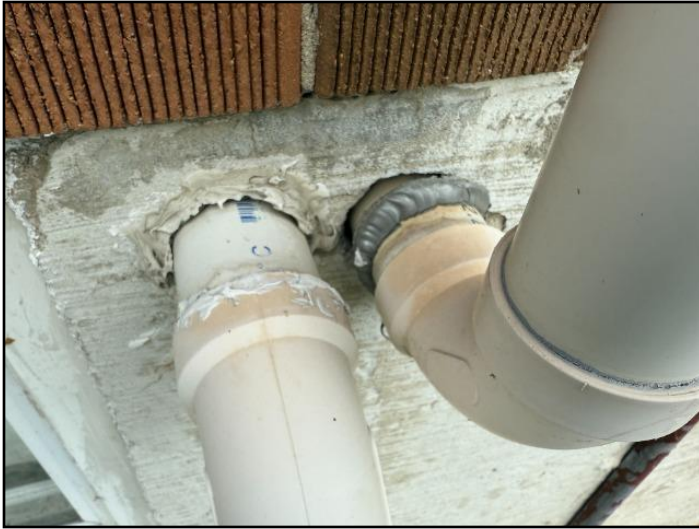
26. provide caulking

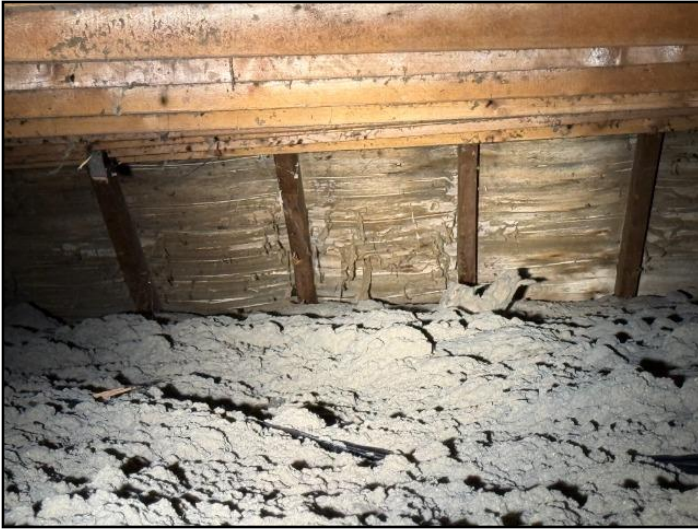
Condition: • [Delaminated](#)

34. Delaminated

Task: Replace sheathing at next roof replacement

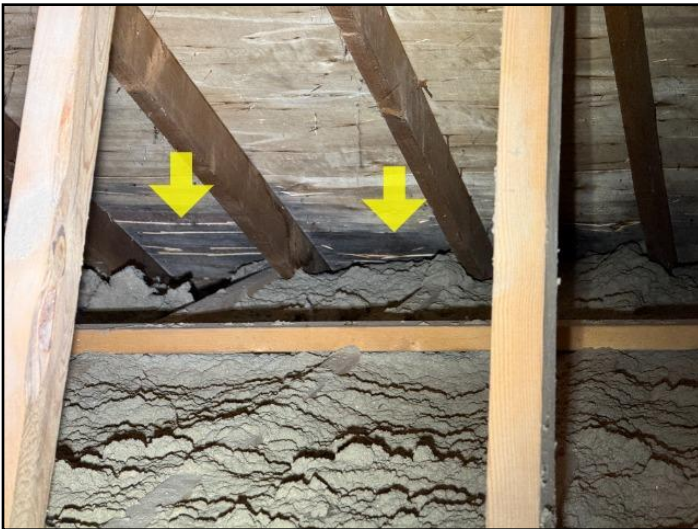
Condition: • Mold / Fungi - localized area(s)

Observed at localized areas of sheathing. Mold assessment is outside our scope of work. Consult specialist or contact us for list of service providers.

36. Mold / Fungi - localized area(s)

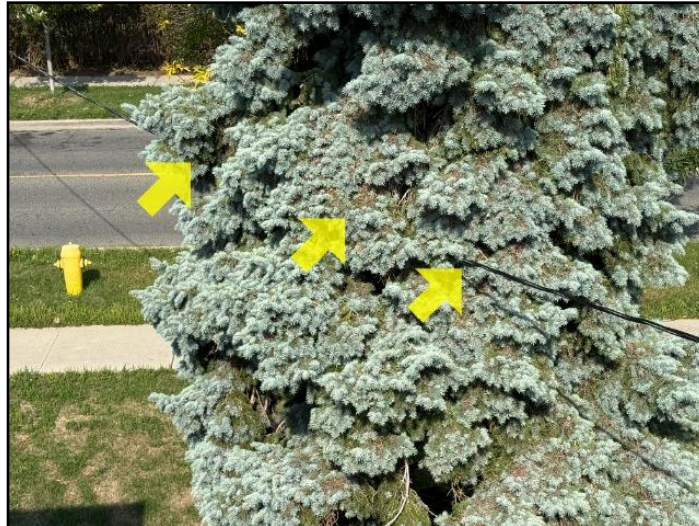
Condition: • [Branches / vines interfering with wires](#)

Implication(s): Damage to wire | Electric shock | Interruption of electrical service

39. Branches / vines interfering with wires

Task: Correct

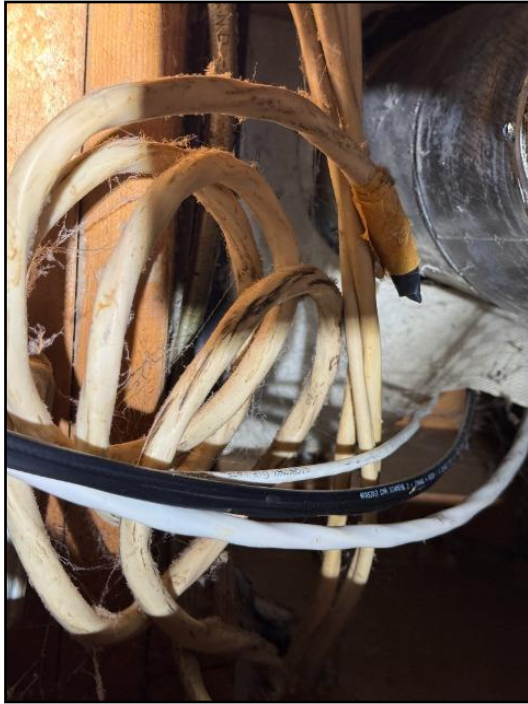
42. Abandoned wire

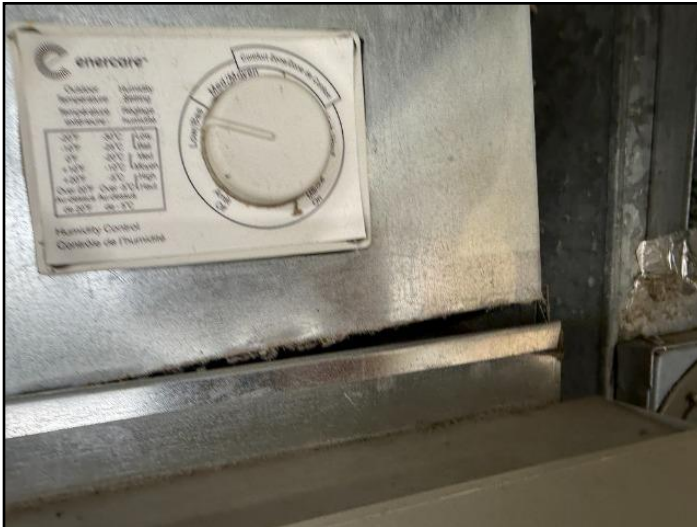
Condition: • [Disconnected ducts](#)

Return ducting not secured. Entire section loose

48. Disconnected ducts

Task: Correct

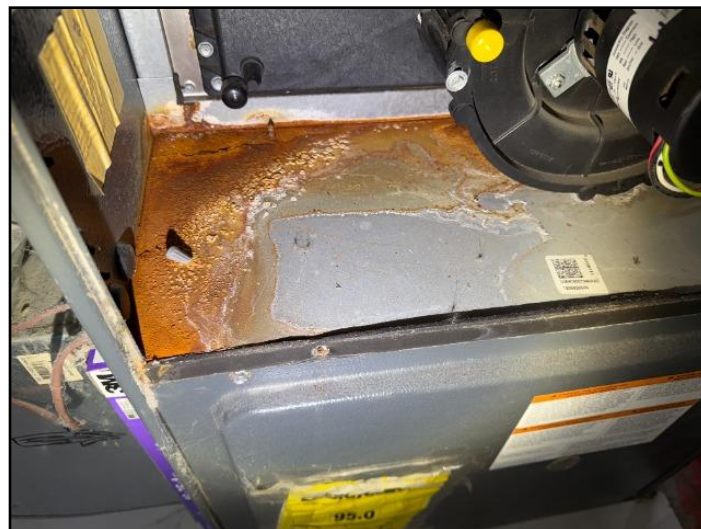
50. Condensate problems

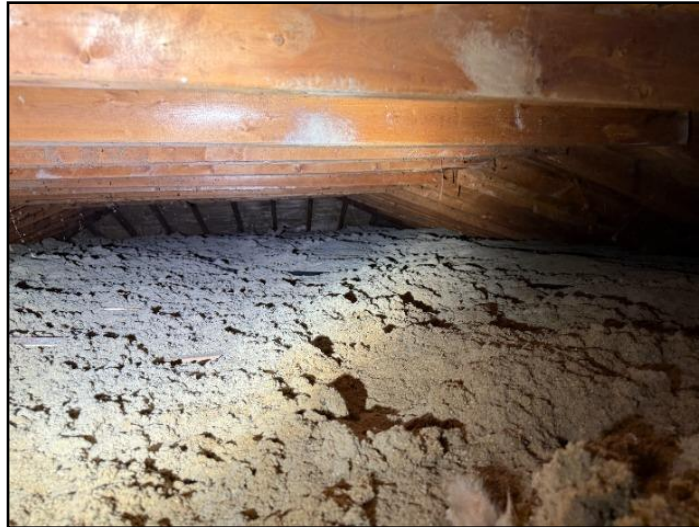
Cellulose fiber blown in over top original Glass fiber

52. cellulose fiber

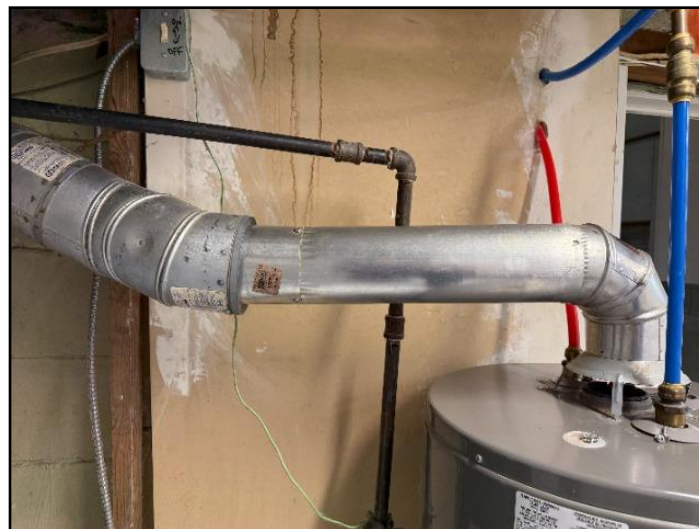
Condition: • [Poor slope](#)

Implication(s): Equipment not operating properly | Hazardous combustion products entering home

56. Poor slope

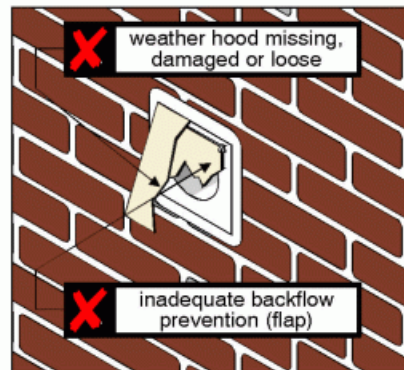
62. Not insulated in unconditioned space

Condition: • [Not insulated in unconditioned space](#)

Implication(s): Chance of condensation damage to finishes and/or structure

Exhaust fan conditions

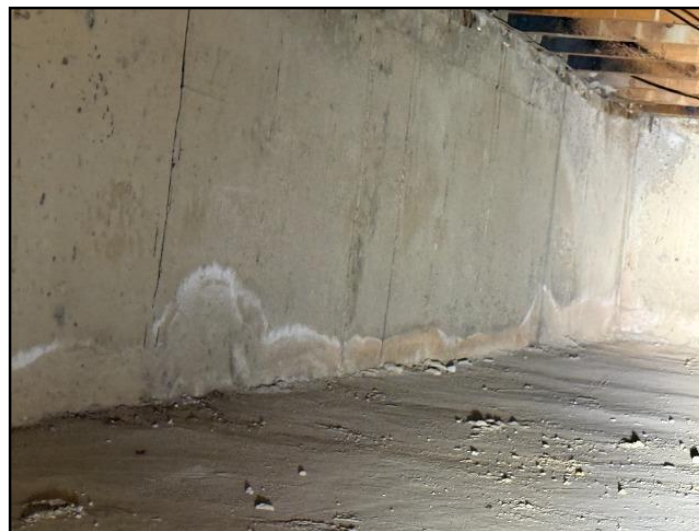
63. Water marks

Condition: • [Water marks](#)

Evidence of prior water stains and efflorescence. It is very common to find stains and efflorescence in crawlspaces. Some have likely been present for decades. Prudent to monitor ongoing and view after heavy rainfalls.

Implication(s): Chance of water damage to structure, finishes and contents

Task: Monitor for moisture / water intrusion

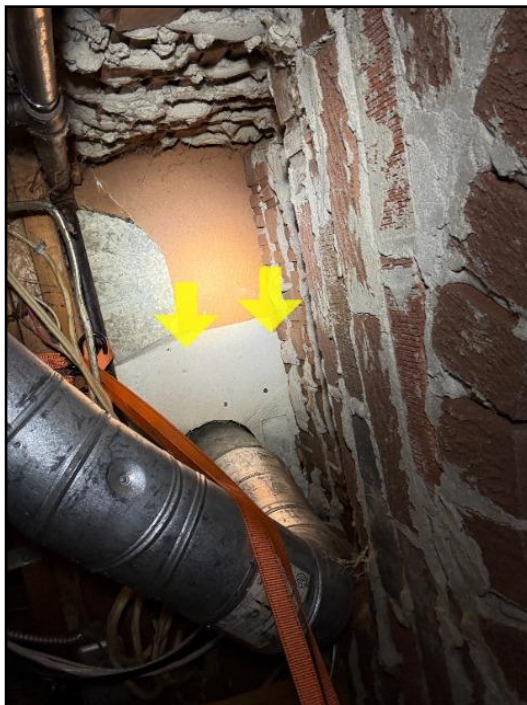
64. Possible asbestos containing materials

Condition: • Possible asbestos containing materials

In homes of this age, it was common to wrap floor registers and vent penetrations (such as around a water heater or furnace vent passing through ceilings or walls) with insulation to reduce heat transfer. These wraps may contain asbestos; however, confirming asbestos content is outside the scope of a home inspection. Health Canada advises that suspected asbestos materials be left undisturbed. If renovations are planned or if there are concerns, consult a qualified specialist for testing and recommendations.

Implication(s): Health hazard

Time: Before disturbing material

Cost: \$150 - \$250 per register if asbestos is present
